Charles River Amphitheatre Baseline Documentation Report

Prepared for: Town of Medway

Prepared by: Anne Capra, Conservation Works, LLC

Date of Report: May 5, 2018

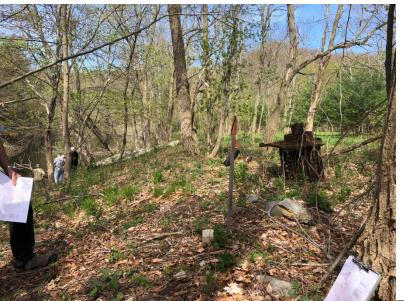
Several piles of dumped brick and concrete debris were observed along the east boundary in the southeast and northeast corners. A rusted metal implement was also observed int eh southeast corner (waypoint 2, photo 3).

To be the last		<u> </u>
Photo	Cardinal	Wpt#	Location Description	Description of Photo Subject
#	Direction			
3	W	2	Southeast corner at concrete bound	View into property; concrete bound and
			with drill hole approx. 30' from	stake; rusted metal implement; Charles
			bank of Charles River	River on left

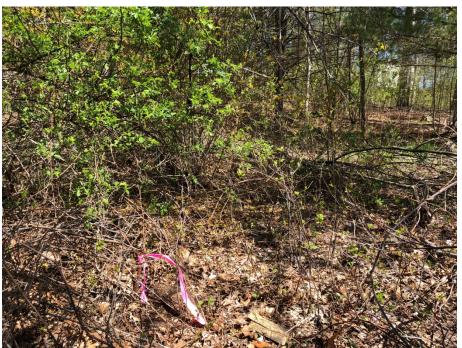
boundary follows the Charles River to an iron rebar at waypoint 5 (photo 7). According to the survey, this corner should be marked with a concrete bound with drill hole which was not found. The from this pin along the entire west boundary to the northwest corner, in a northwesterly direction, is a metal fence approximately 3' tall attached to green metal stakes. In the northwest corner, a concrete bound with drill hole was located (waypoint 6; photos 9-12). From this corner, the boundary heads northeast to a concrete bound with drill hole at waypoint 8 (photos 14-16). The north boundary continues northeast to another concrete bound with drill hole at waypoint 10 (photo 20). A drill hole set in boulder as indicated on the survey between waypoints 8 and 10 was not located. The boundary turns southeast and continues to another concrete bound with drill hole at waypoint 11 (photos 22, 23). Continuing southeast, a concrete bound with drill hole was located at waypoint 12 (photos 24, 25). Then turning southeast, concrete bounds with drill holes were located at waypoint 13 (photos 26, 27) and waypoint 14 (photo 28). The boundary turns southeast to a concrete bound with drill hole at waypoint 15 (photos 29, 30). The boundary turns northeast to a concrete bound with drill hole at waypoint 17 (photos 33, 34). The boundary turns southeast to a concrete bound with drill hole at waypoint 16 (photos 31, 32). From this northeast corner, the boundary turns southwest to join waypoint 2 and close the boundary.

Photo	Cardinal	Wpt #	Location Description	Description of Photo Subject		
#	Direction					
7	NW	5	Rebar pin at estimated southwest	Metal rebar with pink flag; property on		
			corner, wire fence on green metal	right; property line thick with multiflora		
			posts	rose

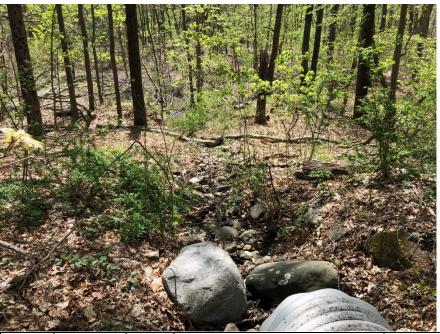
Several small wetlands were observed at the base of the slope along the northern boundary. Two stormwater outfall pipes were observed at waypoints 7 and 9 (photos 13, 18), with eroded channels down the slope at both locations.

Photo	Cardinal	Wpt#	Location Description	Description of Photo Subject
#	Direction			
13	S	7	Approximate north property line at	View into property at 24" CMP; eroded
			concrete retaining wall	outfall path down slope

Consider hand-pulling garlic mustard throughout the forested portion of the	
site	
Stormwater Management	
Locate and map storm drains connected to outfall pipes along slope on north	2019
property boundary	
Evaluate erosion at storm drain outfalls and design and, engineer best	2019-2025
management practices to restore eroded areas, capture and treat runoff	
Incorporate any and all stormwater management efforts into the town's NPDES	2019+
Phase 2 program	
Ecological Management	
To maintain the meadow, continue to mow at least twice per year (mid-June	On-going
and after hard frost in Fall)	
Maintain woody debris along the banks of the Charles River as habitat	On-going
Nurture native woody saplings (maple, ash) to establish in areas cleared of	On-going
invasive species to encourage a multi-aged forest	
Consider planting native tree, shrub and herbaceous plants in areas cleared of	2019+
invasive species and not mowed (forest and forest edge)

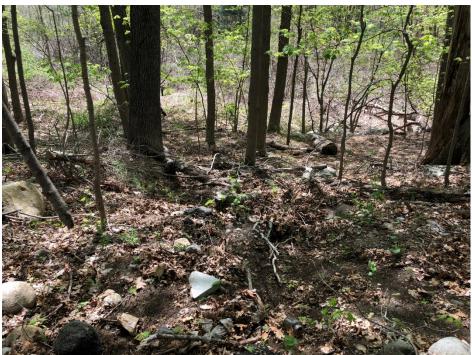
Photo	Cardinal	Wpt#	Location Description	Description of Photo Subject		
#	Direction					
17	S	8	Concrete bound with drill hole on	View into property of erosion on		
			north property line	forested slope, located 20' east of		
				waypoint 8

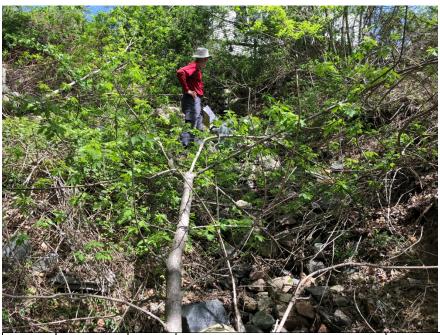
Photo	Cardinal	Wpt#	Location Description	Description of Photo Subject
#	Direction			
18	N	9	Approximate north boundary line at	View out of property to pipe outfall
			erosion channel at outfall of 12"	buried under woody debris; erosion gully
			HDPE	with rip rap

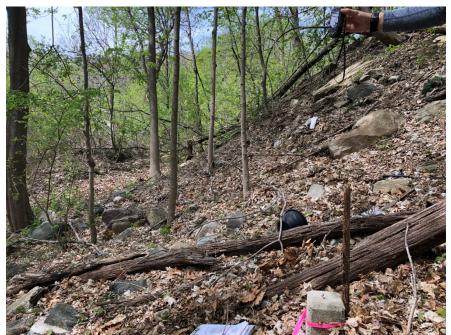
Photo	Cardinal	Wpt#	Location Description	Description of Photo Subject
#	Direction			
26	W	13	North property line at concrete bound with drill hole	Property on left of concrete bound; steep slope with boulders and sorted fill exposed; trash from abutting residential properties

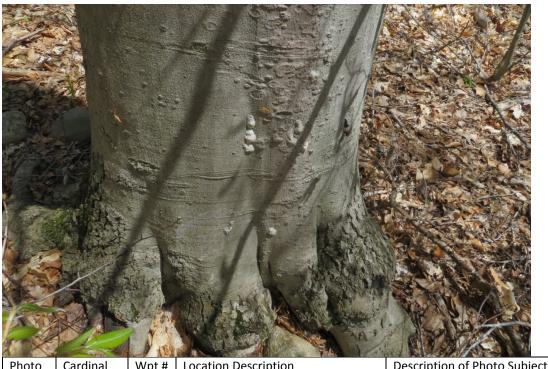
The northern third of the property consisted of an upland mixed hardwood forest, with roughly seventy percent canopy cover, including, red, black and white oaks, sugar maple, beech, and Norway maple (waypoint 19; photo 37, 38). The shrub layer was noticeably absent due to the active invasive species management. Some cavity trees and snags (standing dead trees) were observed, offering nesting habitat (waypoints 19, 20; photos 40, 42). Gypsy moth egg masses were observed on a beech tree (waypoint 19, photo 39), and deer scat and tracks were observed.

ALL DECEMBER OF THE PARTY OF TH		TA POYA		
Photo	Cardinal	Wpt#	Location Description	Description of Photo Subject
#	Direction			
39	N	19	Interior of property near west	Gypsy moth egg mass on beech tree
			property line

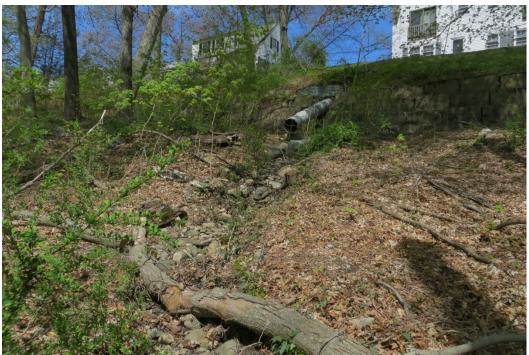
- 1	10000				
	Photo	Cardinal	Wpt#	Location Description	Description of Photo Subject
	#	Direction			
	41	NW	20	Near north boundary at bottom of	Drainage gully
				slope

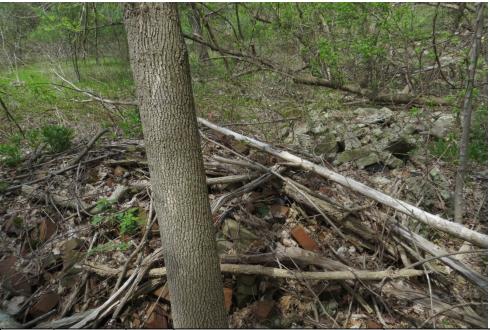
Photo	Cardinal	Wpt#	Location Description	Description of Photo Subject
#	Direction			
46	NW	24	Near northeast corner	Large pile of bricks, concrete and other
				construction debris

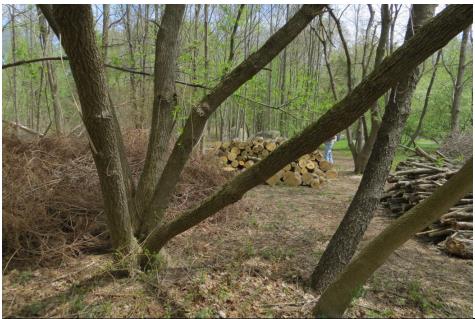
Invasive species are extensive throughout the property. The Open Space Committee with support from the Department of Public Services is actively engaged in manually removing the woody species. The field is also mowed several times per year to both maintain a trail through the field, and to control vegetative re-growth. In April 2018 prior to the site visit, the Boy Scouts worked with members of the Open Space Committee to clear woody invasives. Brush piles and stacks of logs were observed waiting for pick up for disposal by the Department of Public Services (waypoint 25, photo 47).

COMPANY OF STATE OF S			
Photo	Cardinal	Wpt#	Location Description	Description of Photo Subject
#	Direction			
47	NE	25	Center of property near boulders	Brush piles from invasive species removal
				work; two large boulders

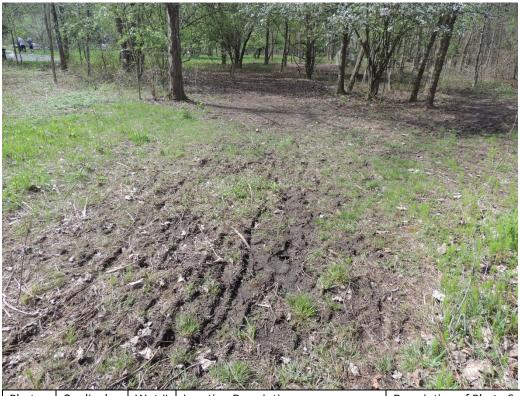
Photo #	Cardinal Direction	Wpt#	Location Description	Description of Photo Subject
52	SW	30	Trail	Wet spot on trail

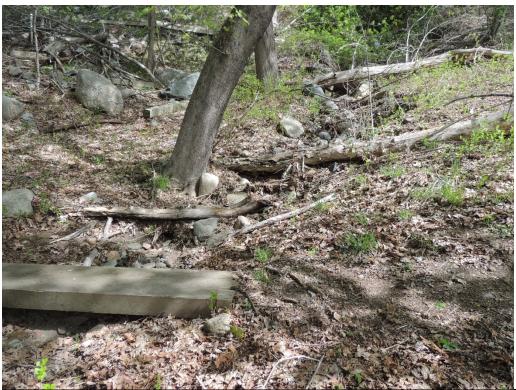
Photo	Cardinal	Wpt#	Location Description	Description of Photo Subject
#	Direction			
58	N	34	Trail	Bog bridge across trail at eroded runoff
				channel
