June 14, 2022 Medway Planning & Economic Development Board Meeting

Construction Reports

RE: Medway Mills - Monthly Inspection Report: 165 Main Street, Medway, MA 02053.

CONSTRUCTION INSPECTION REPORT

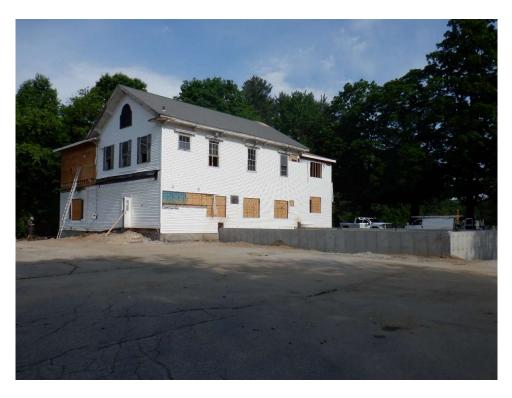
Building addition foundation

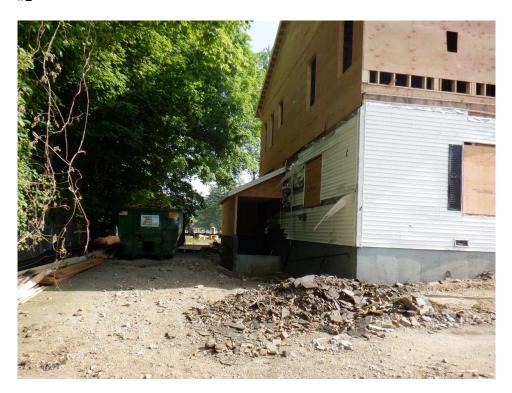
#2

Rear Building - stripped asphalt & new framing

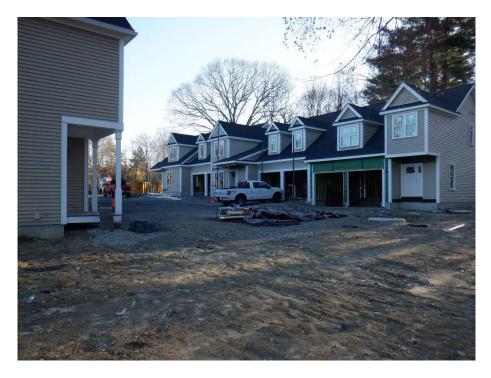
Building 2 Enclosed

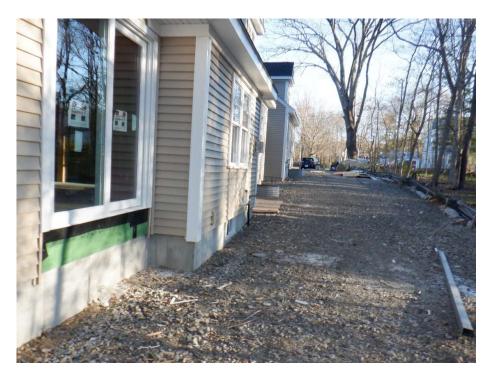
#2

Rear Building 2 – rough graded
