**Medway Planning & Economic Development Board  
Meeting**

**Construction Reports**

## **CONSTRUCTION INSPECTION REPORT**

## Construction Observation Report

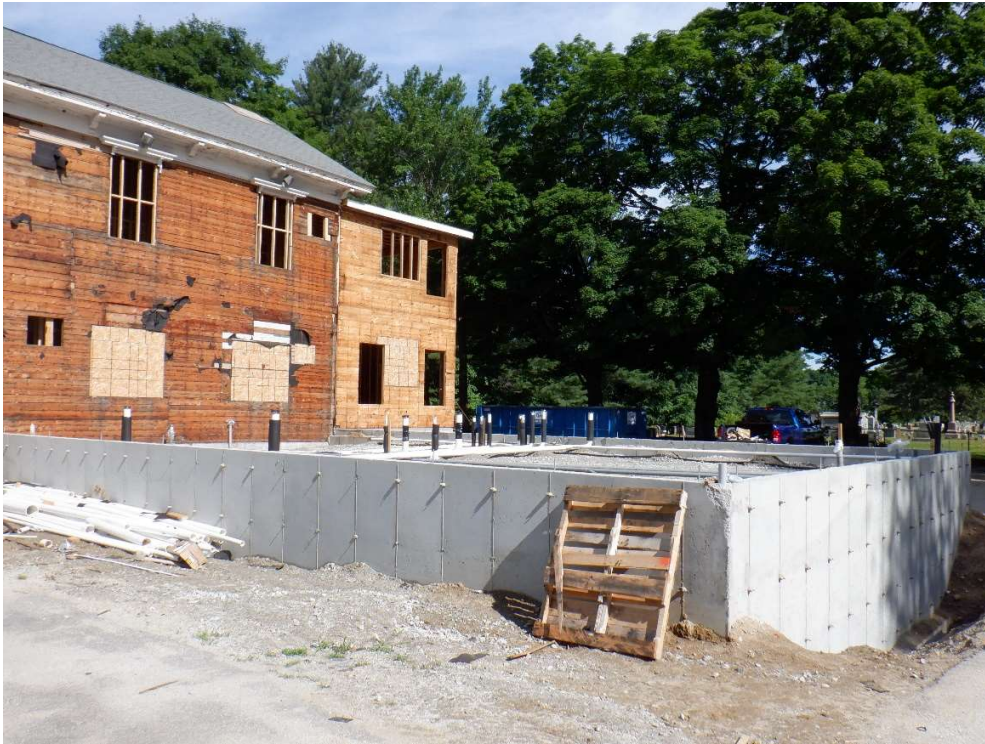
#1

Building addition piping

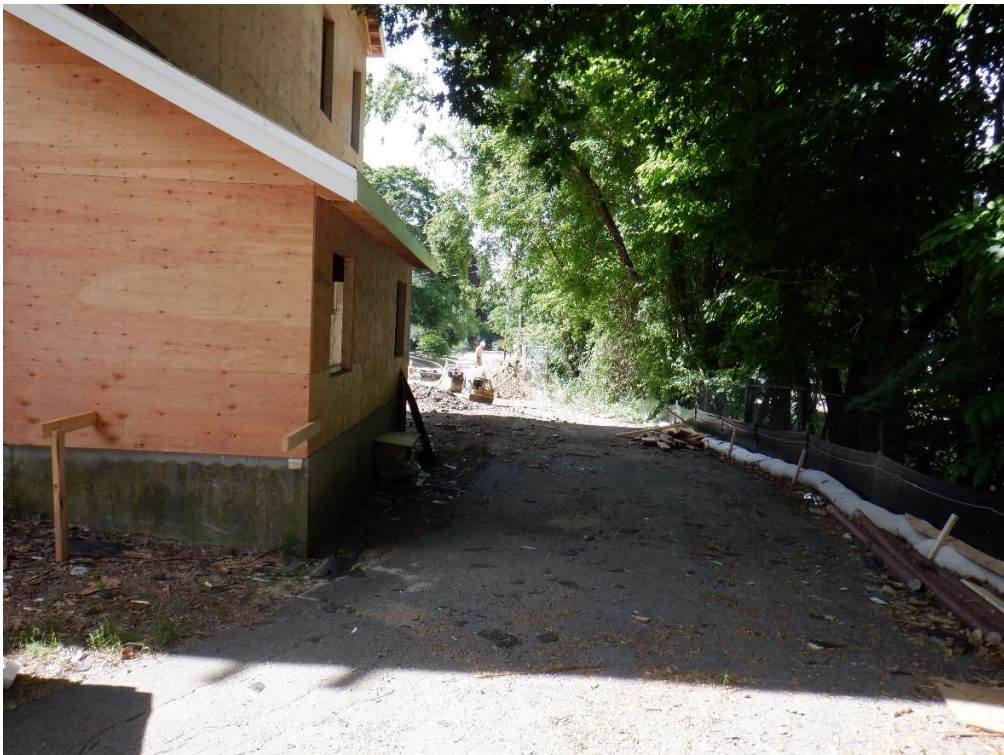
#2

Erosion control maintained

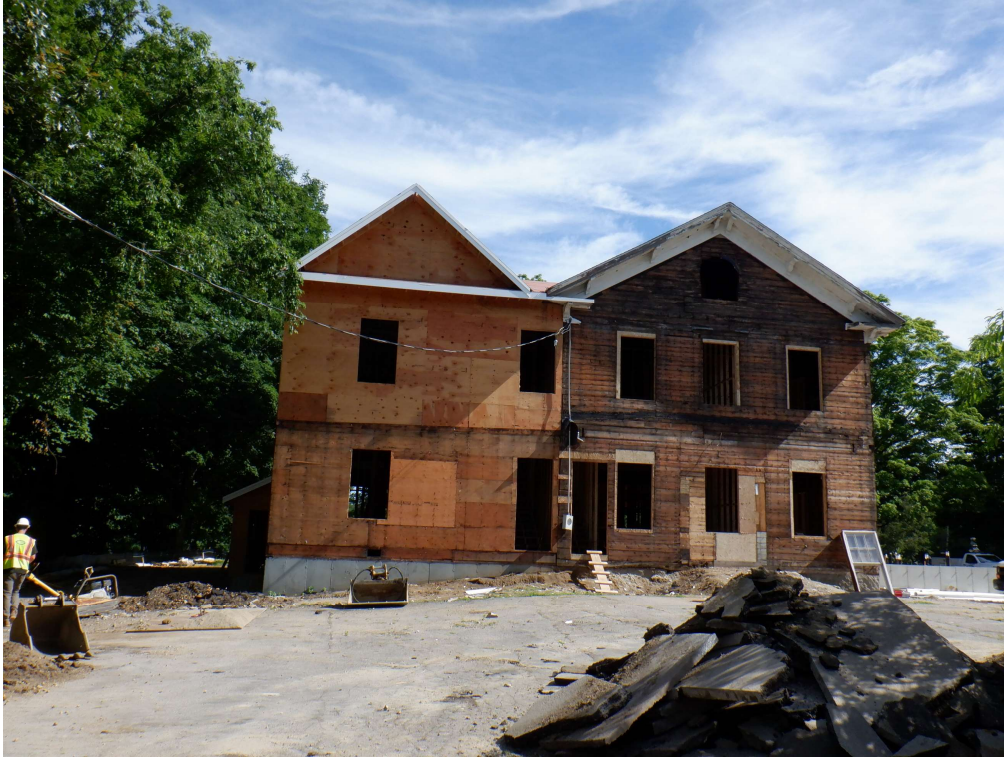
#3

Left side enclosed and roofed

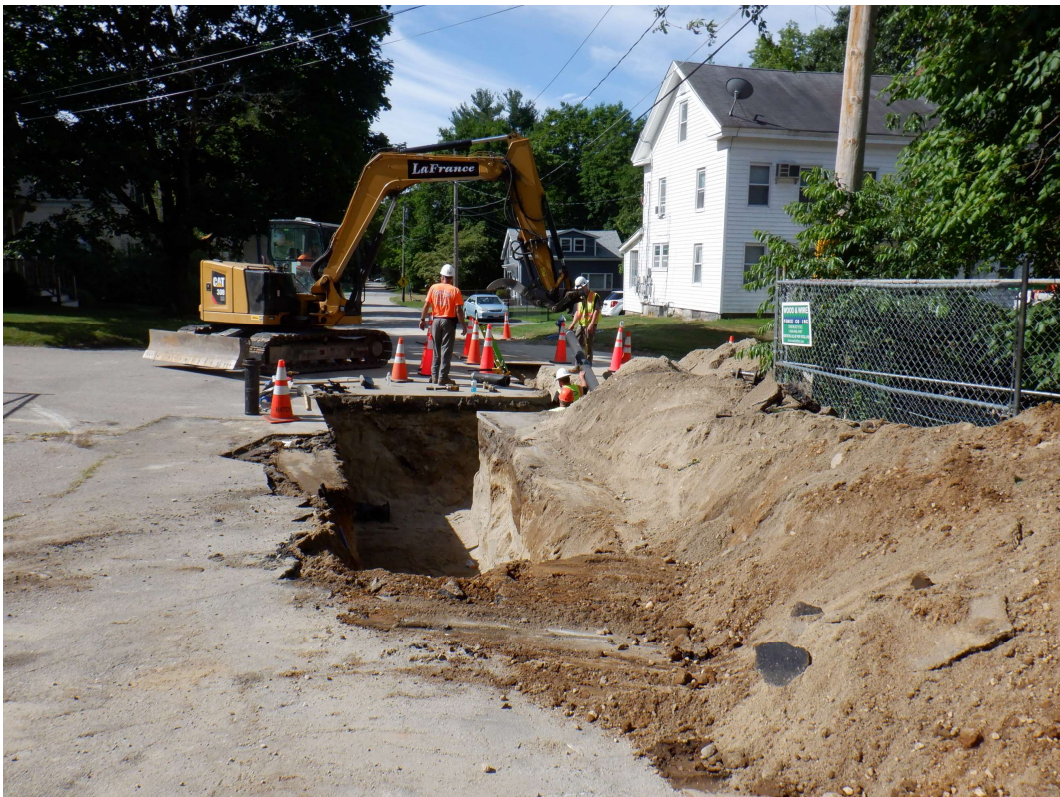
#4

Water main extension through Cutler Street

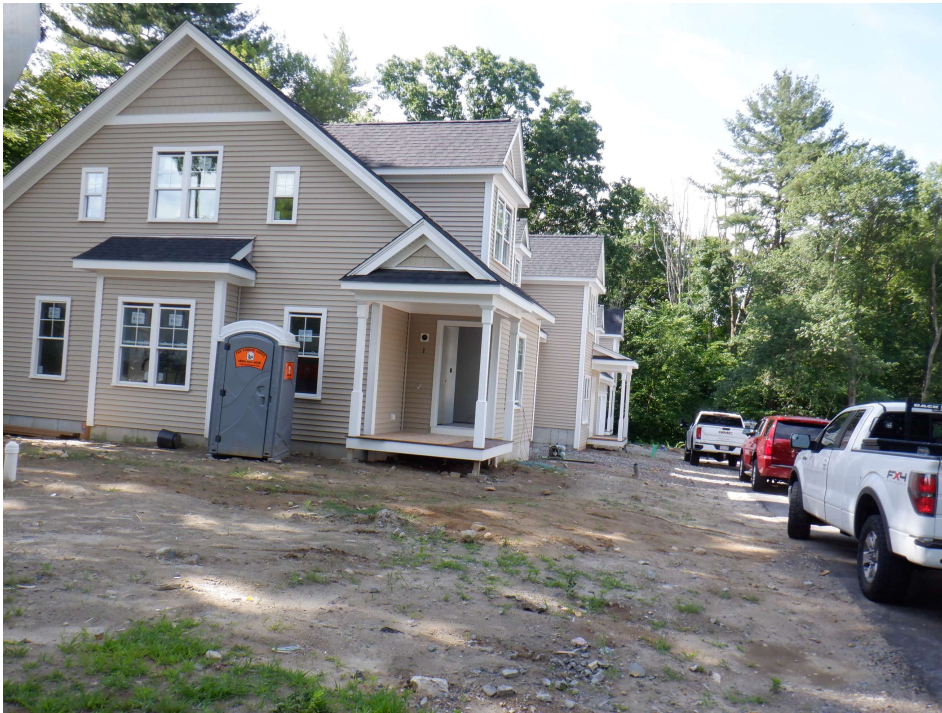
#1

Building 2 Enclosed

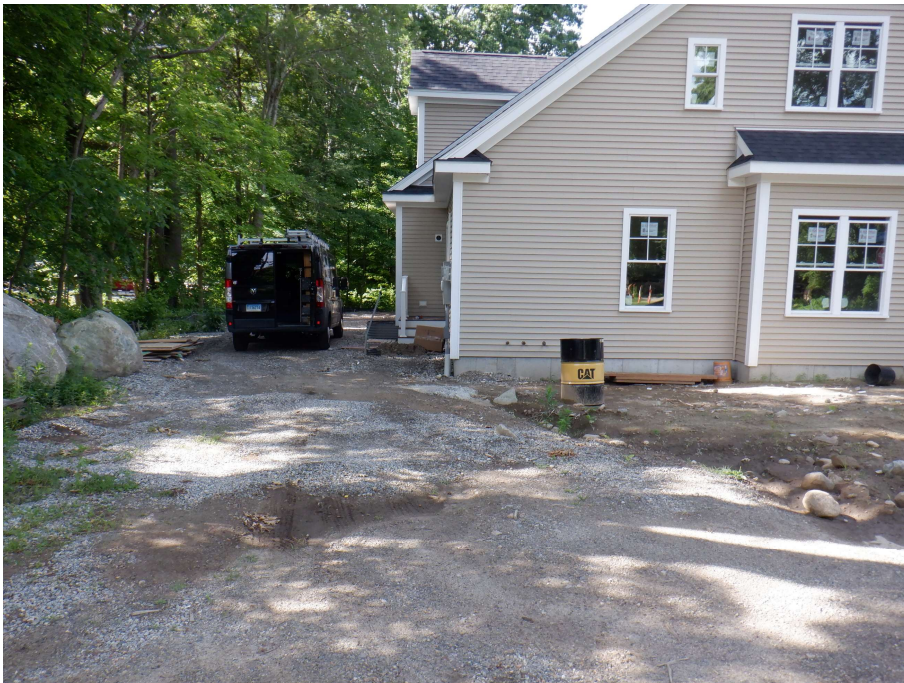
#2

Rear Building 2 – Enclosed
