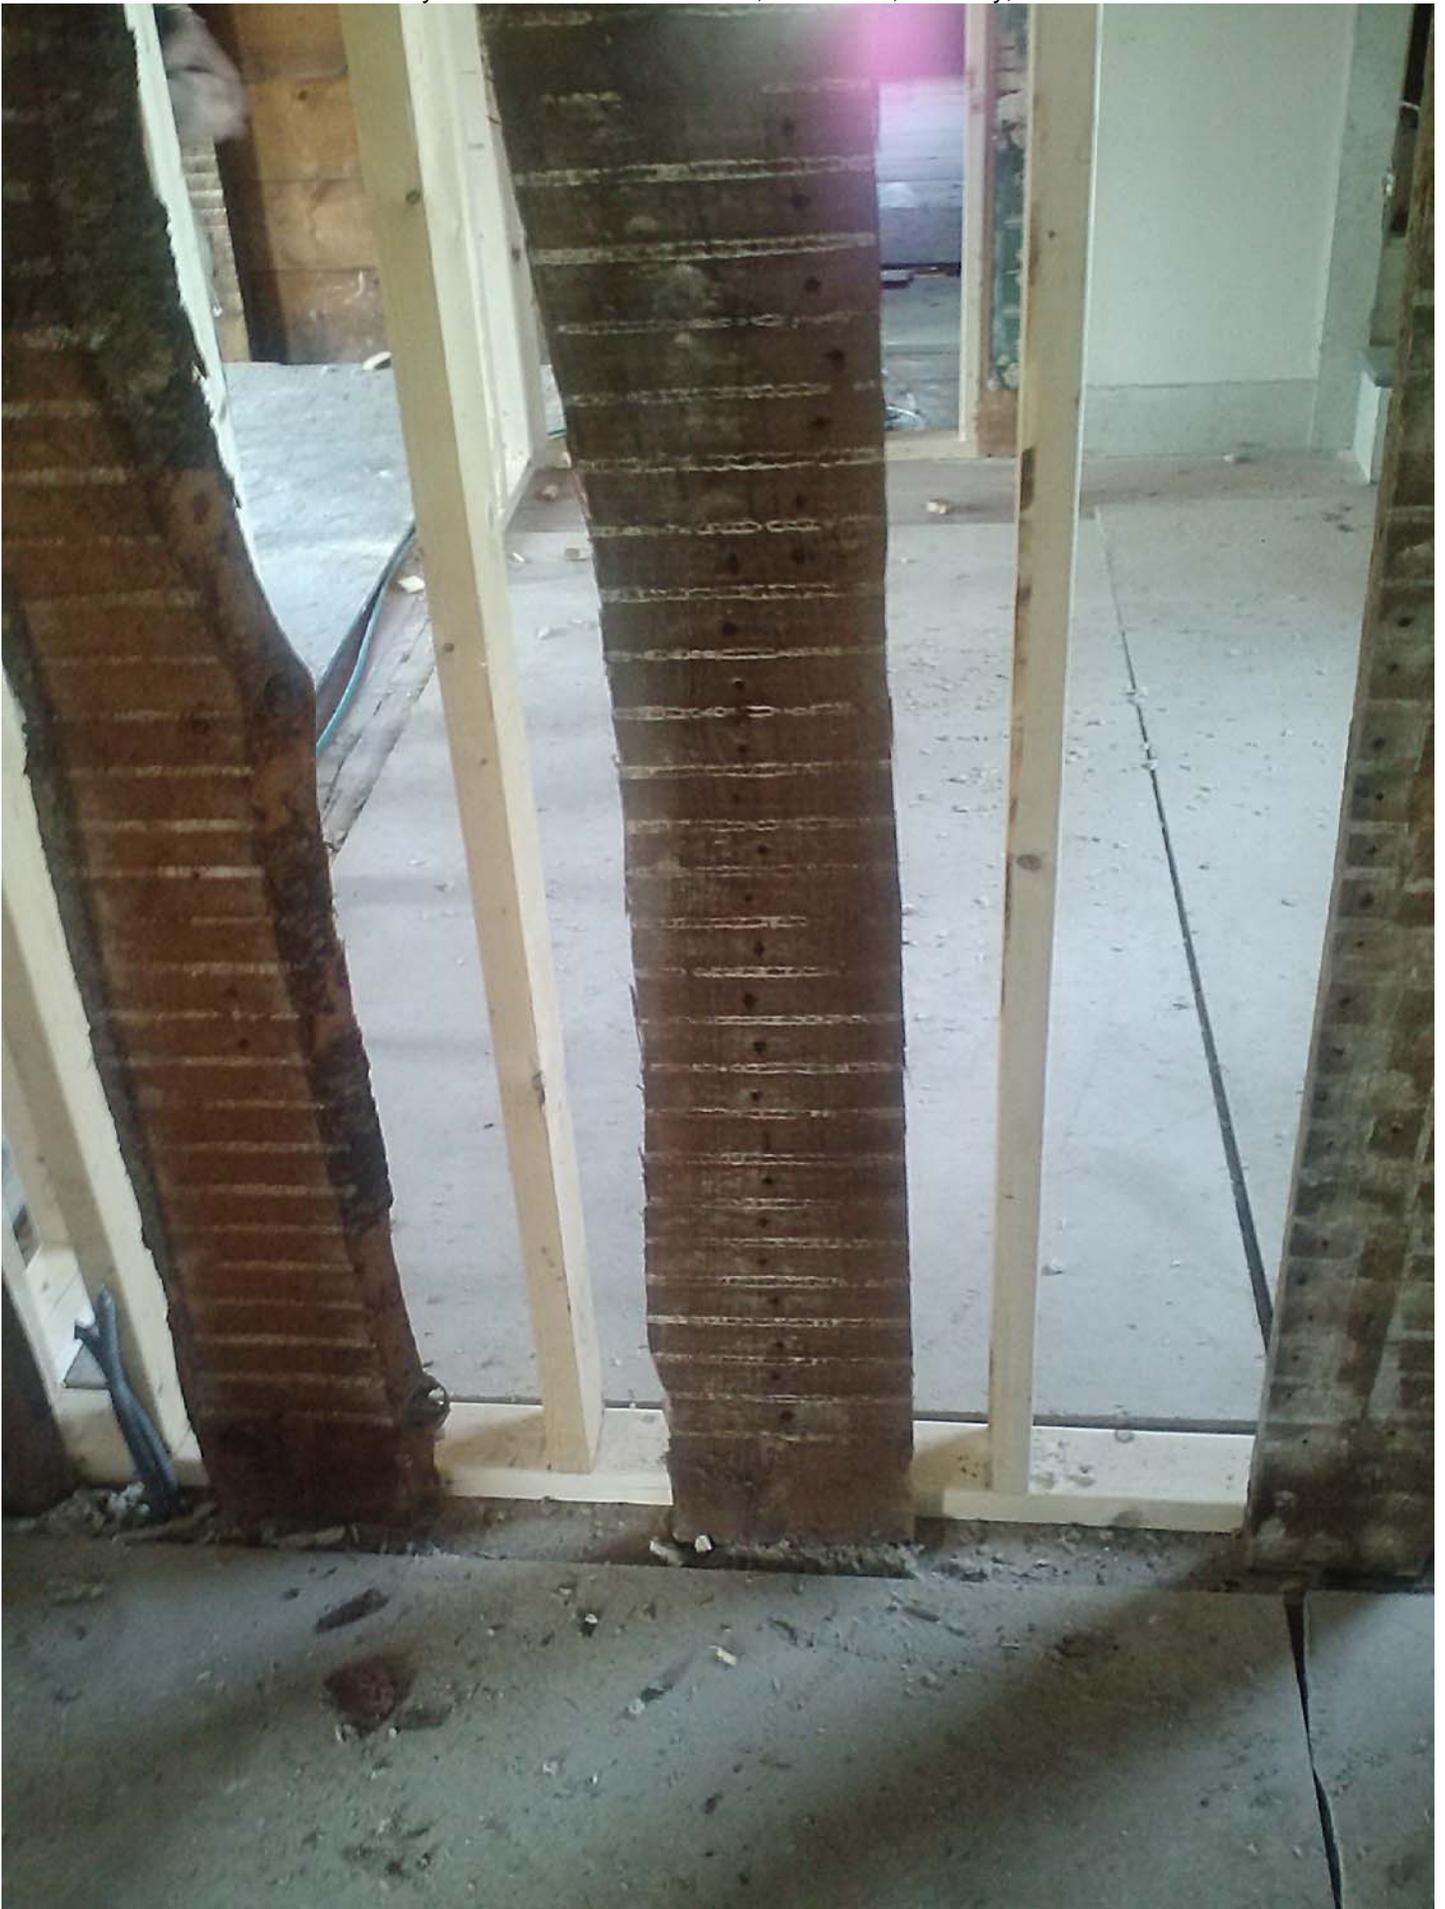
1st floor framing from Entry

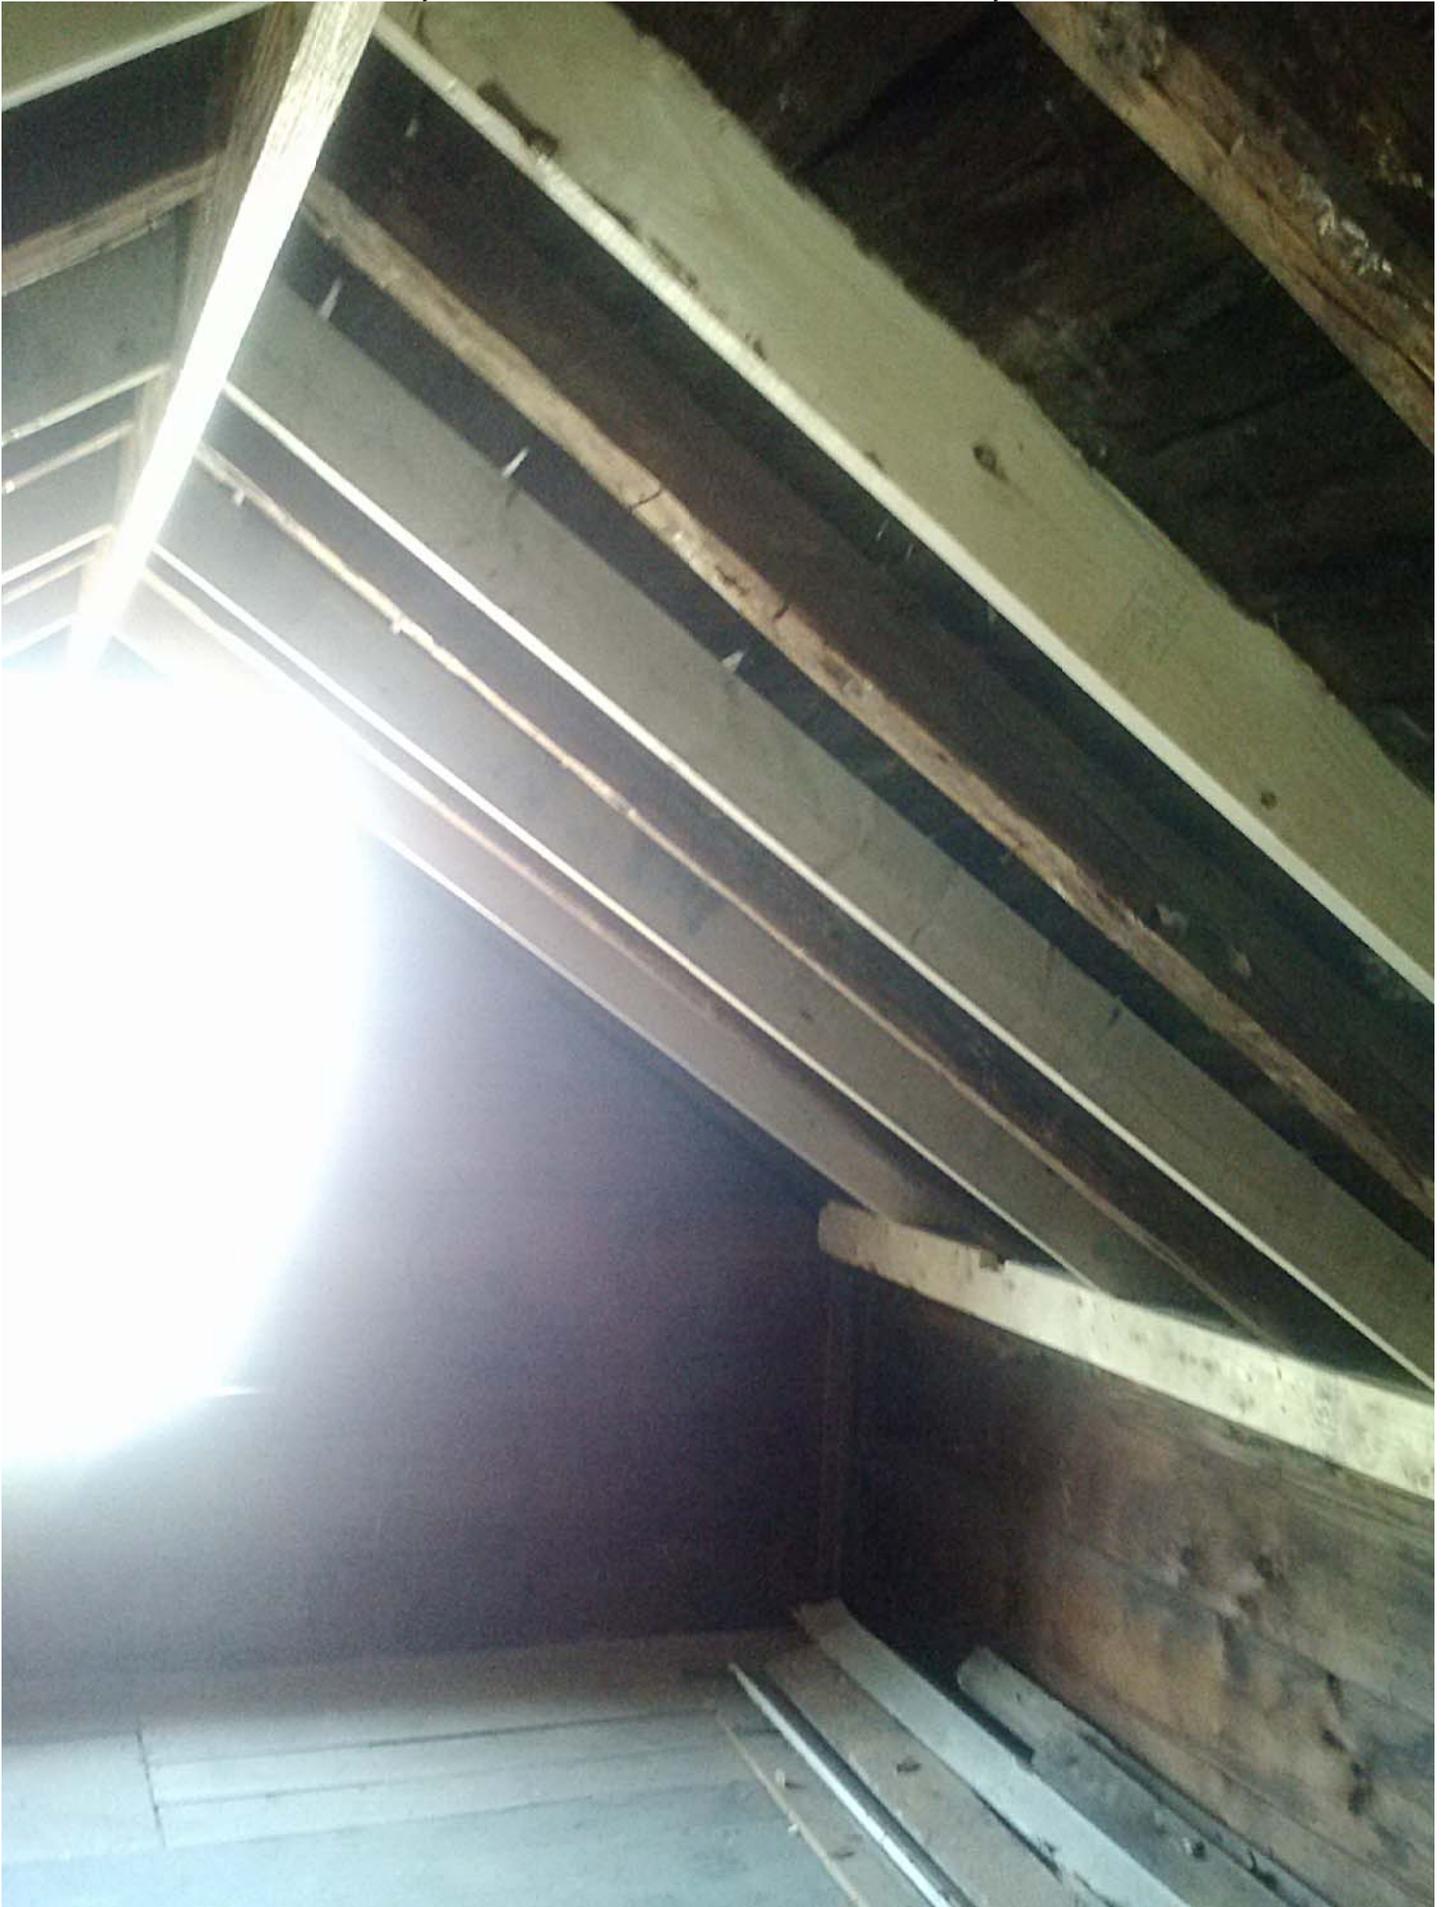
Kitchen framing from Landing 200

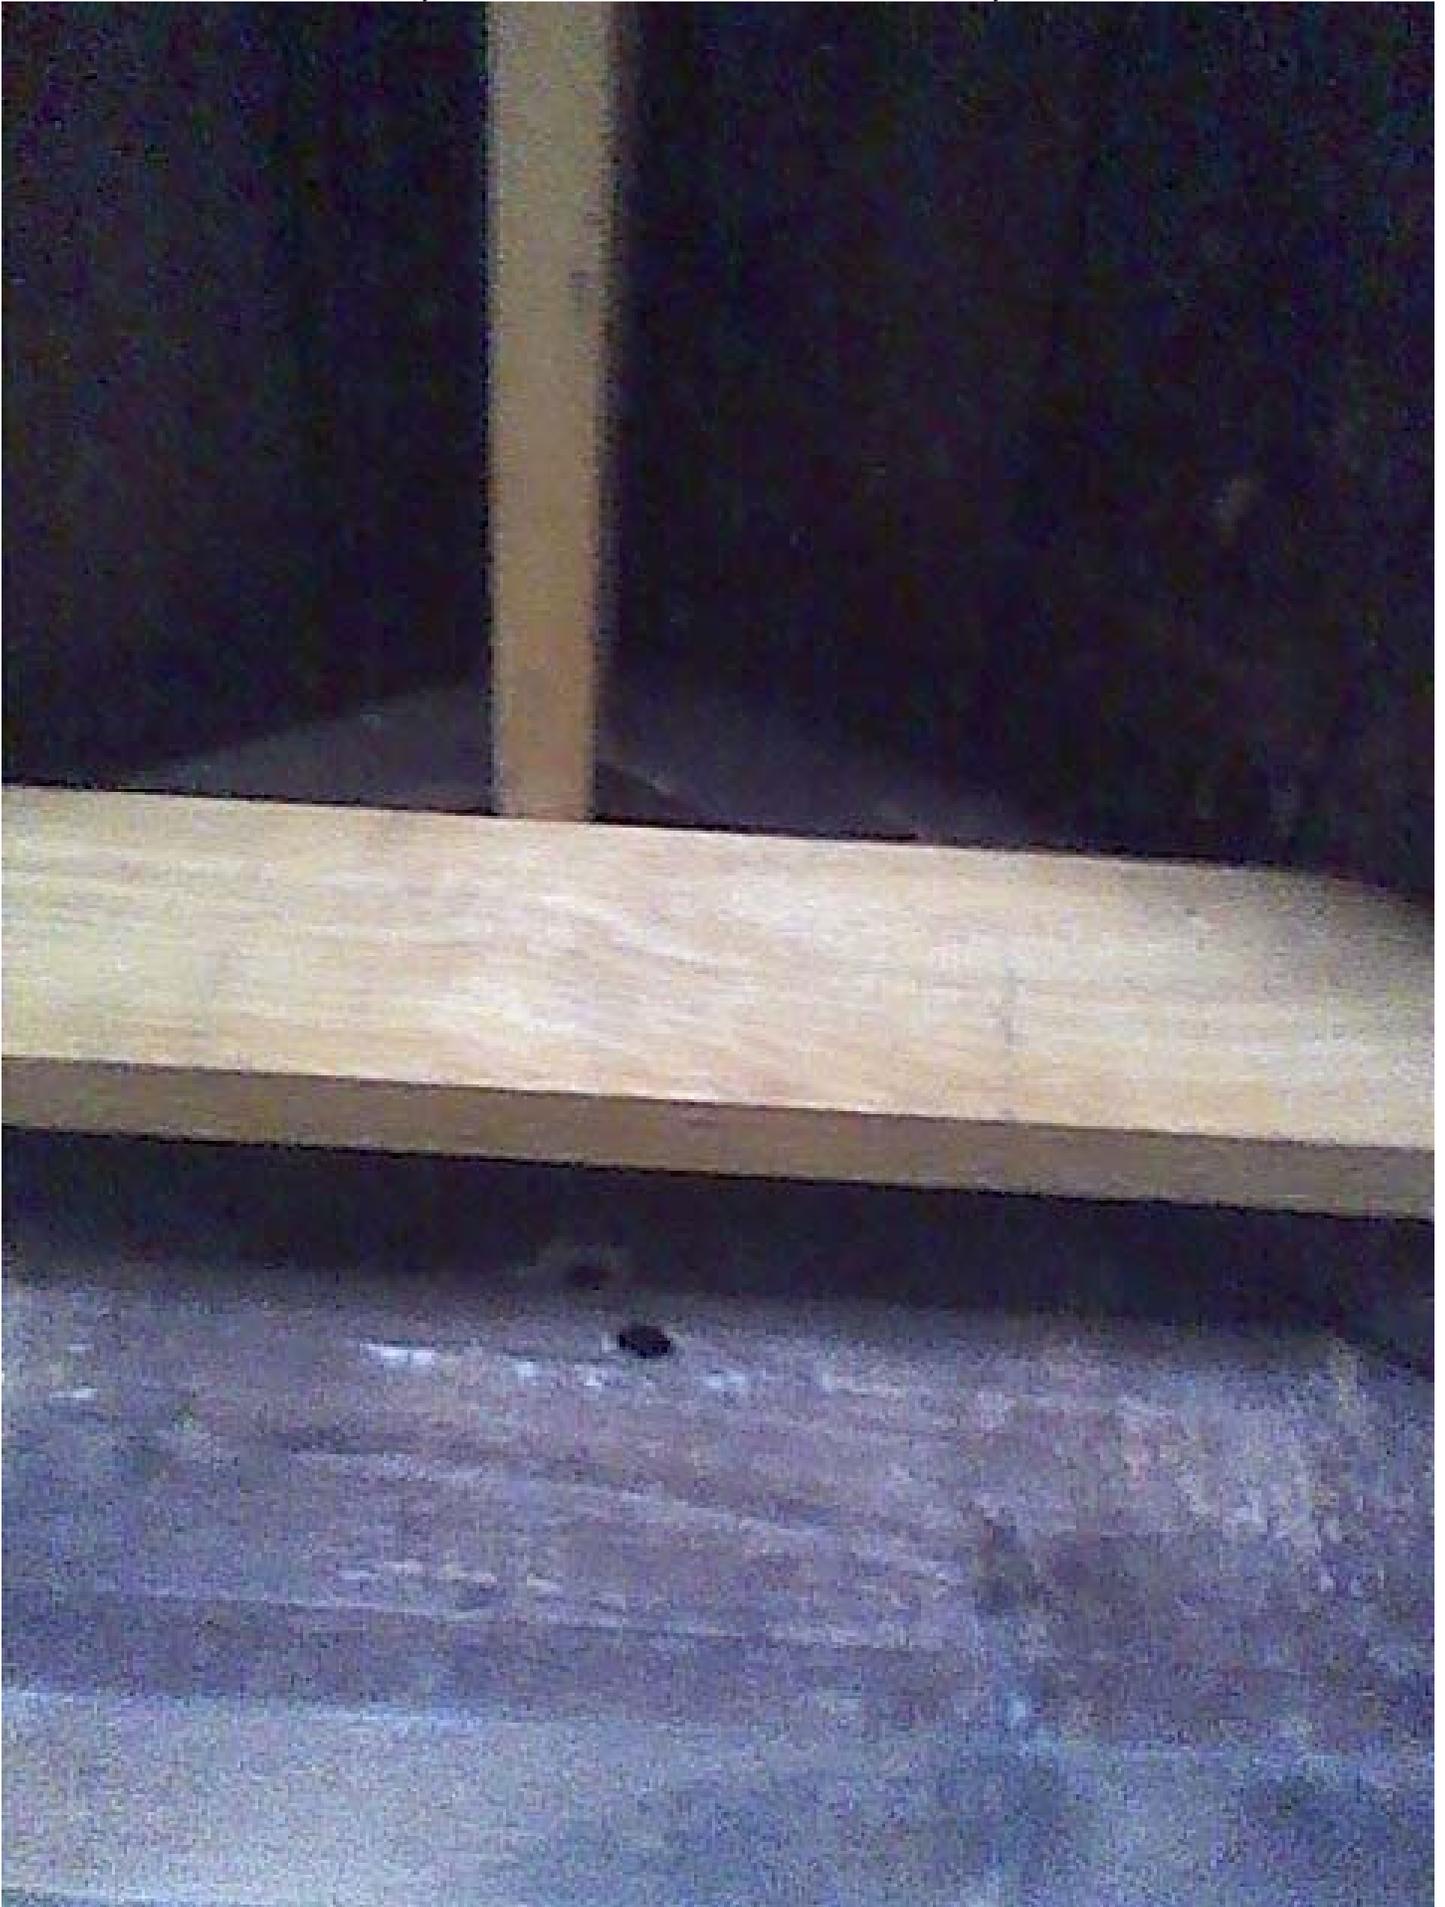
2nd fl attic framing

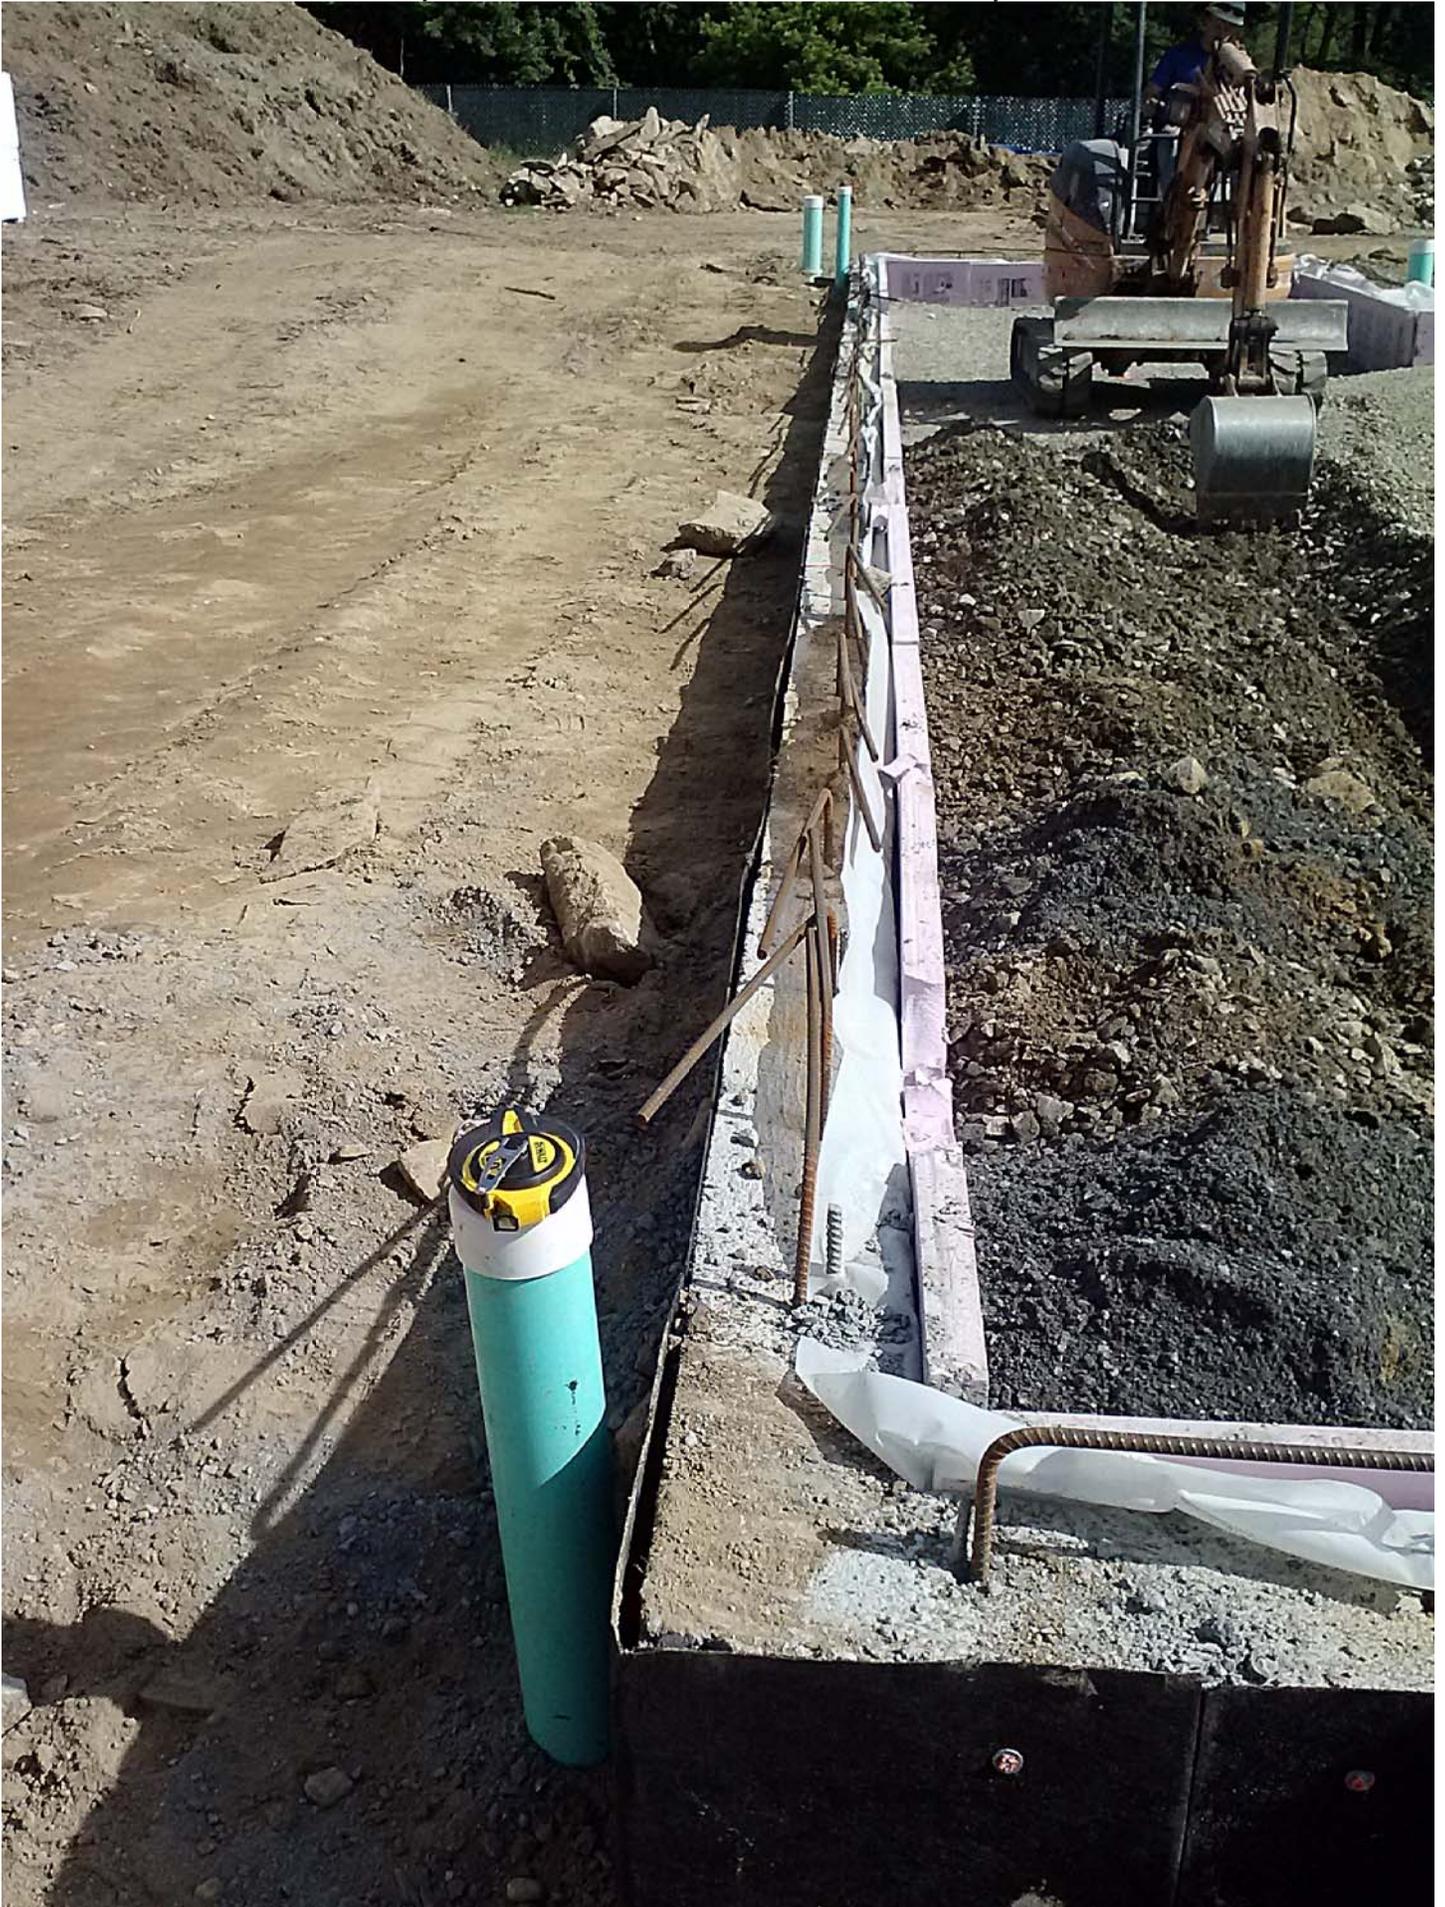
Foundation at Lobby

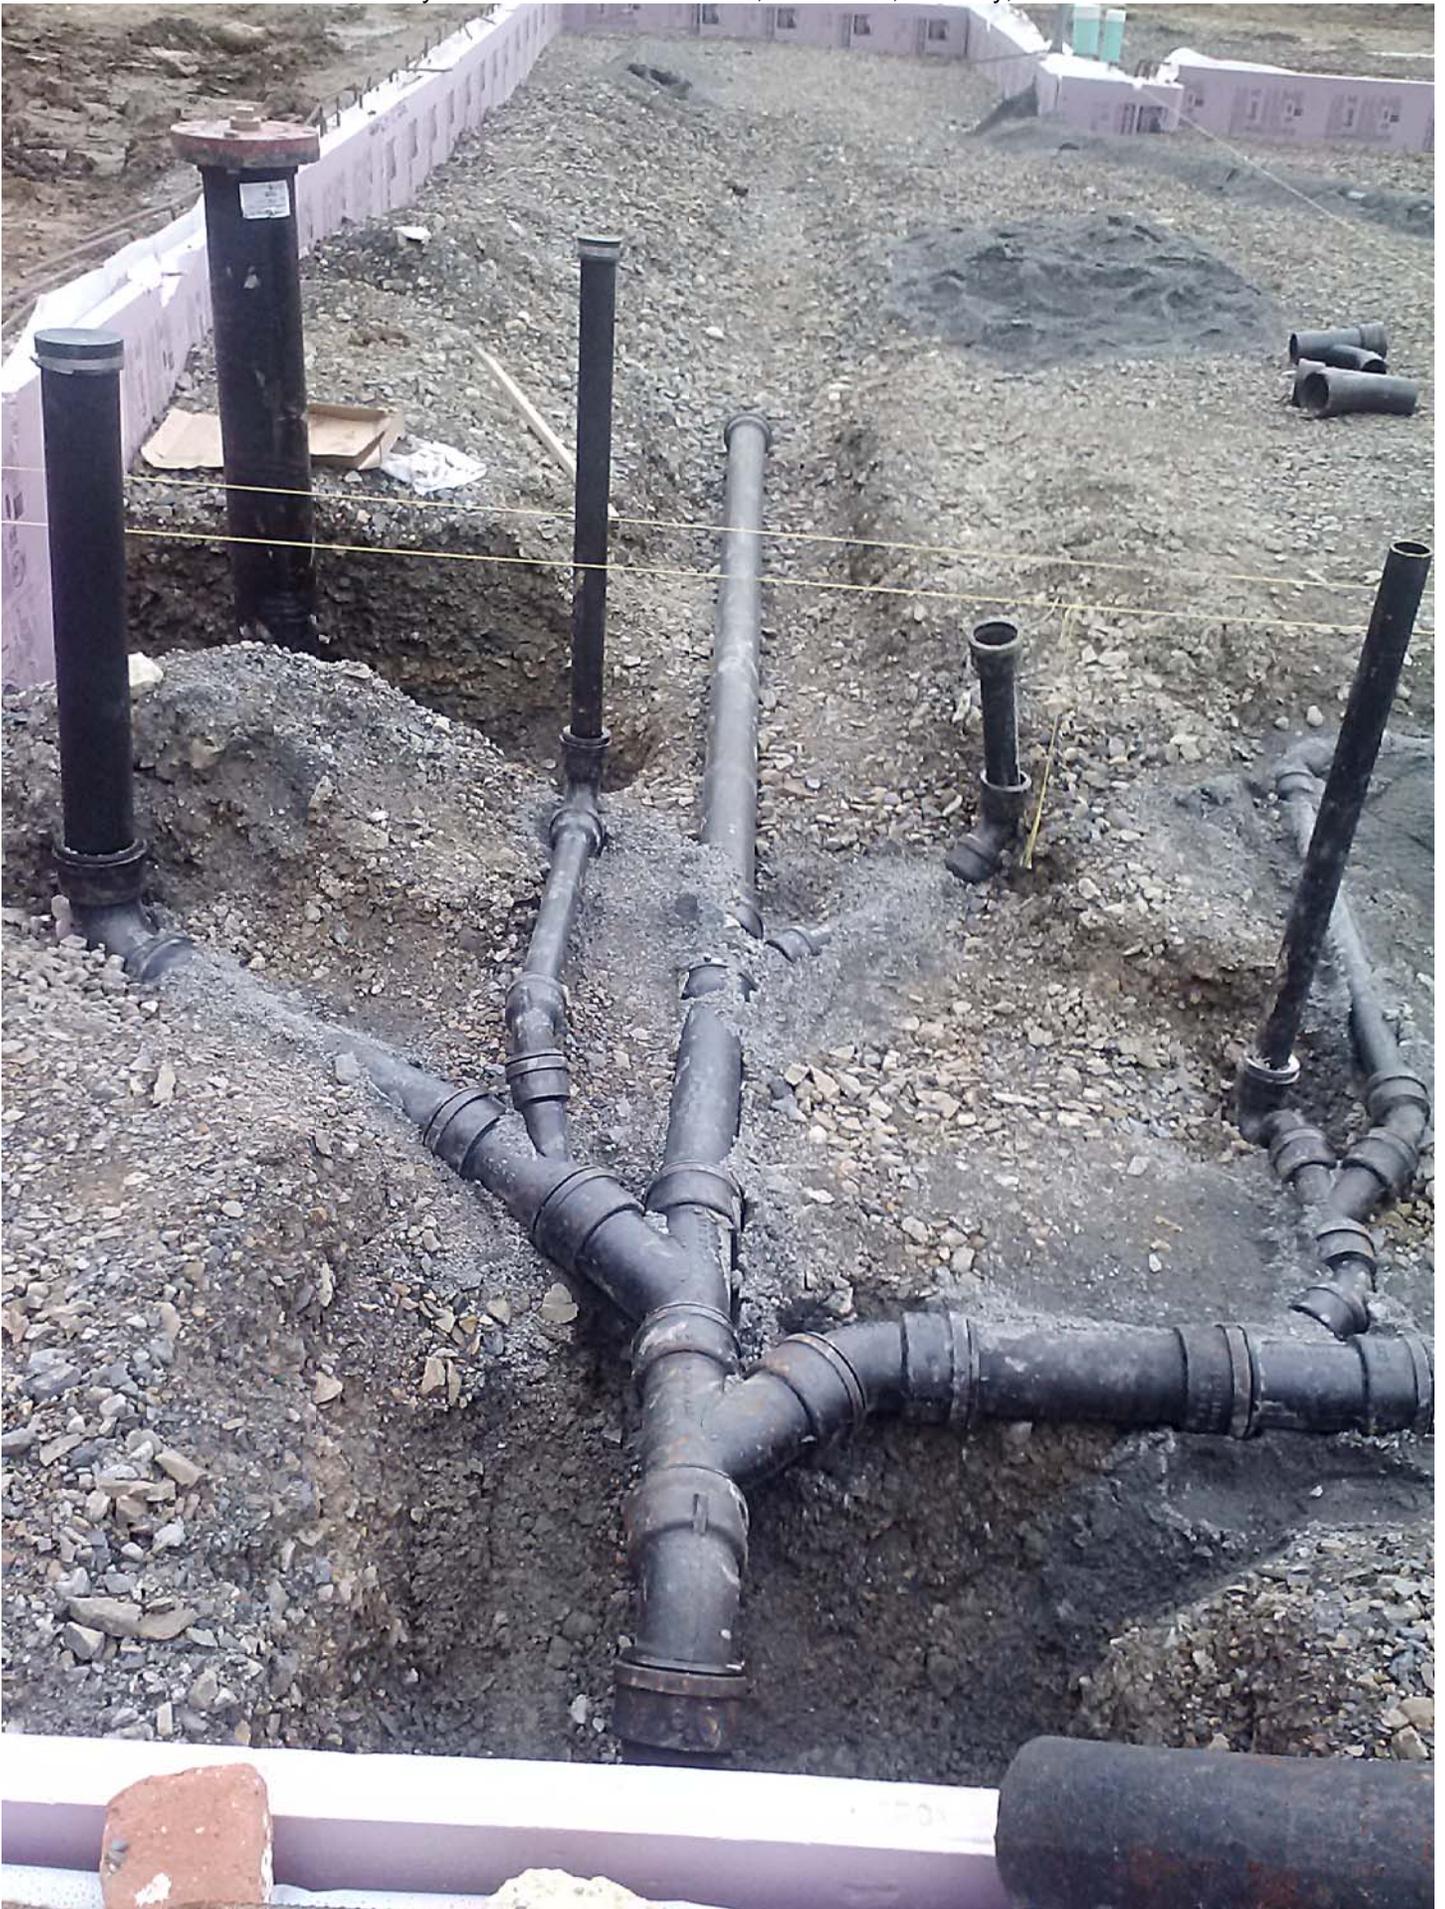
Foundation / Rough plumbing - Slab

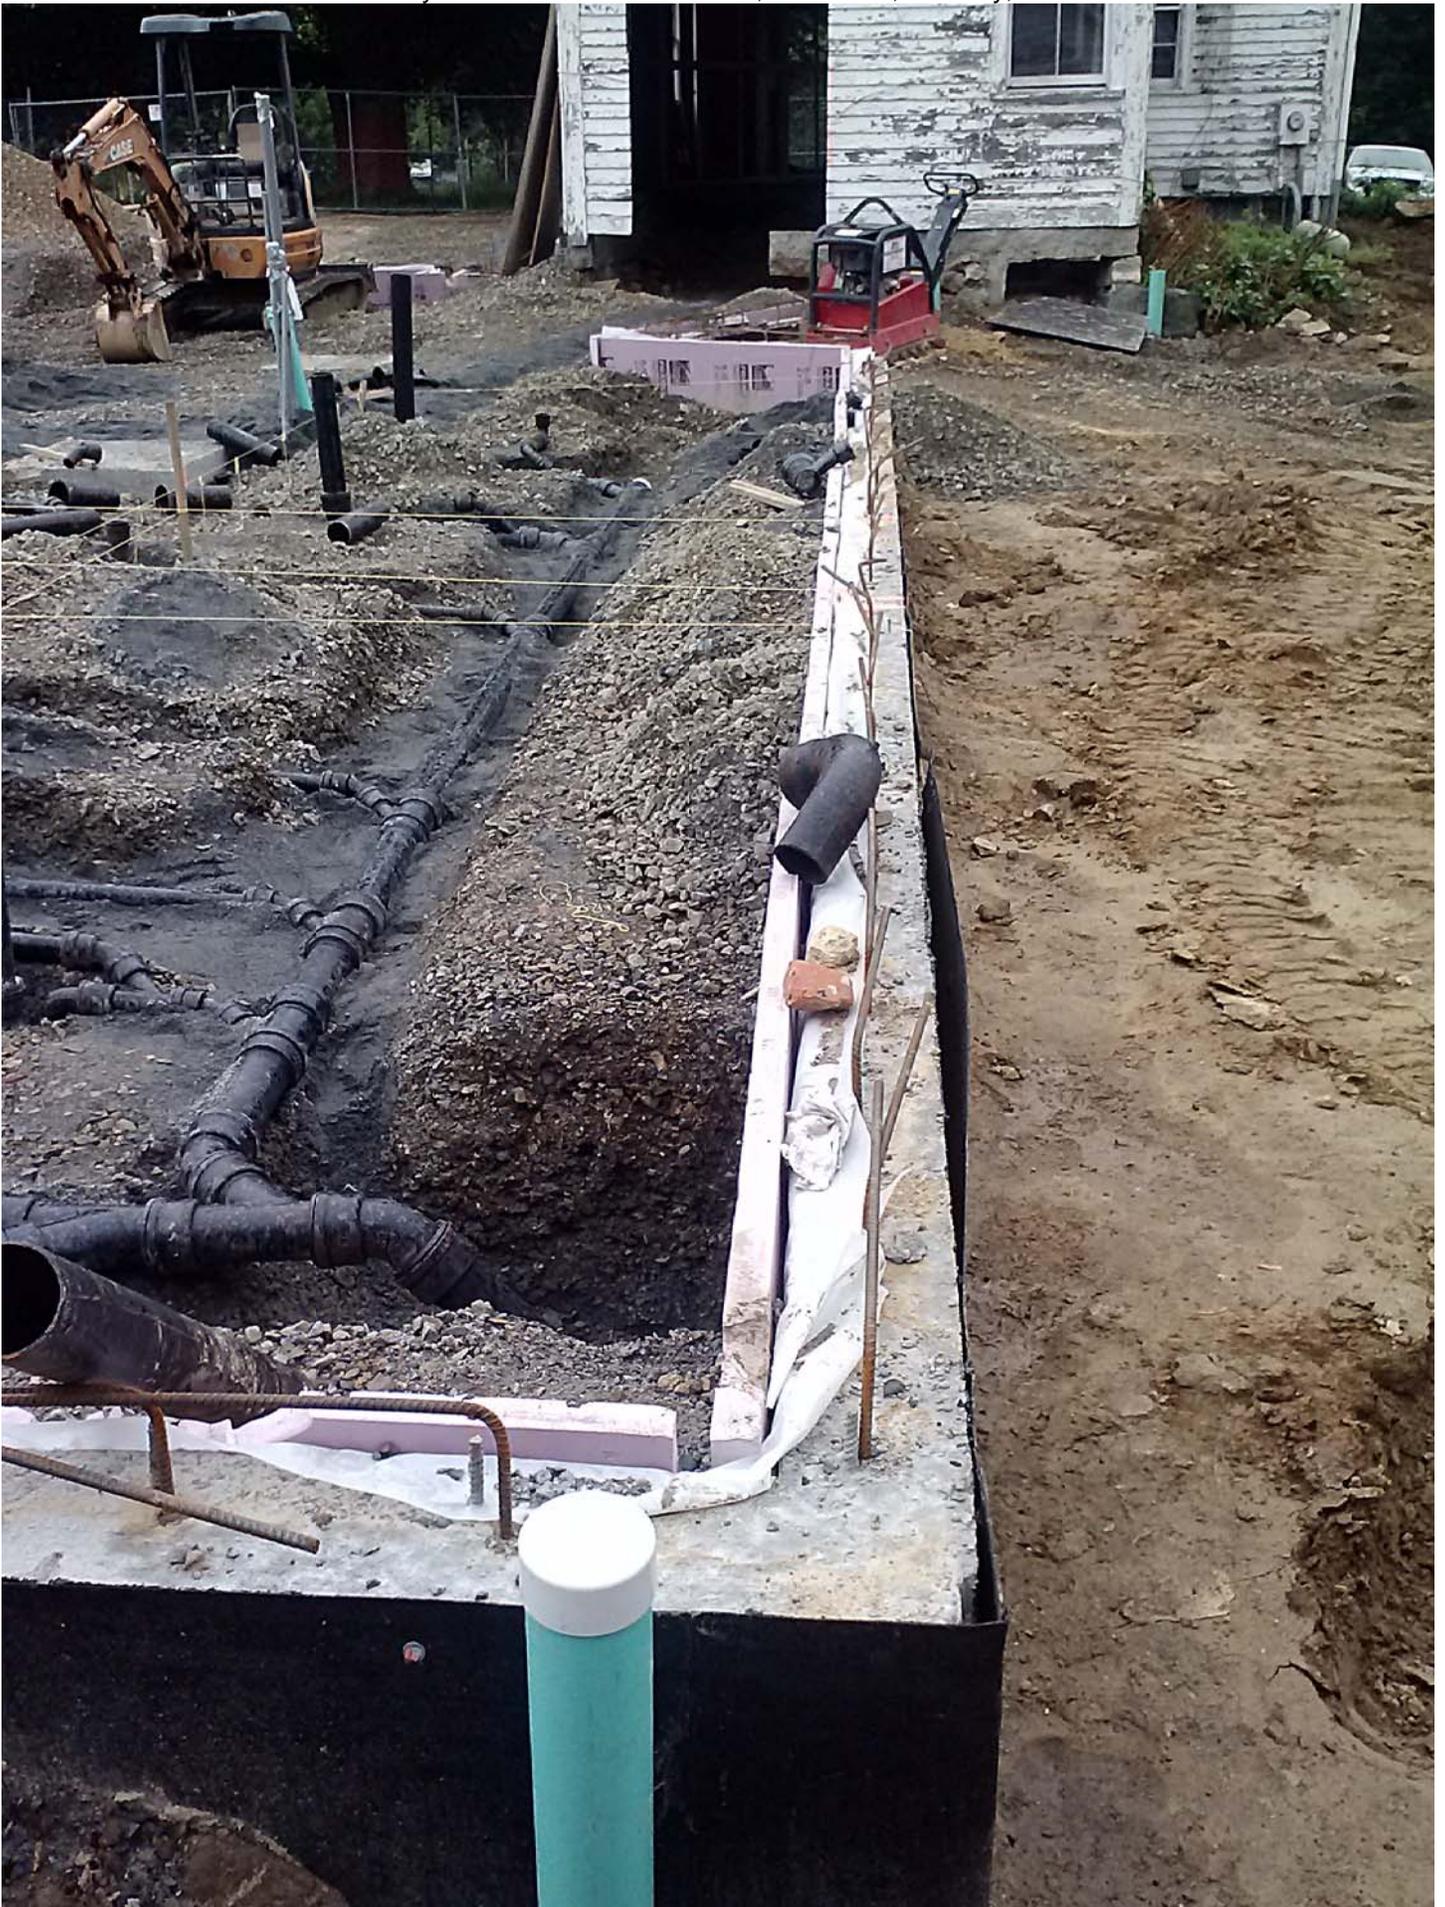
Rough Plumbing at Slab

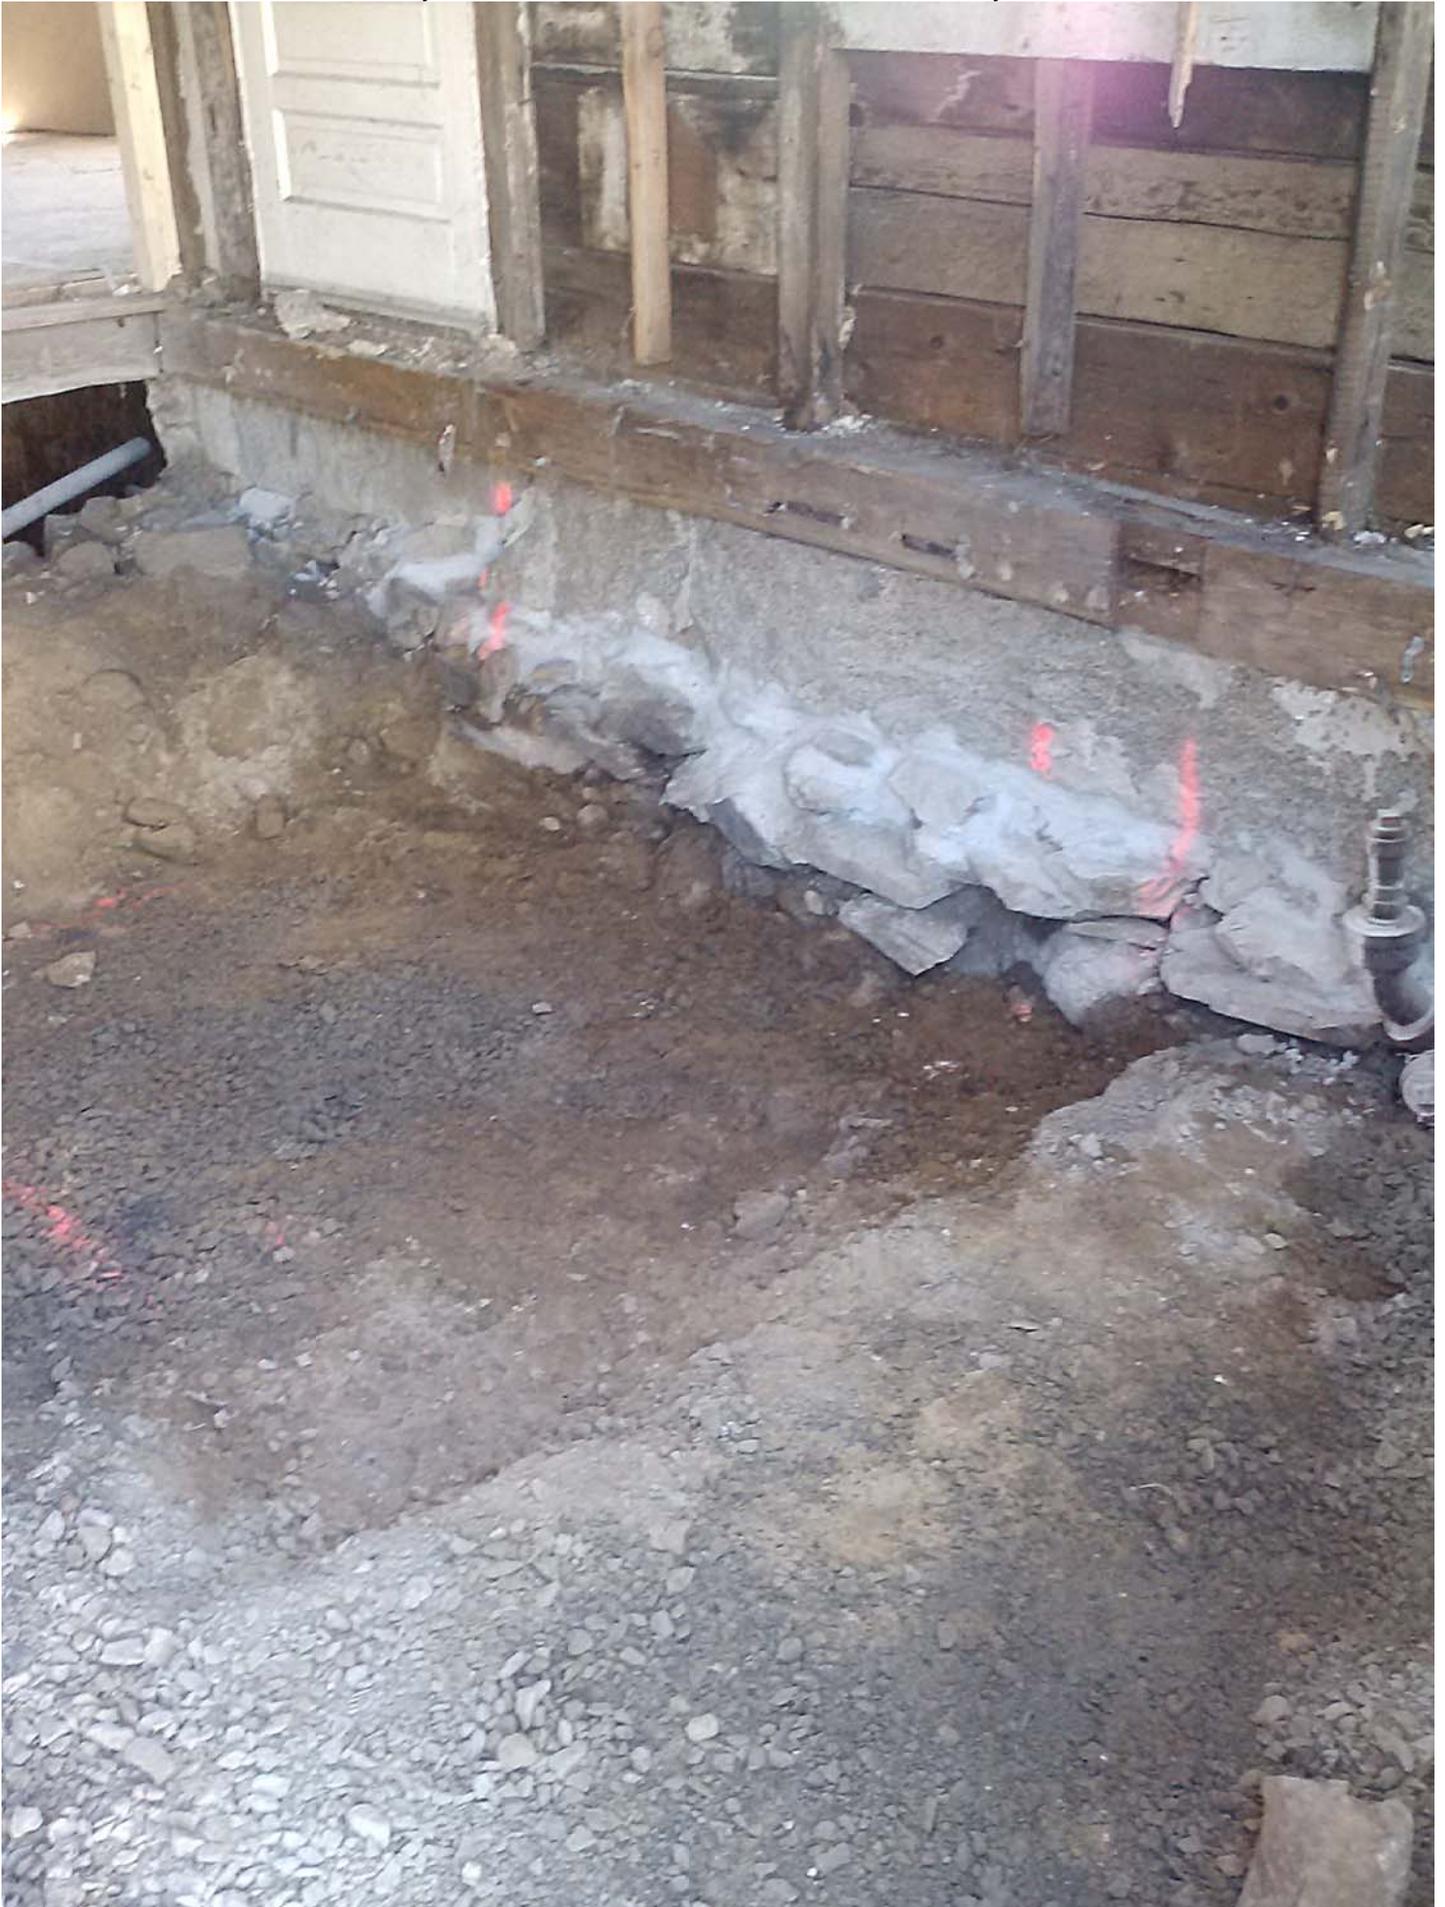
Lower Landing - closet side

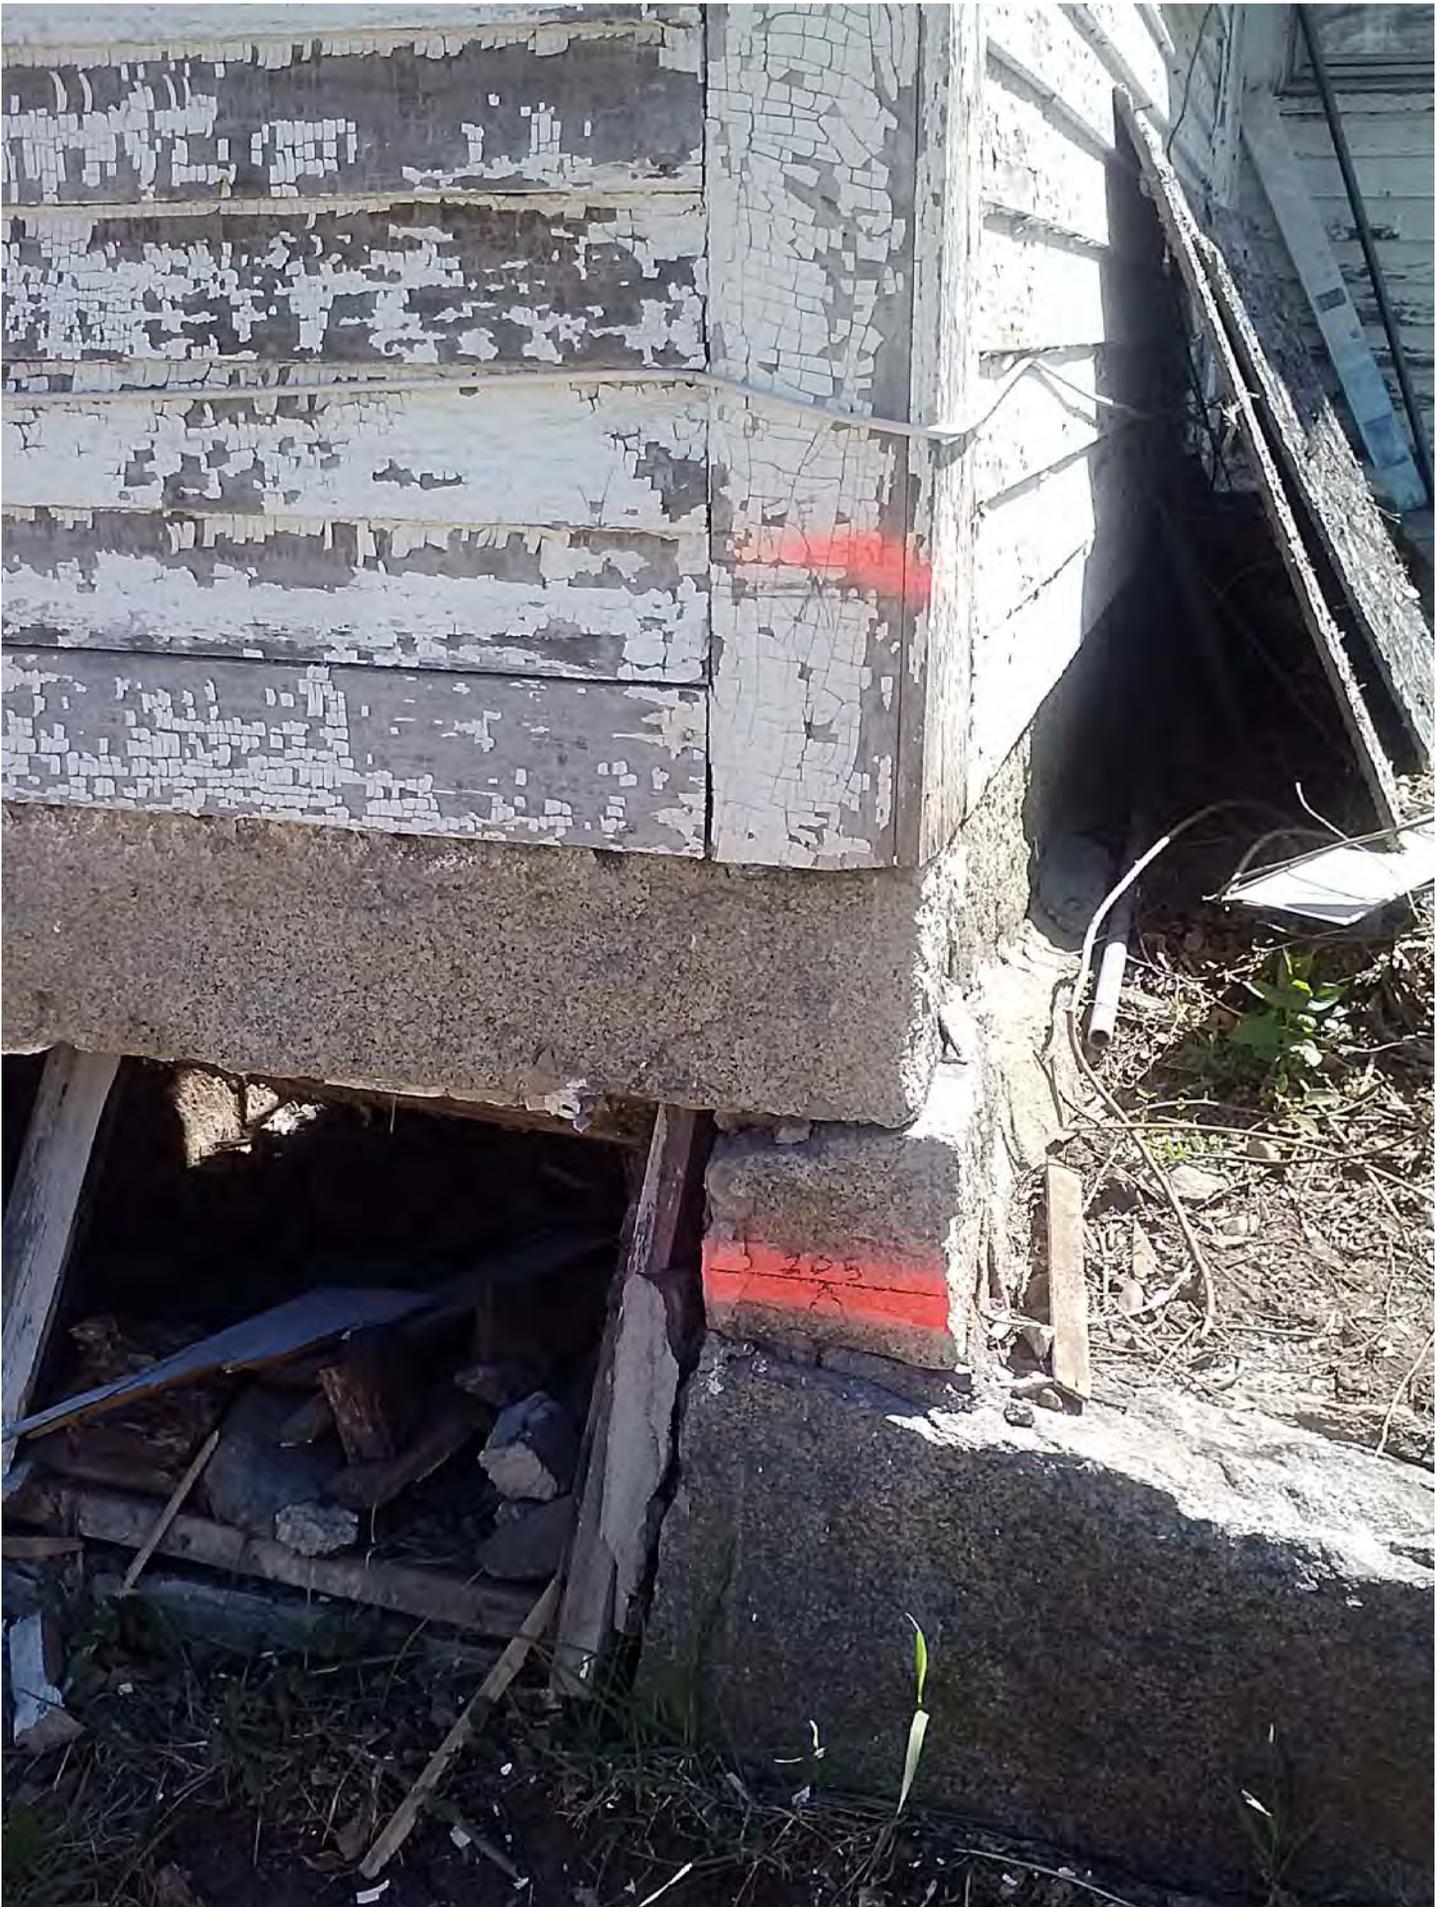
Excavation for addition footing
