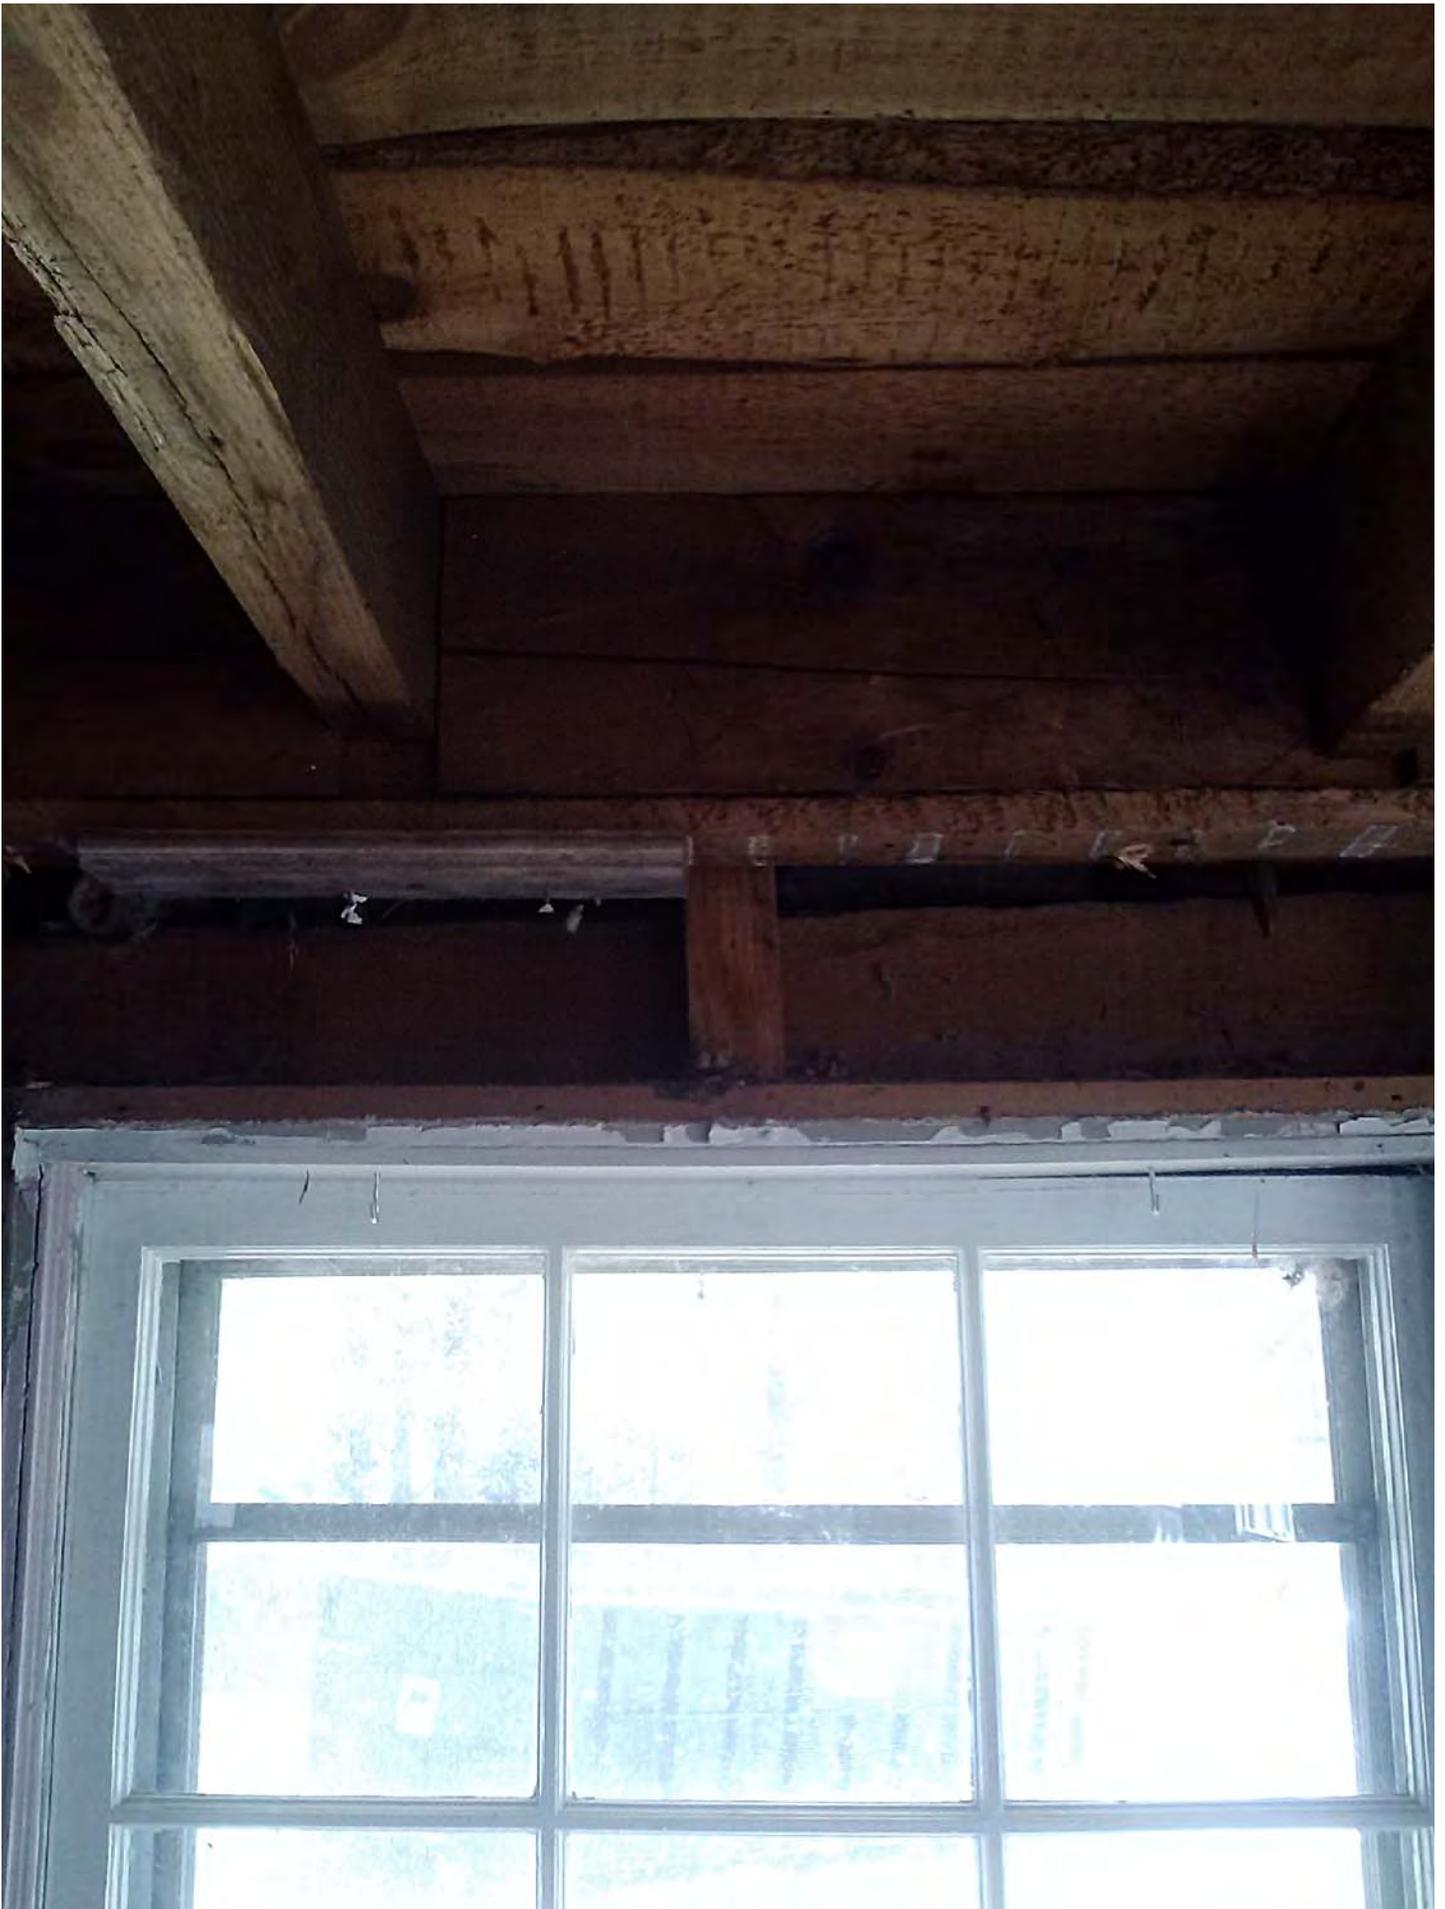
Typical existing window header after demolition

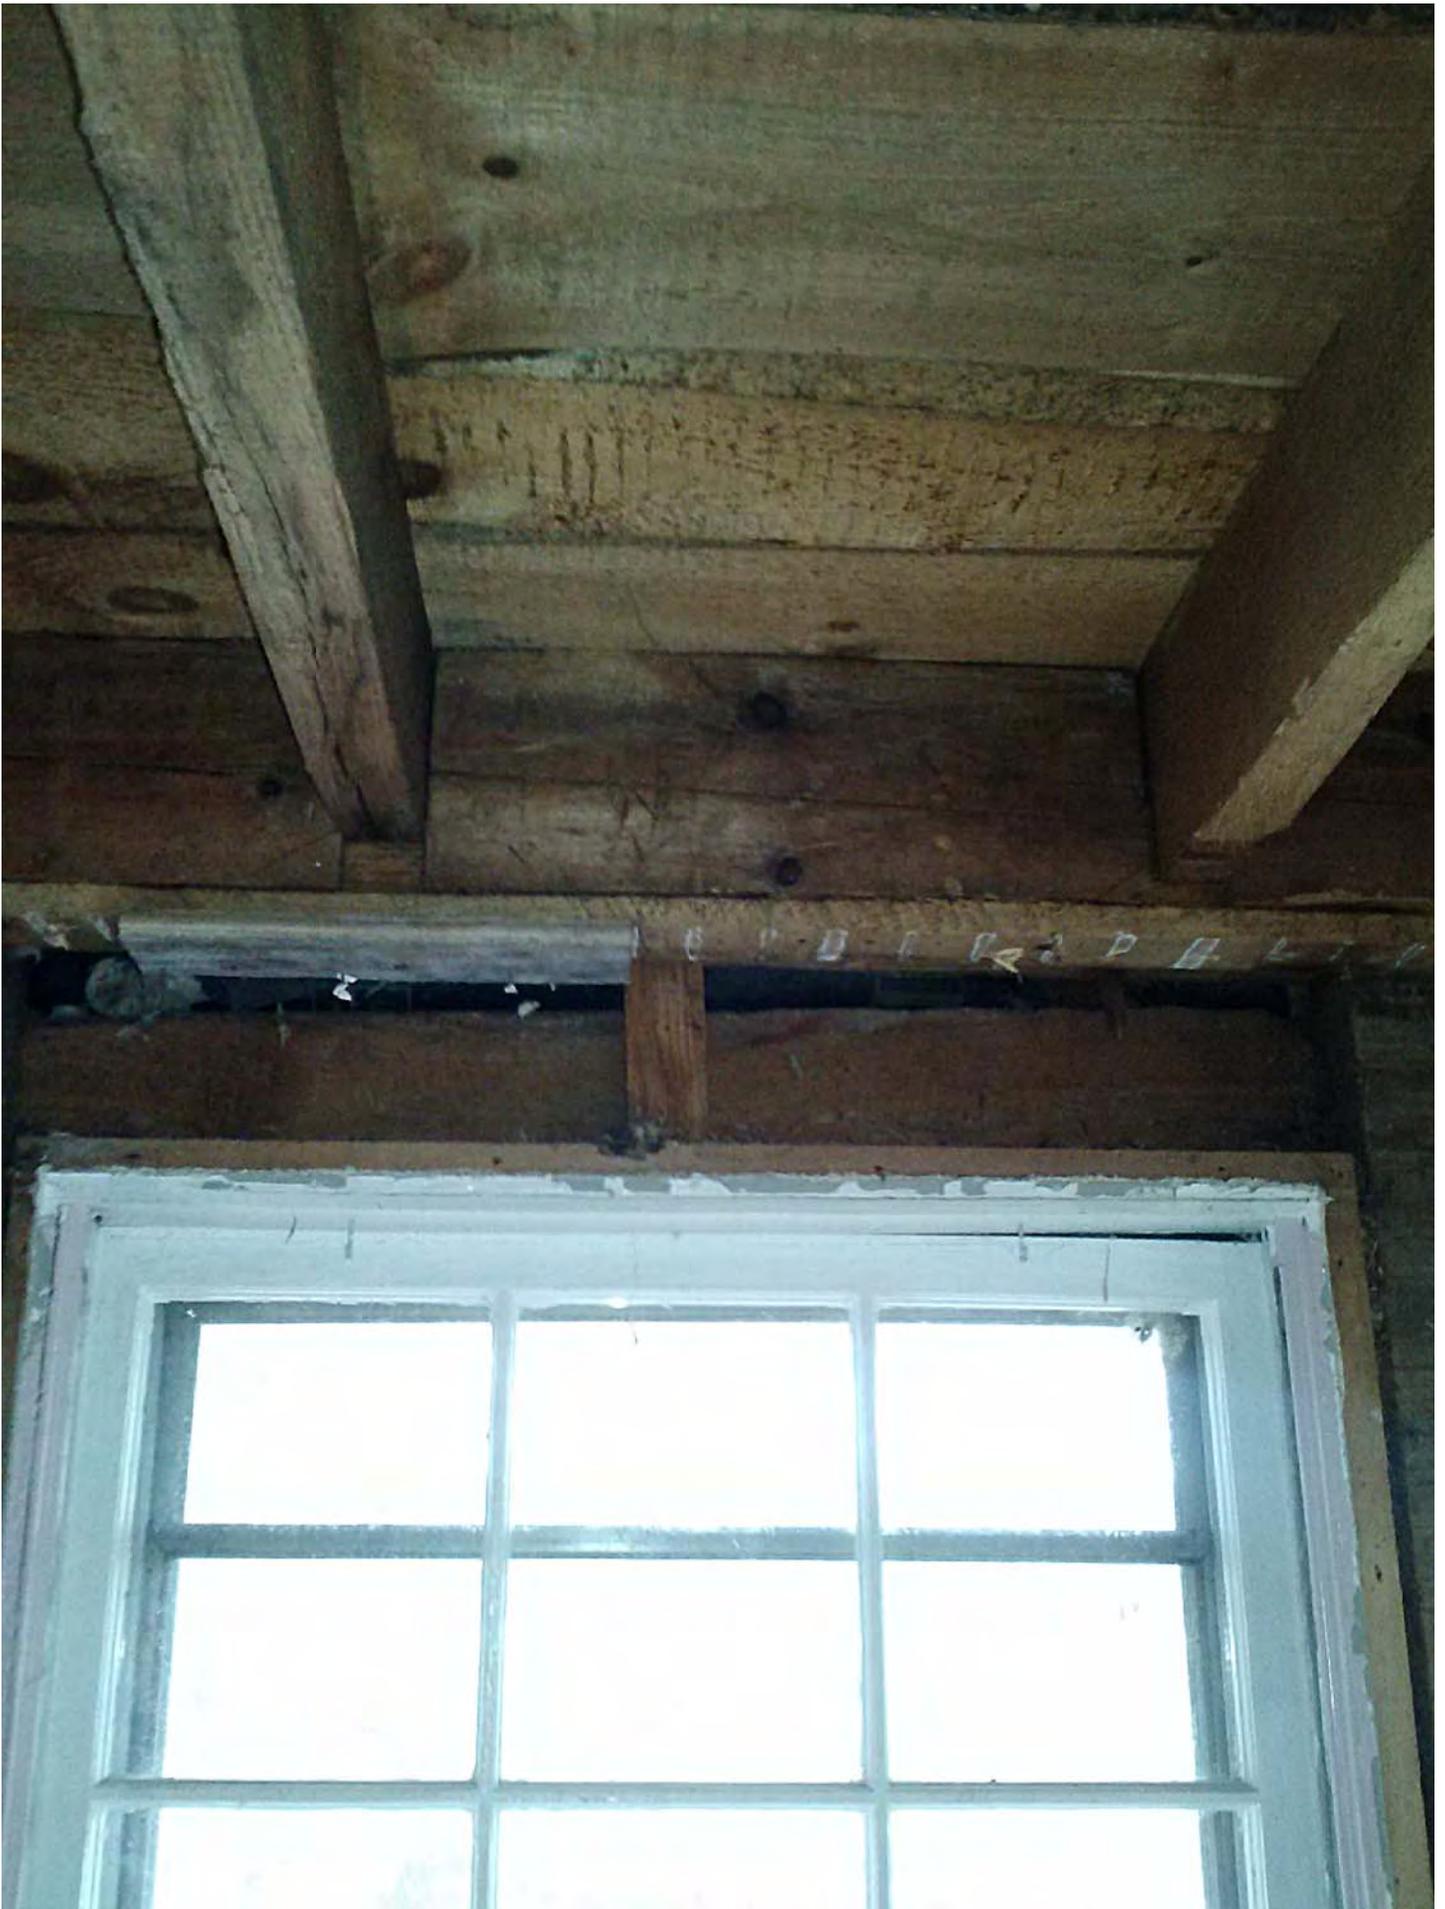
Typical existing window header following demolition

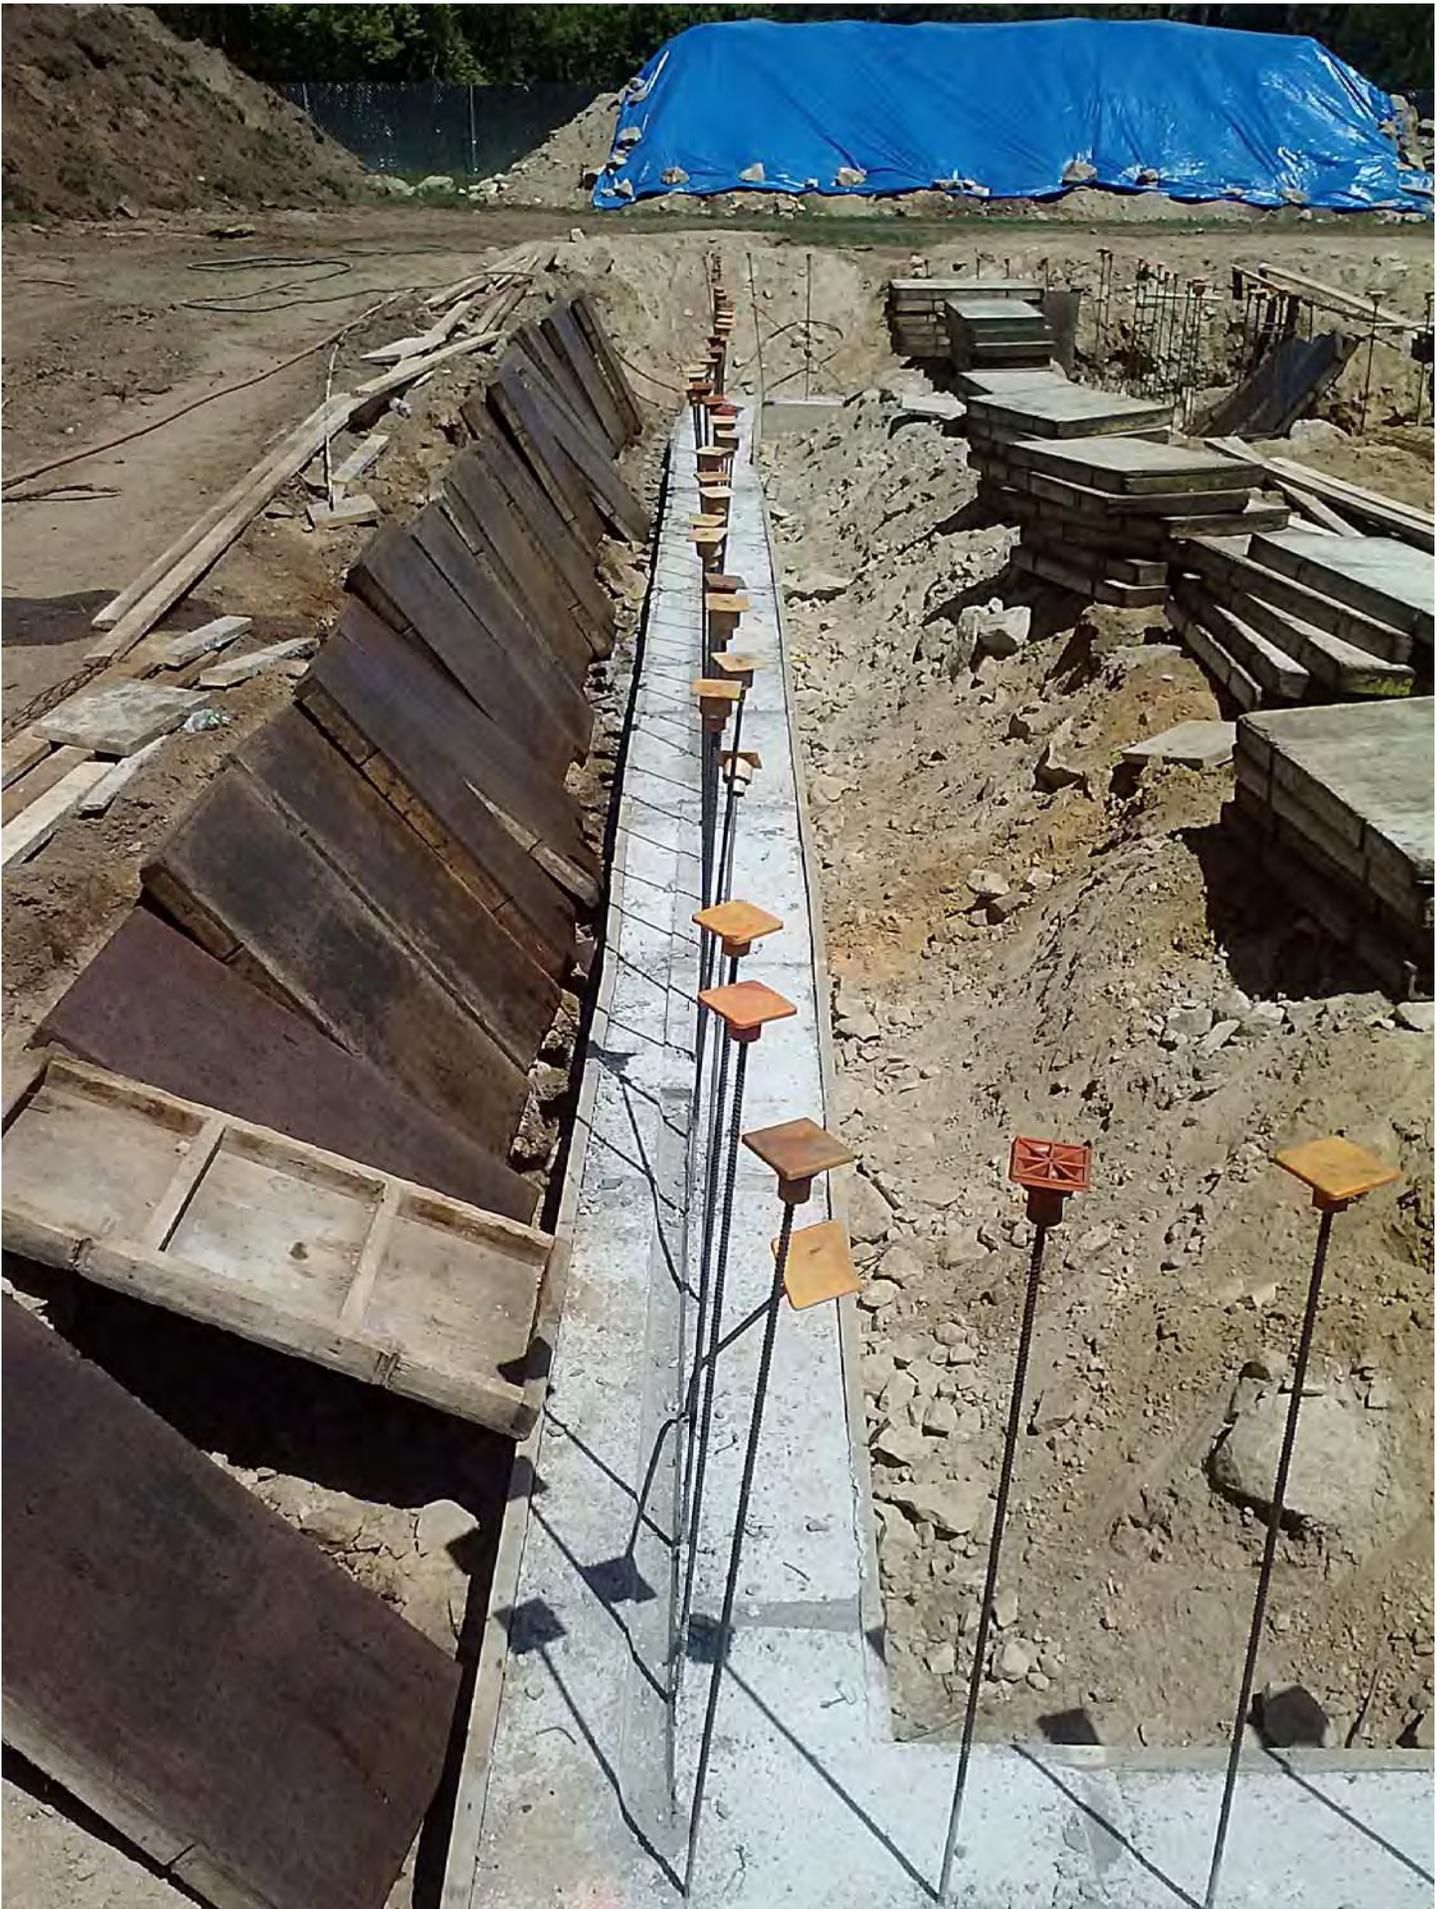
Footing for addition foundation wall

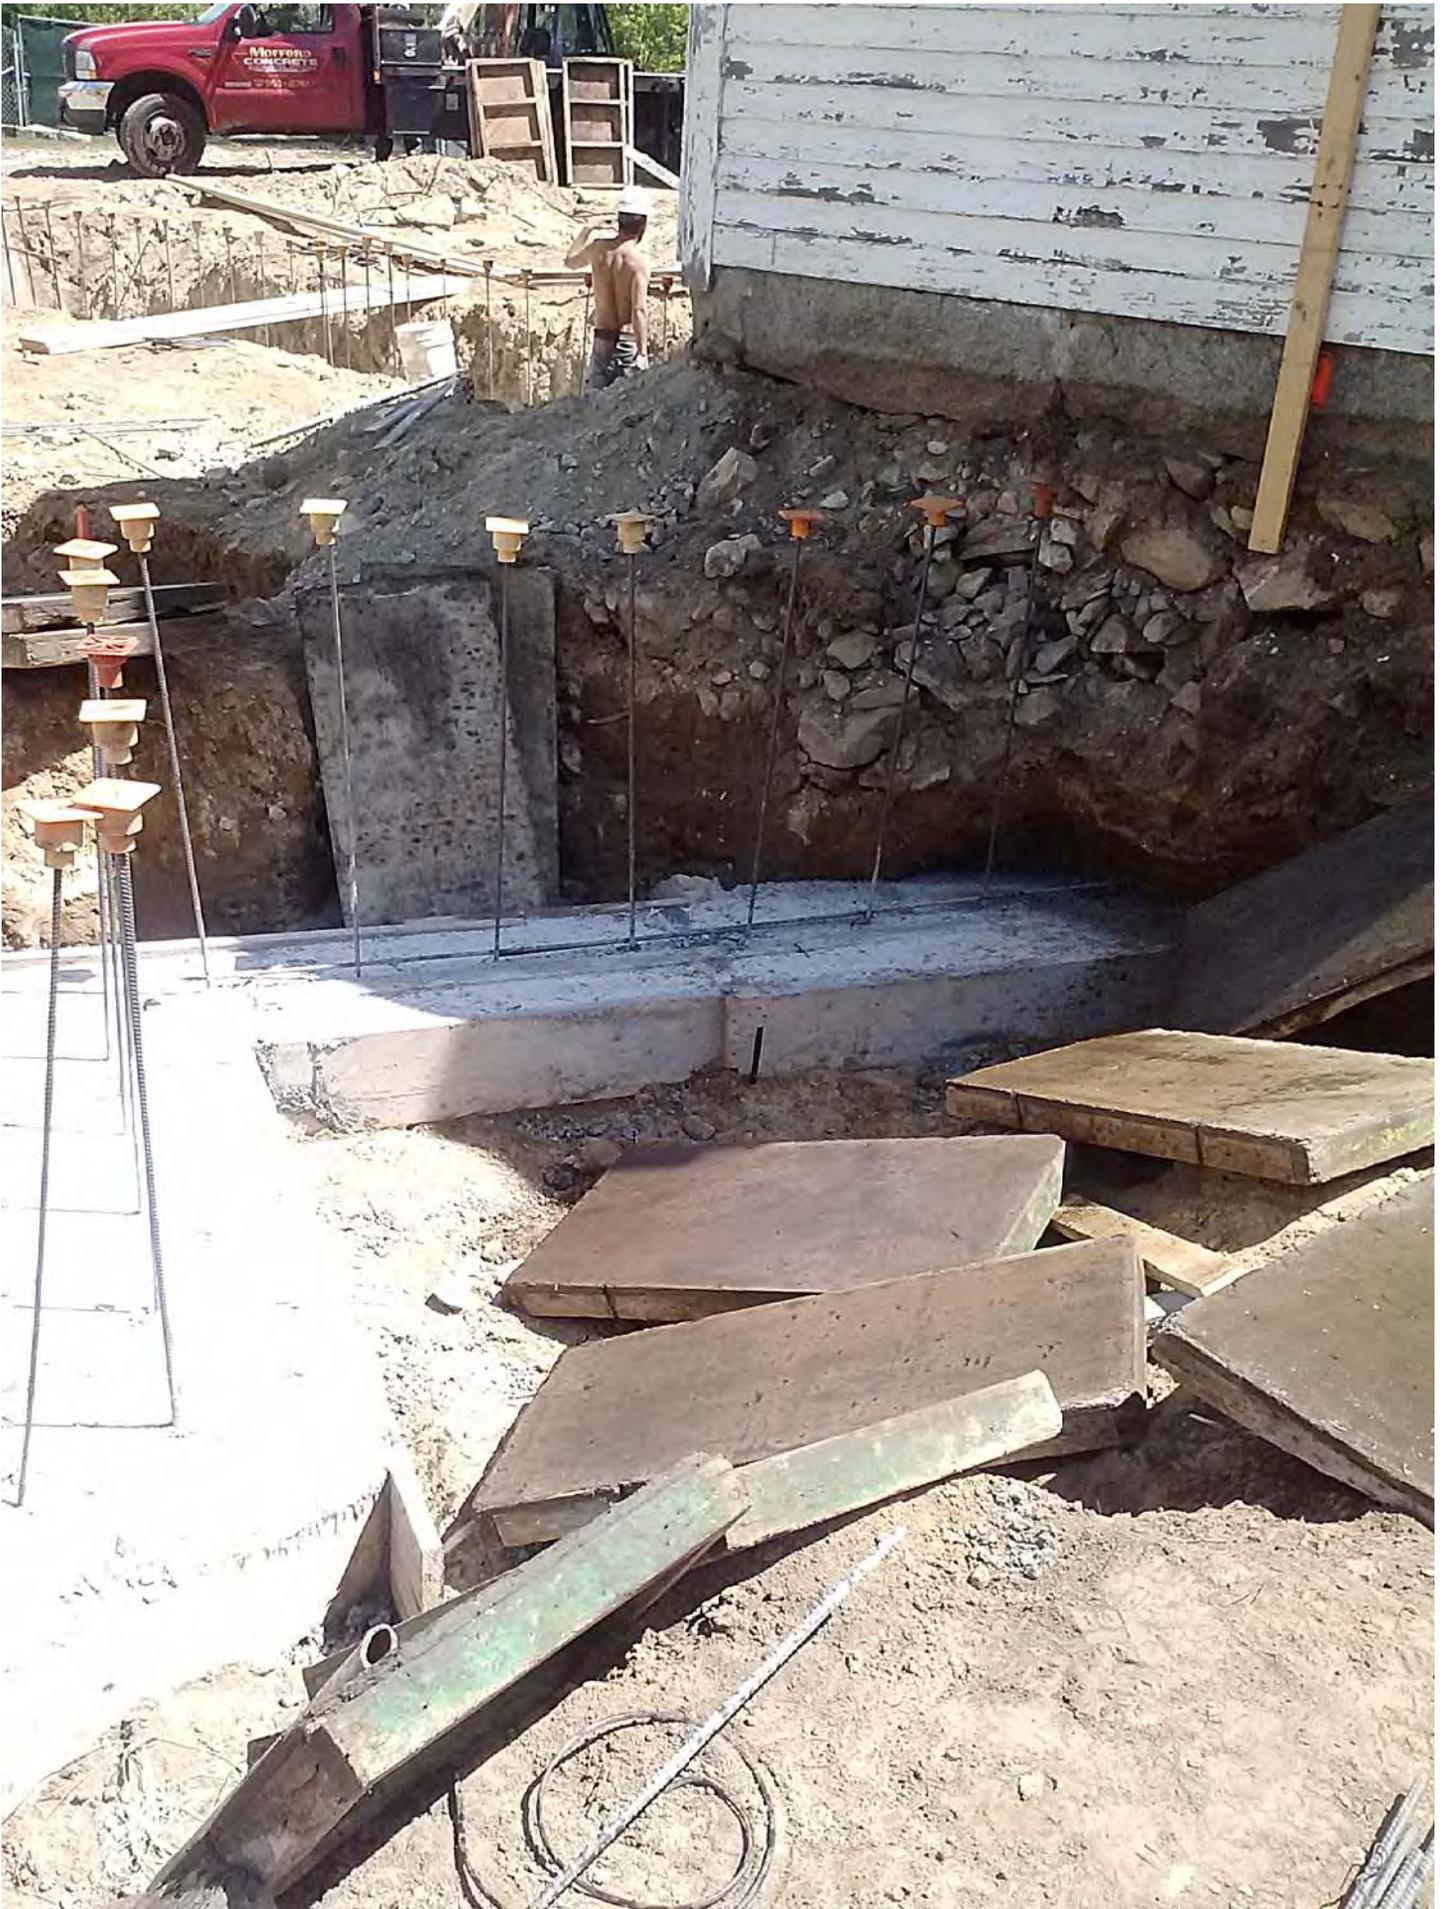
Footing for addition foundation wall

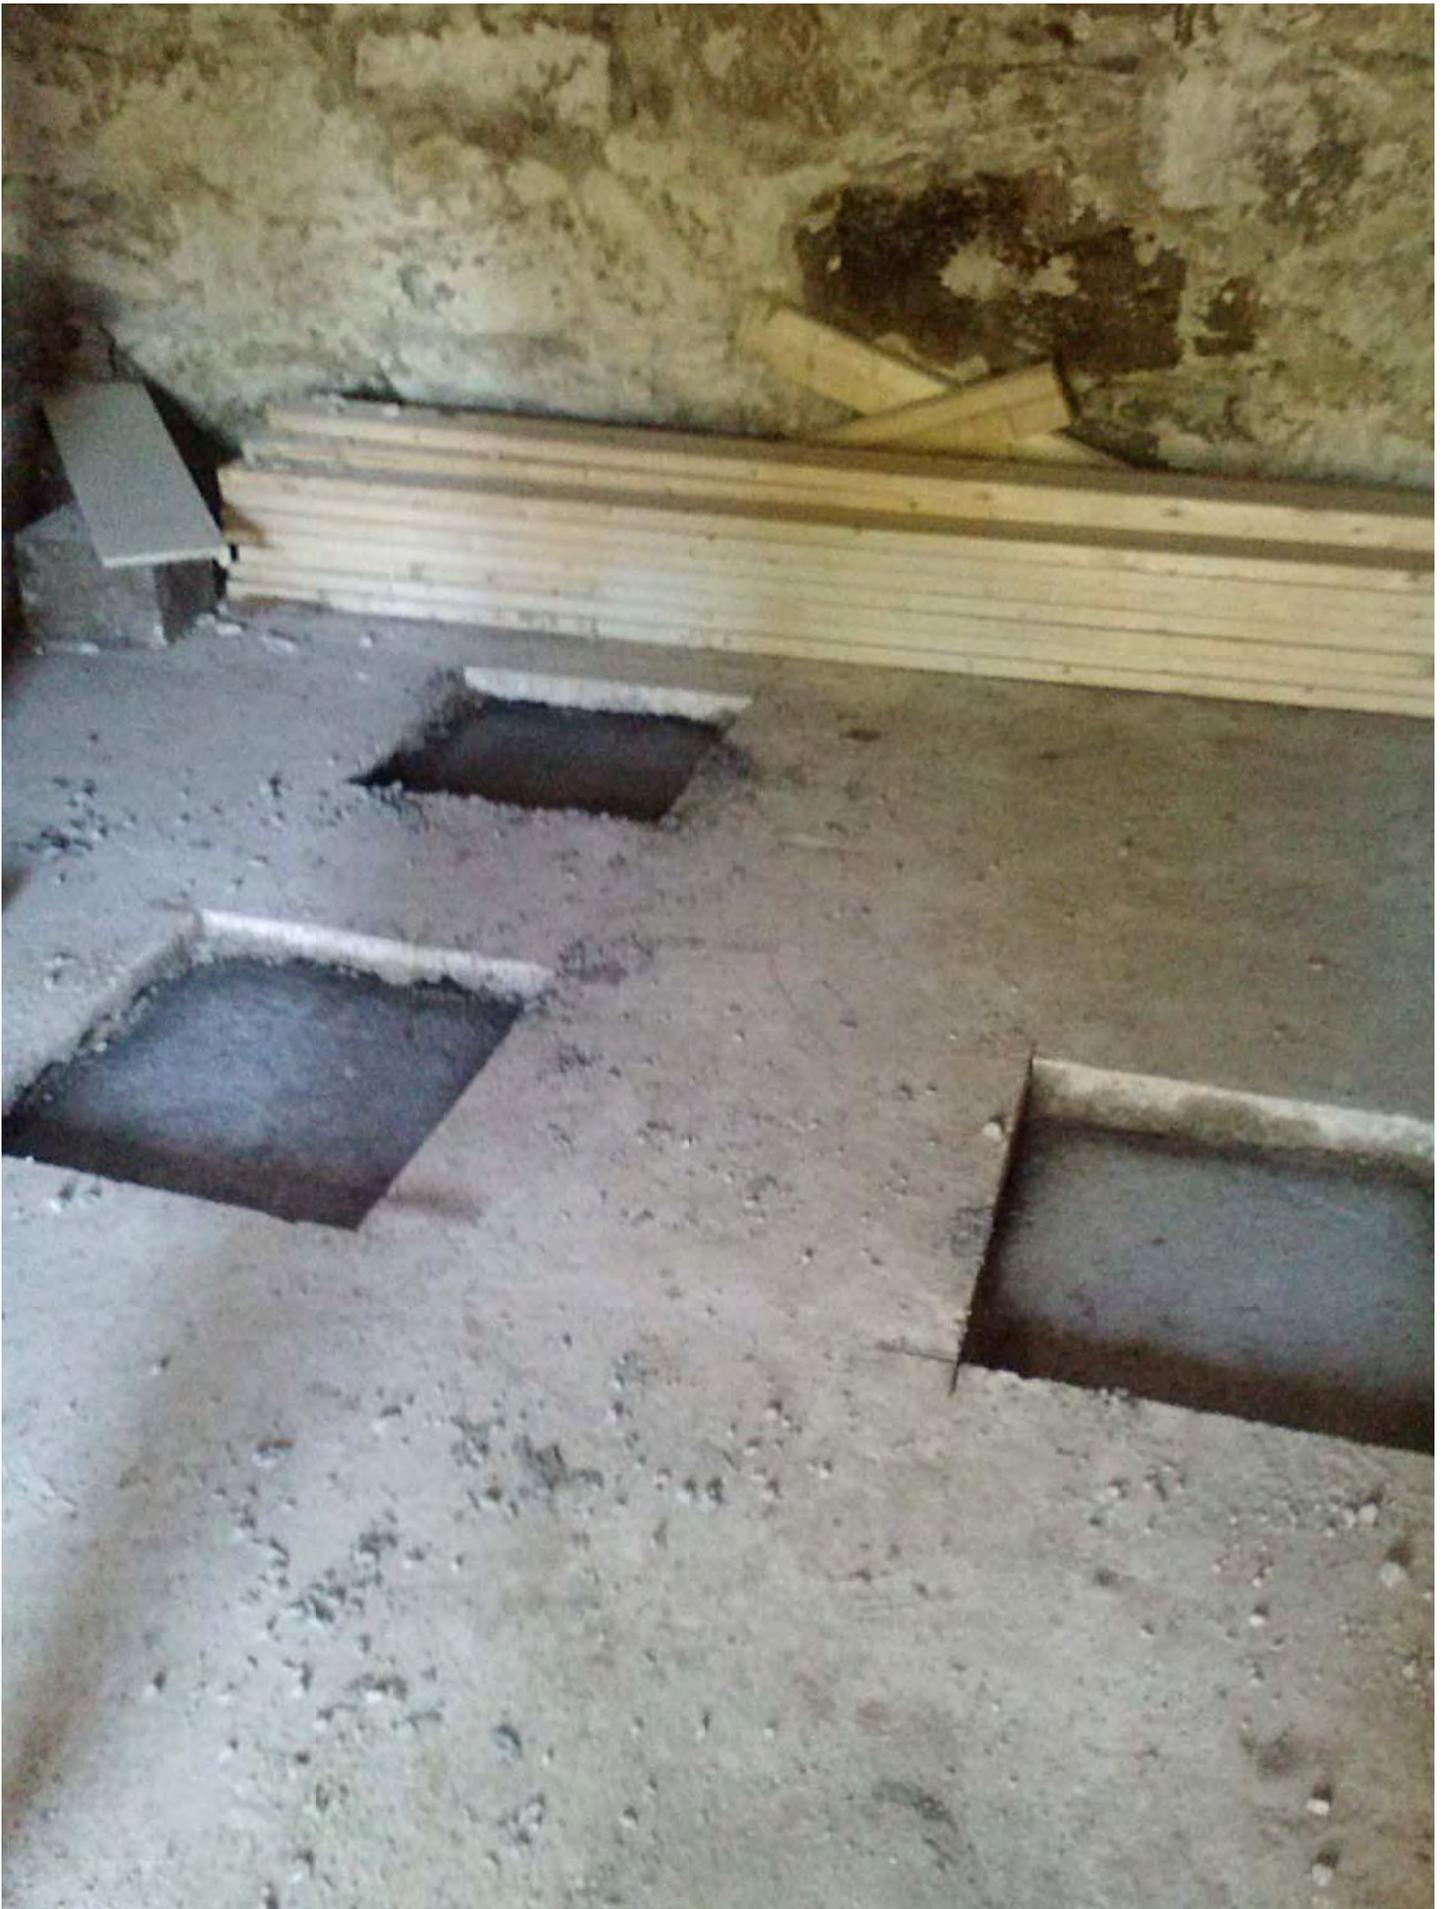
Footing for addition foundation wall by Entry/Lobby

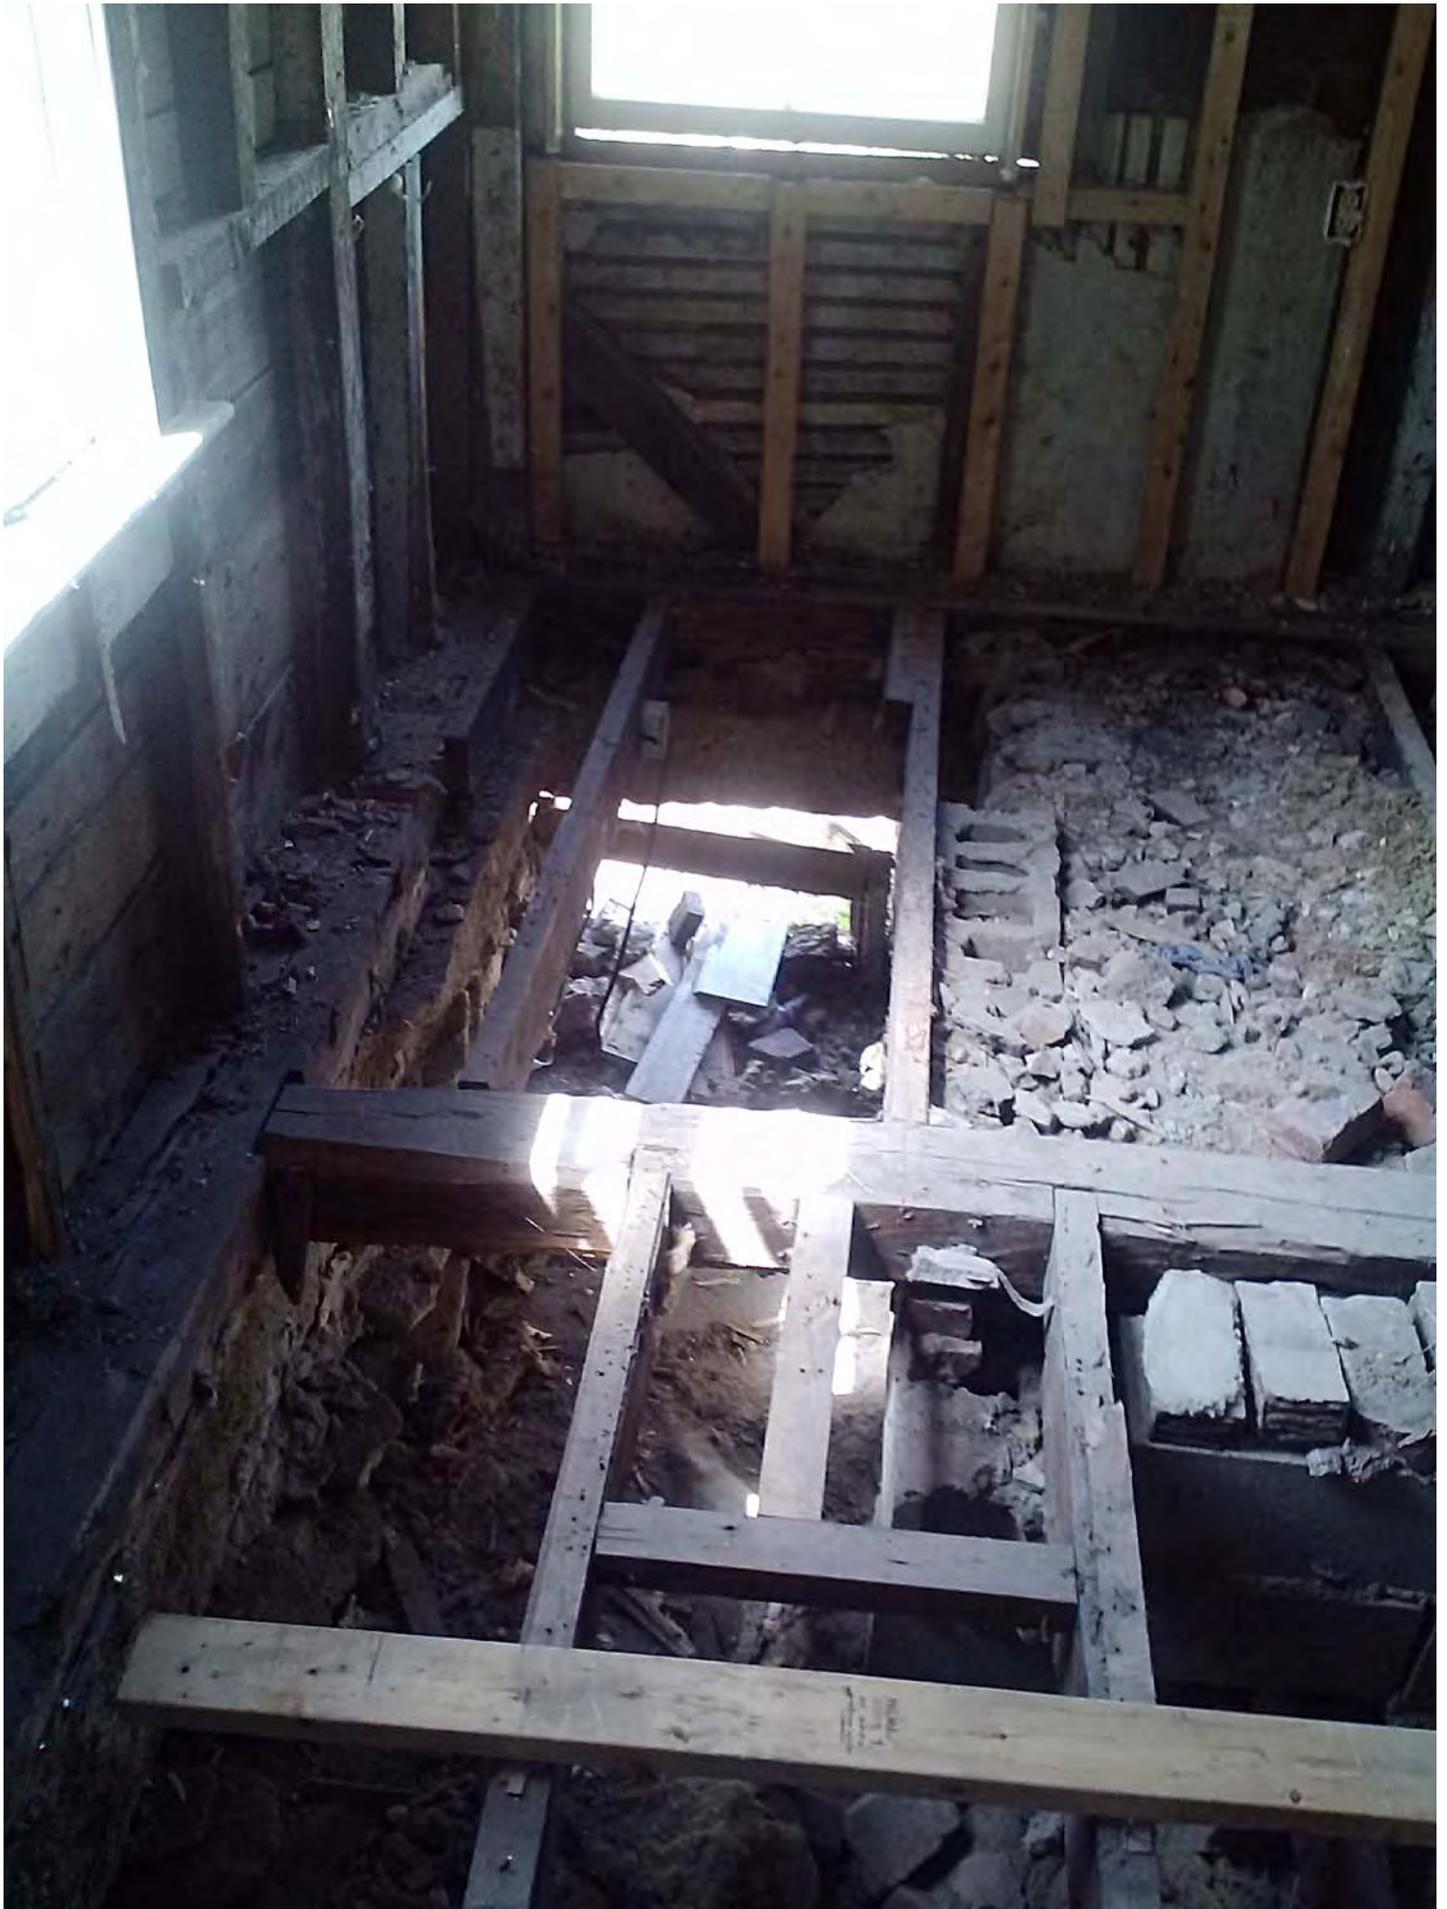
Footing in existing basement

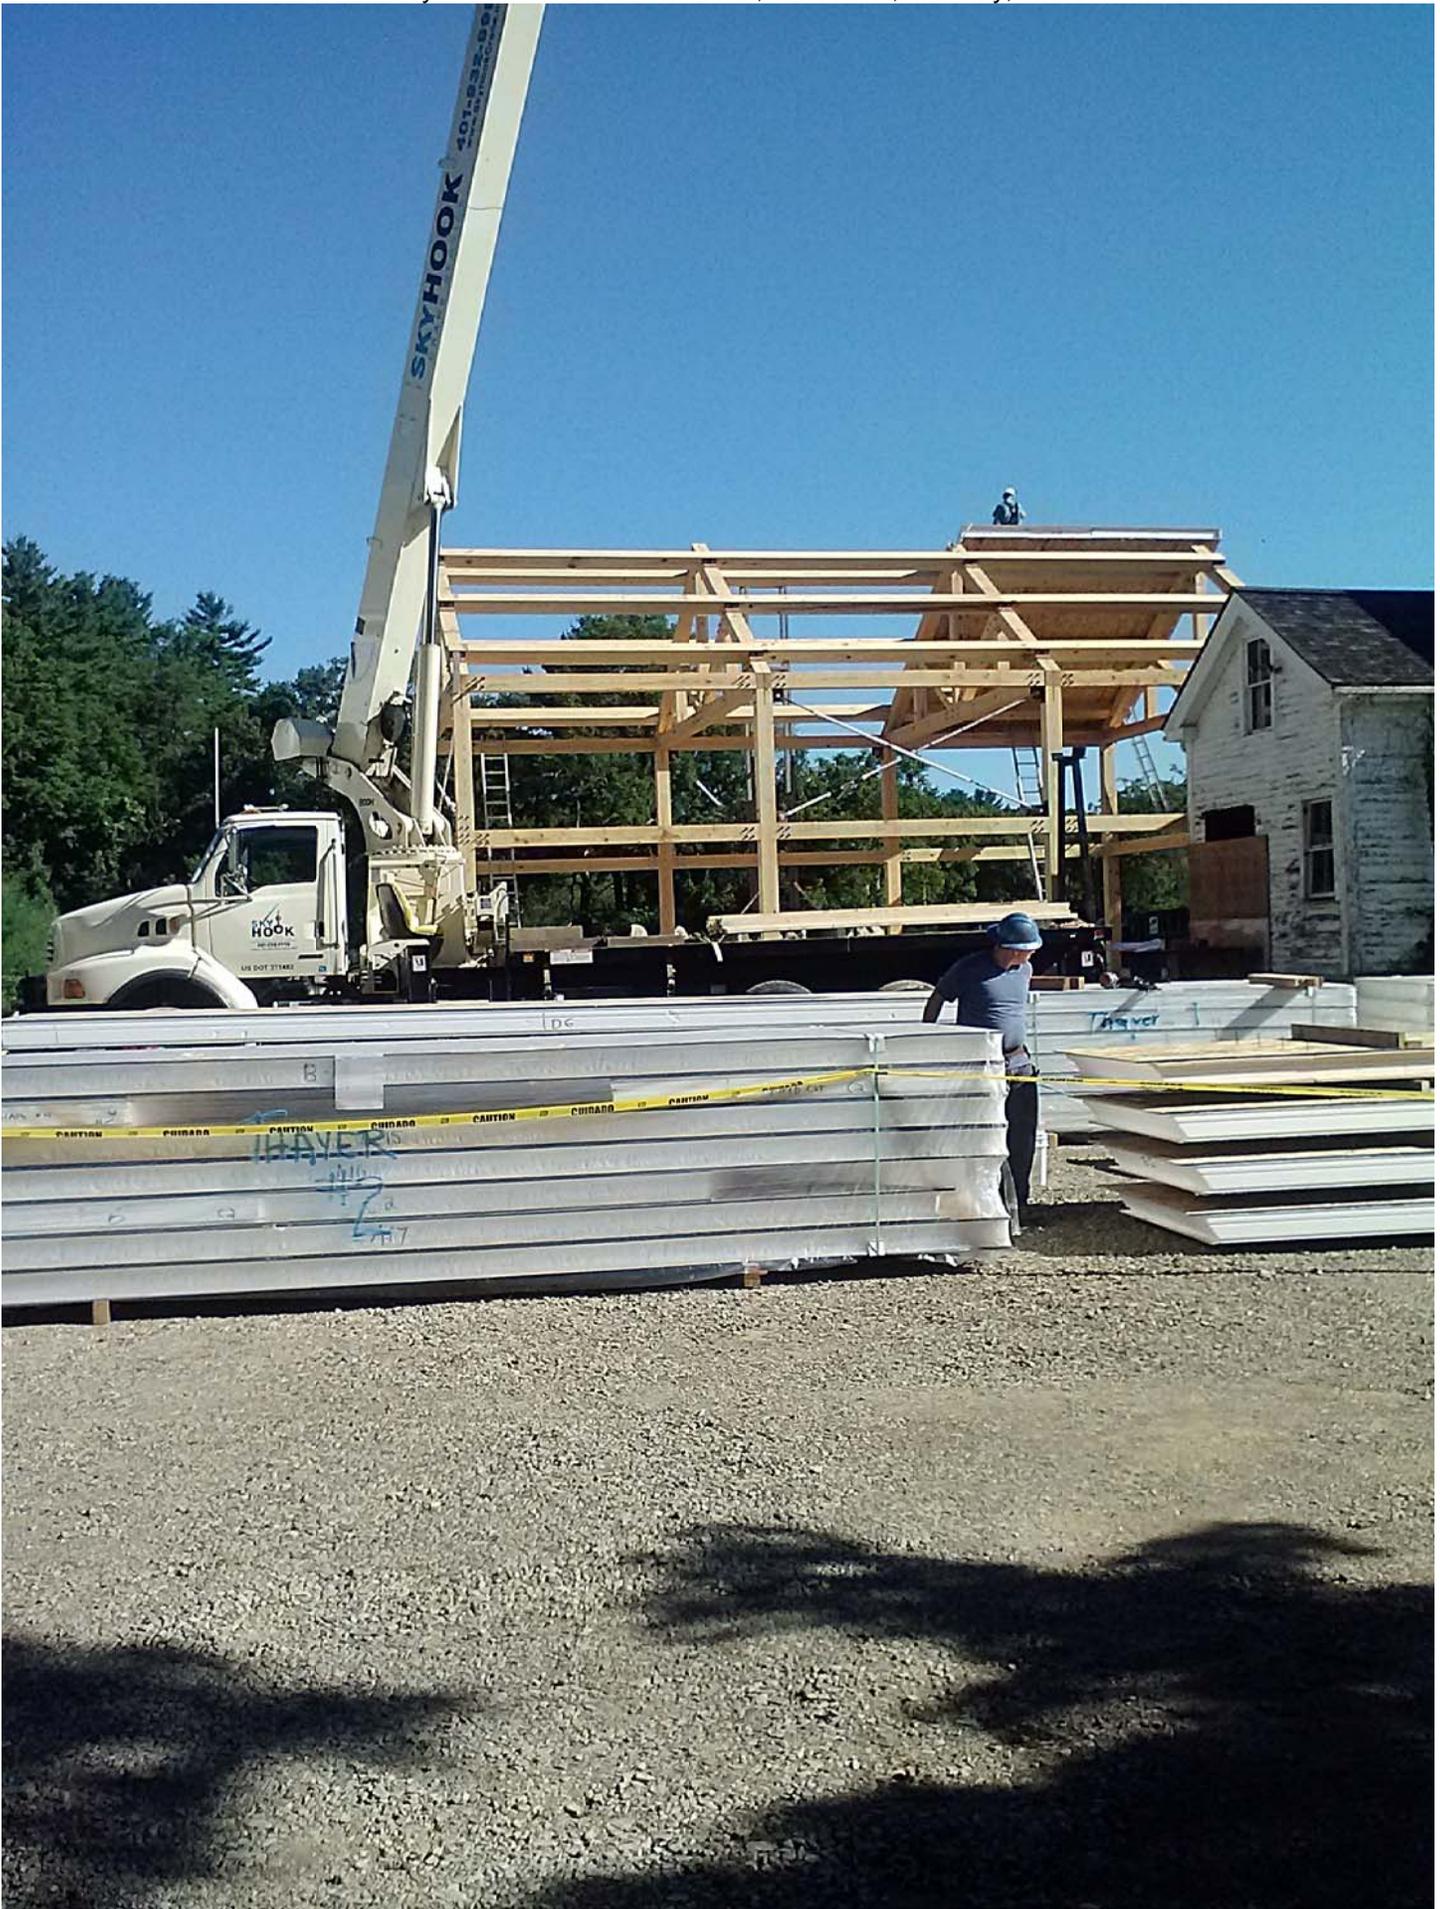
SIPs installation in progress

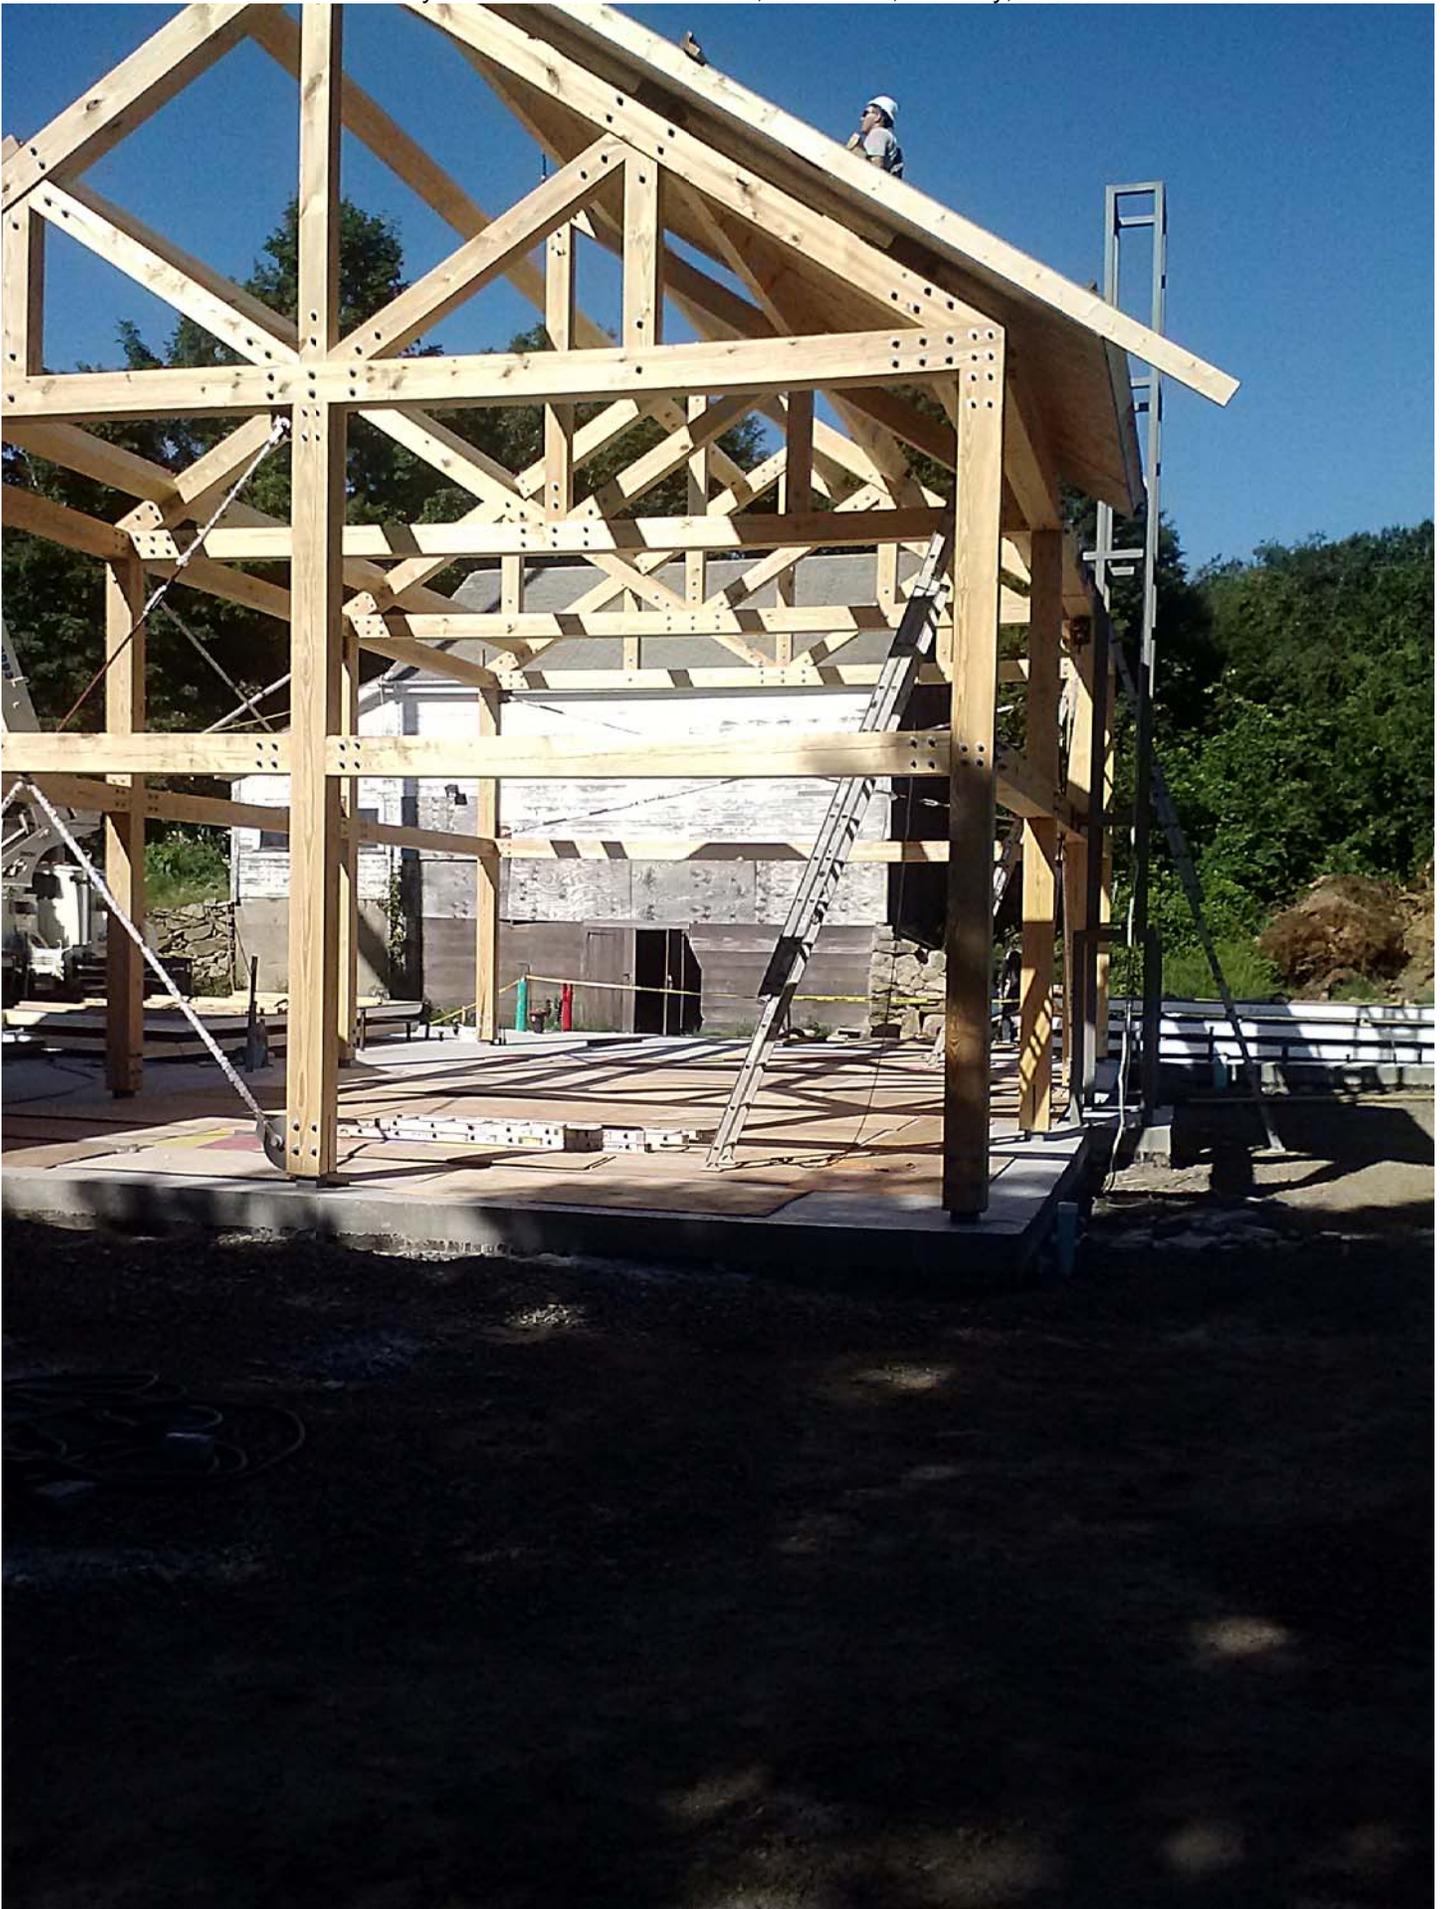
Heavy Timber/ SIPs installation
