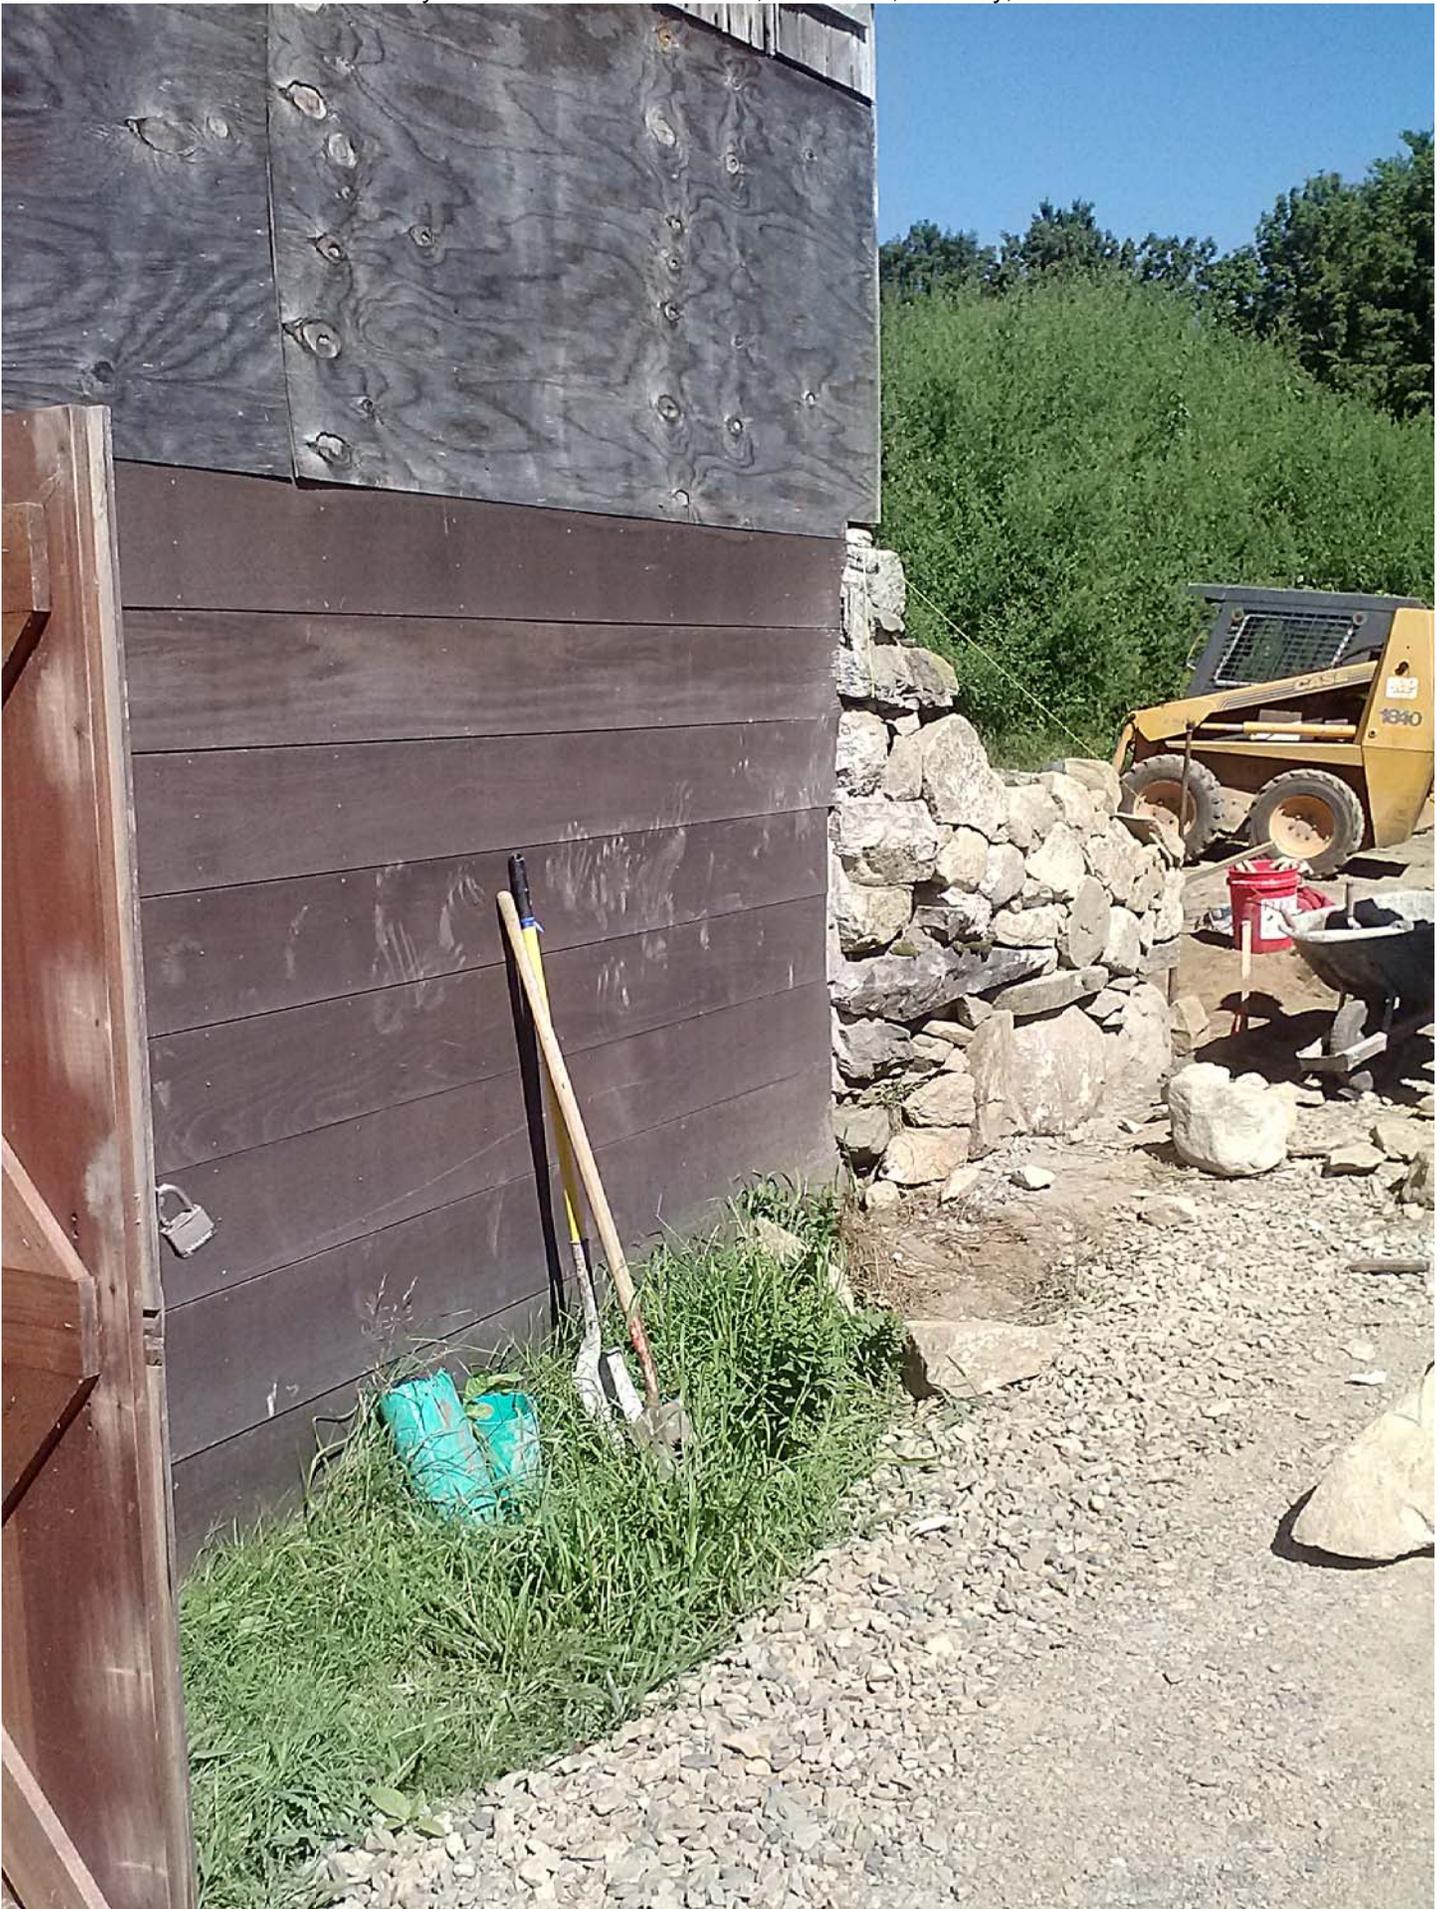
Stone wall at barn in progress

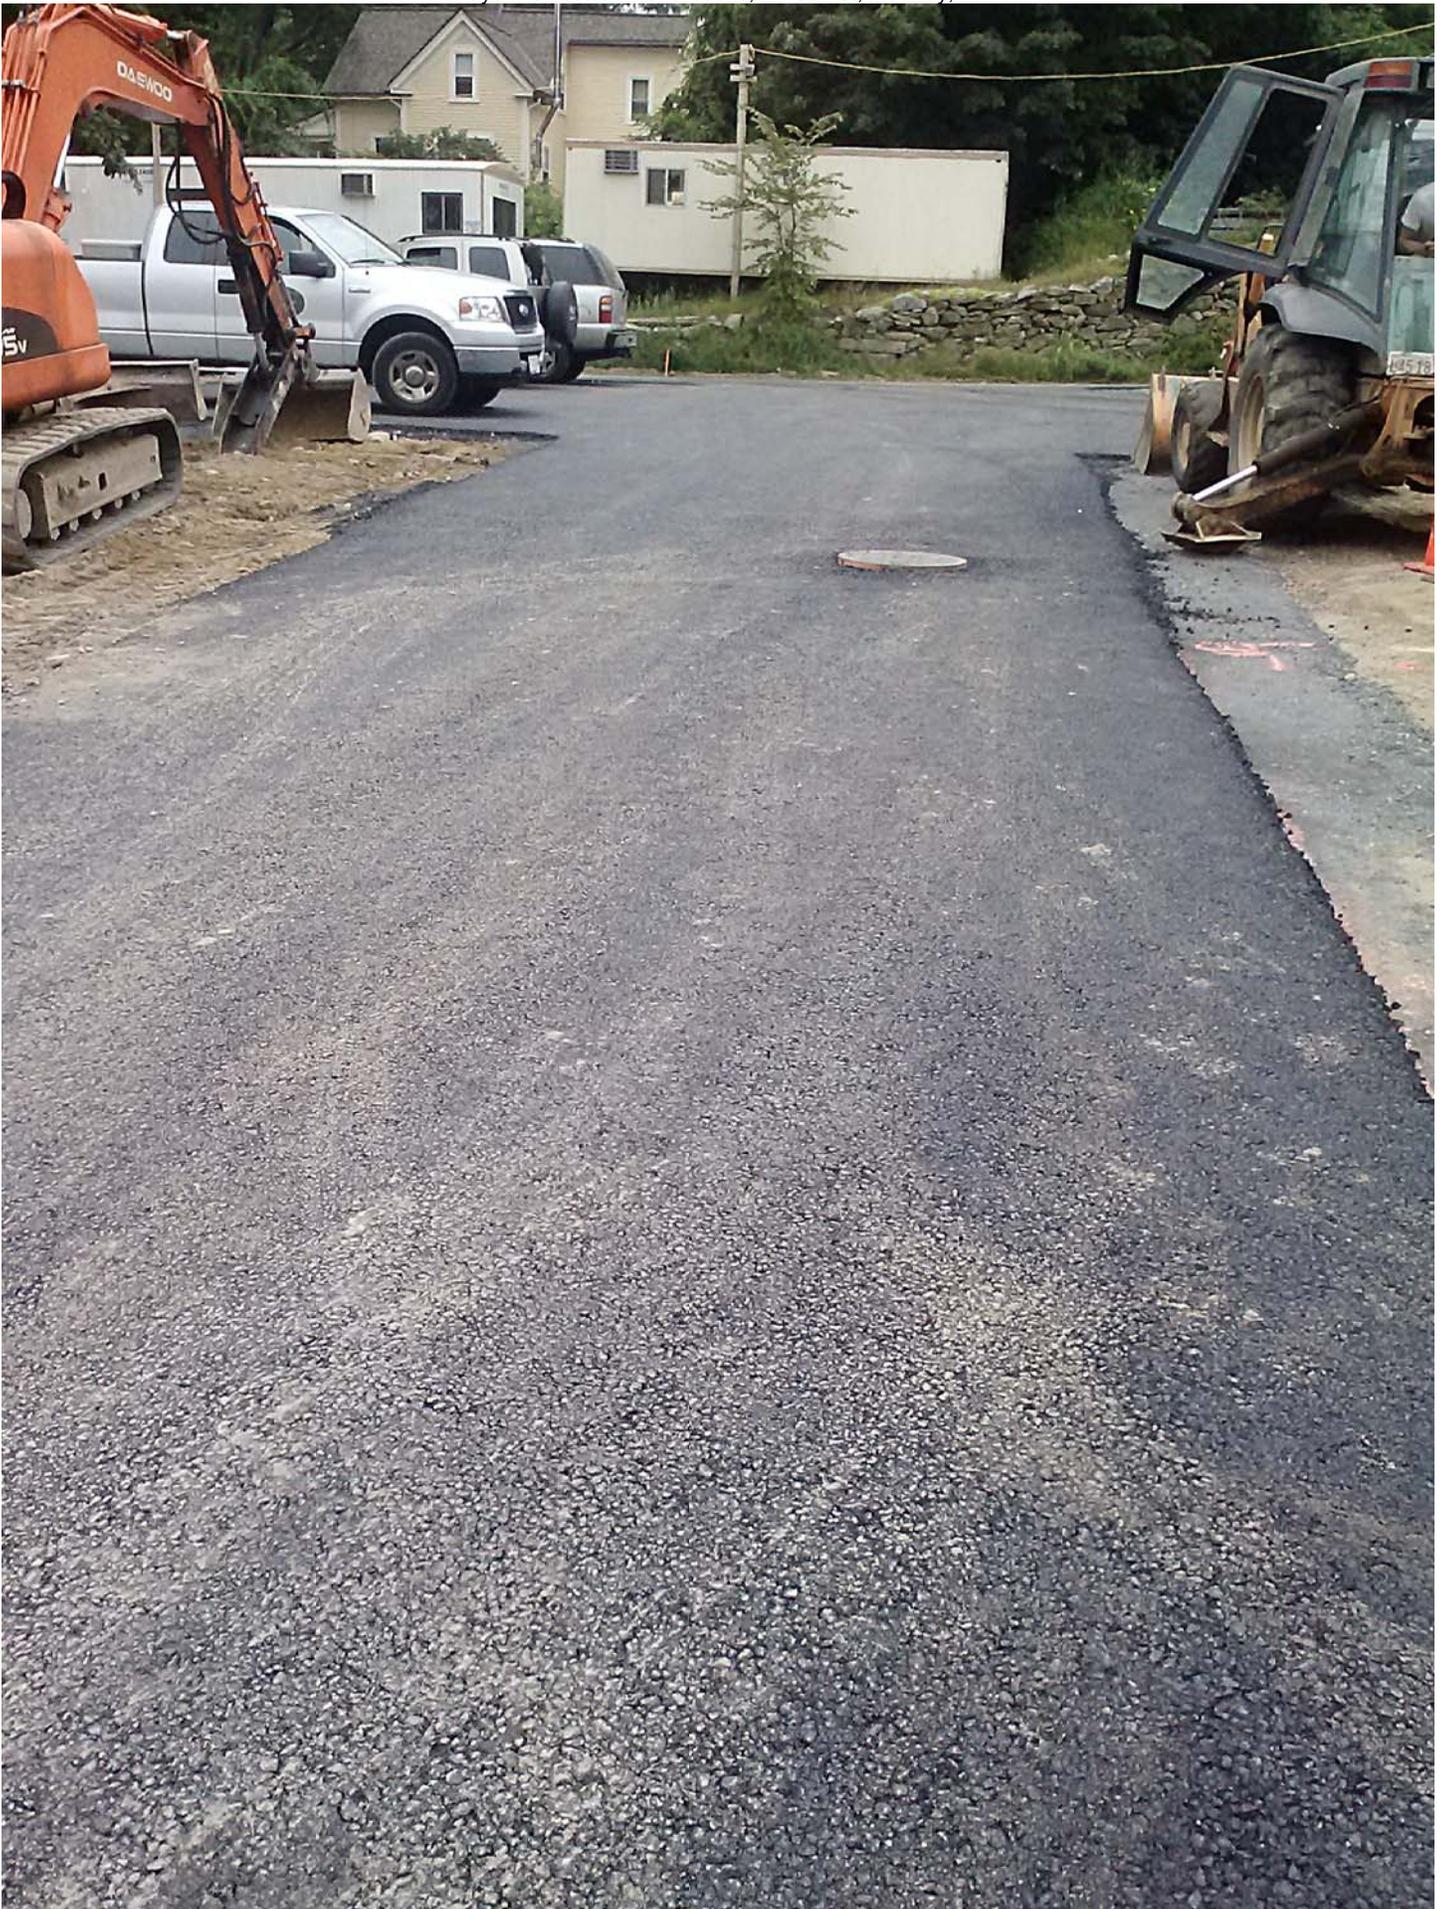
Binder at driveway

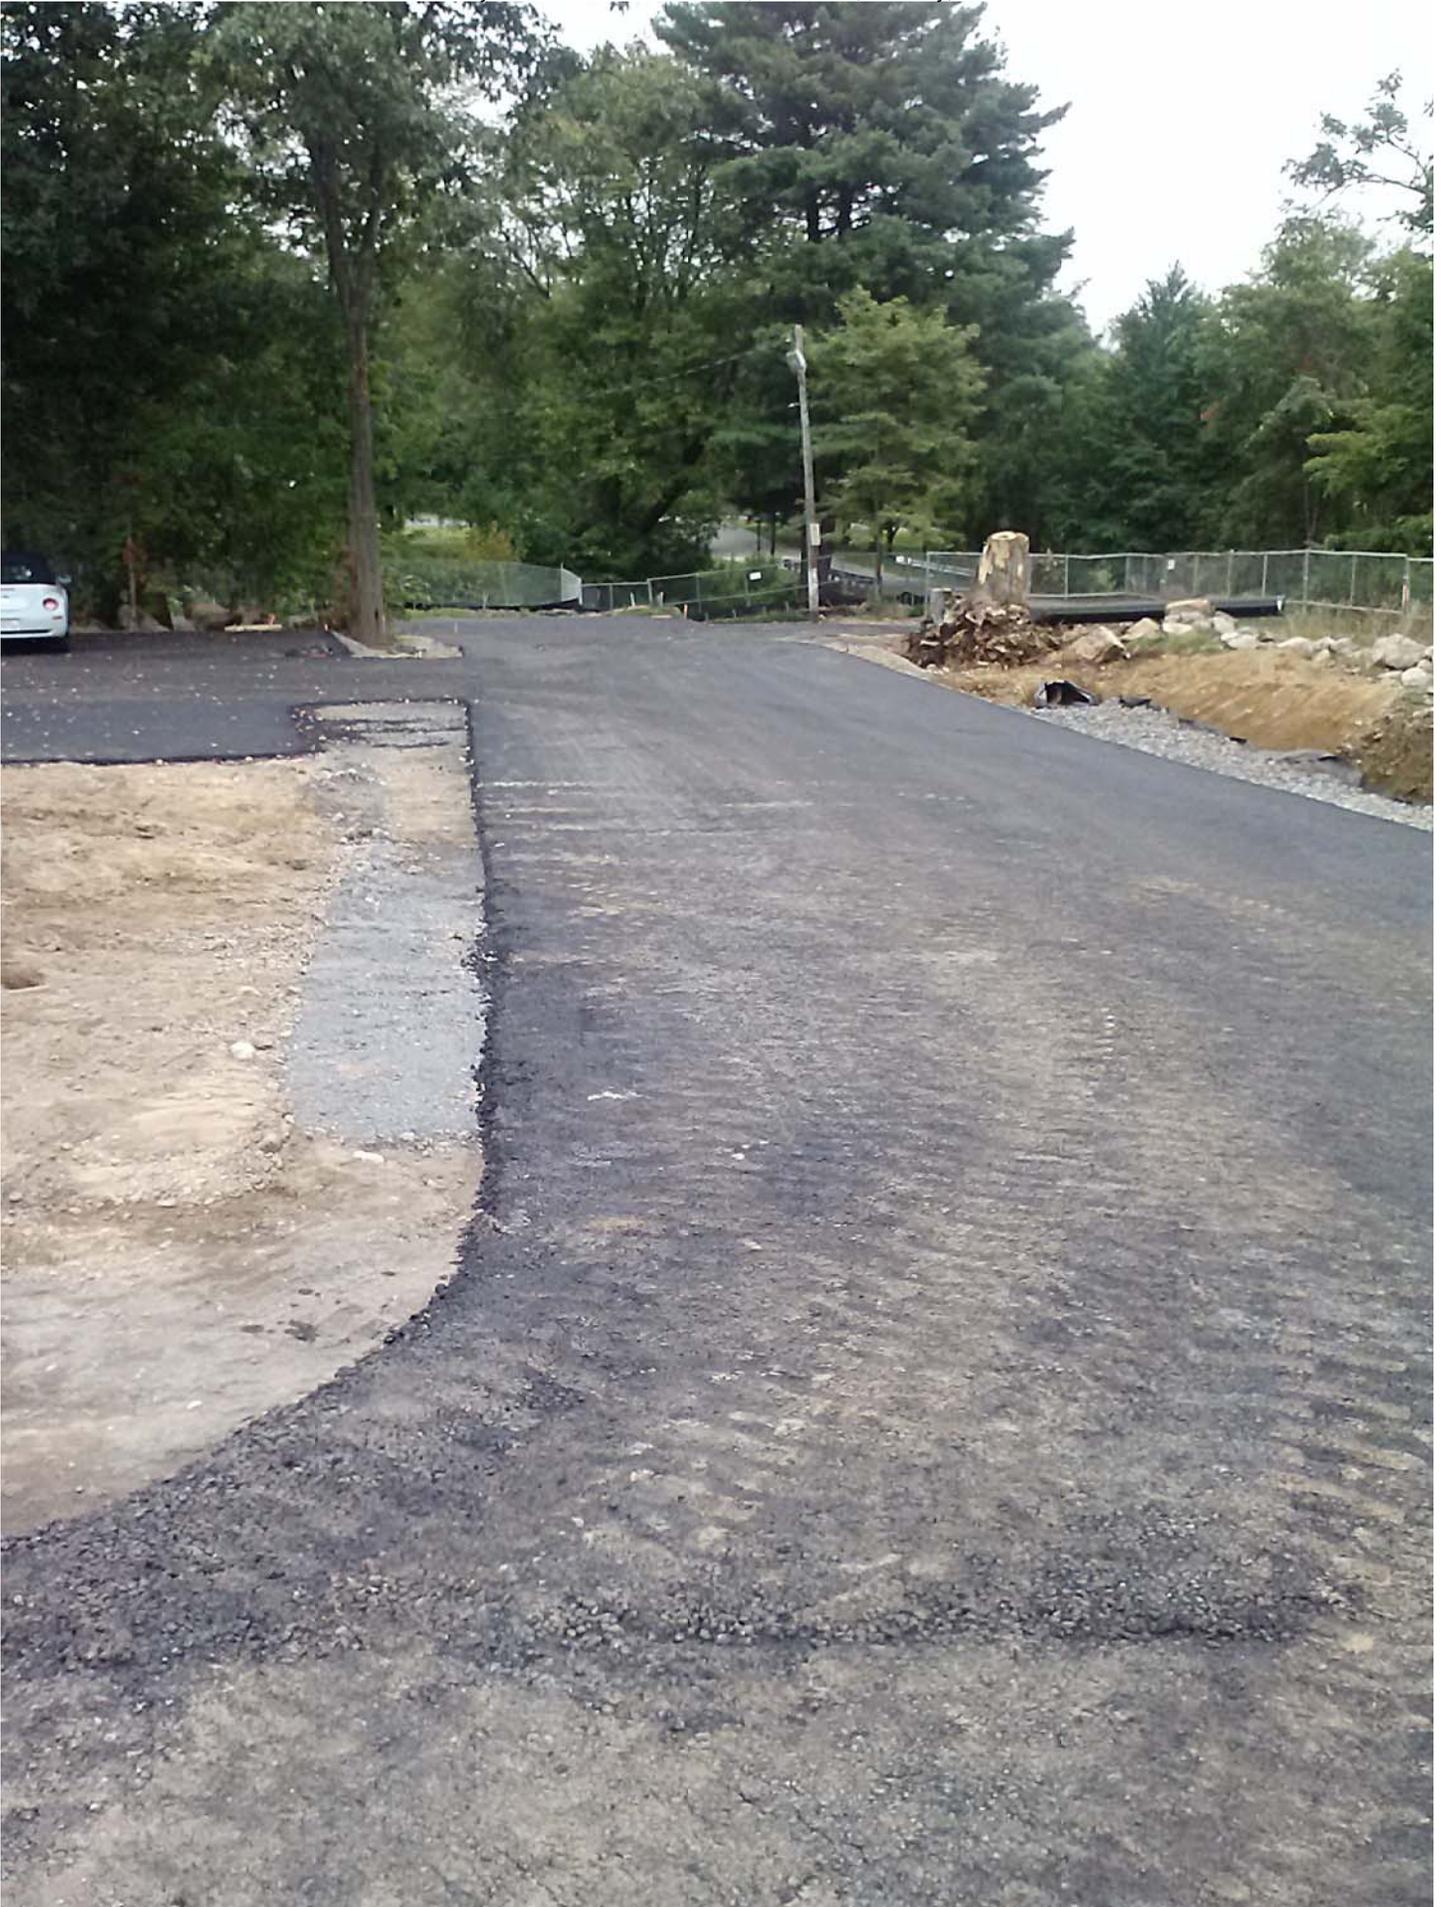
Binder at parking lot

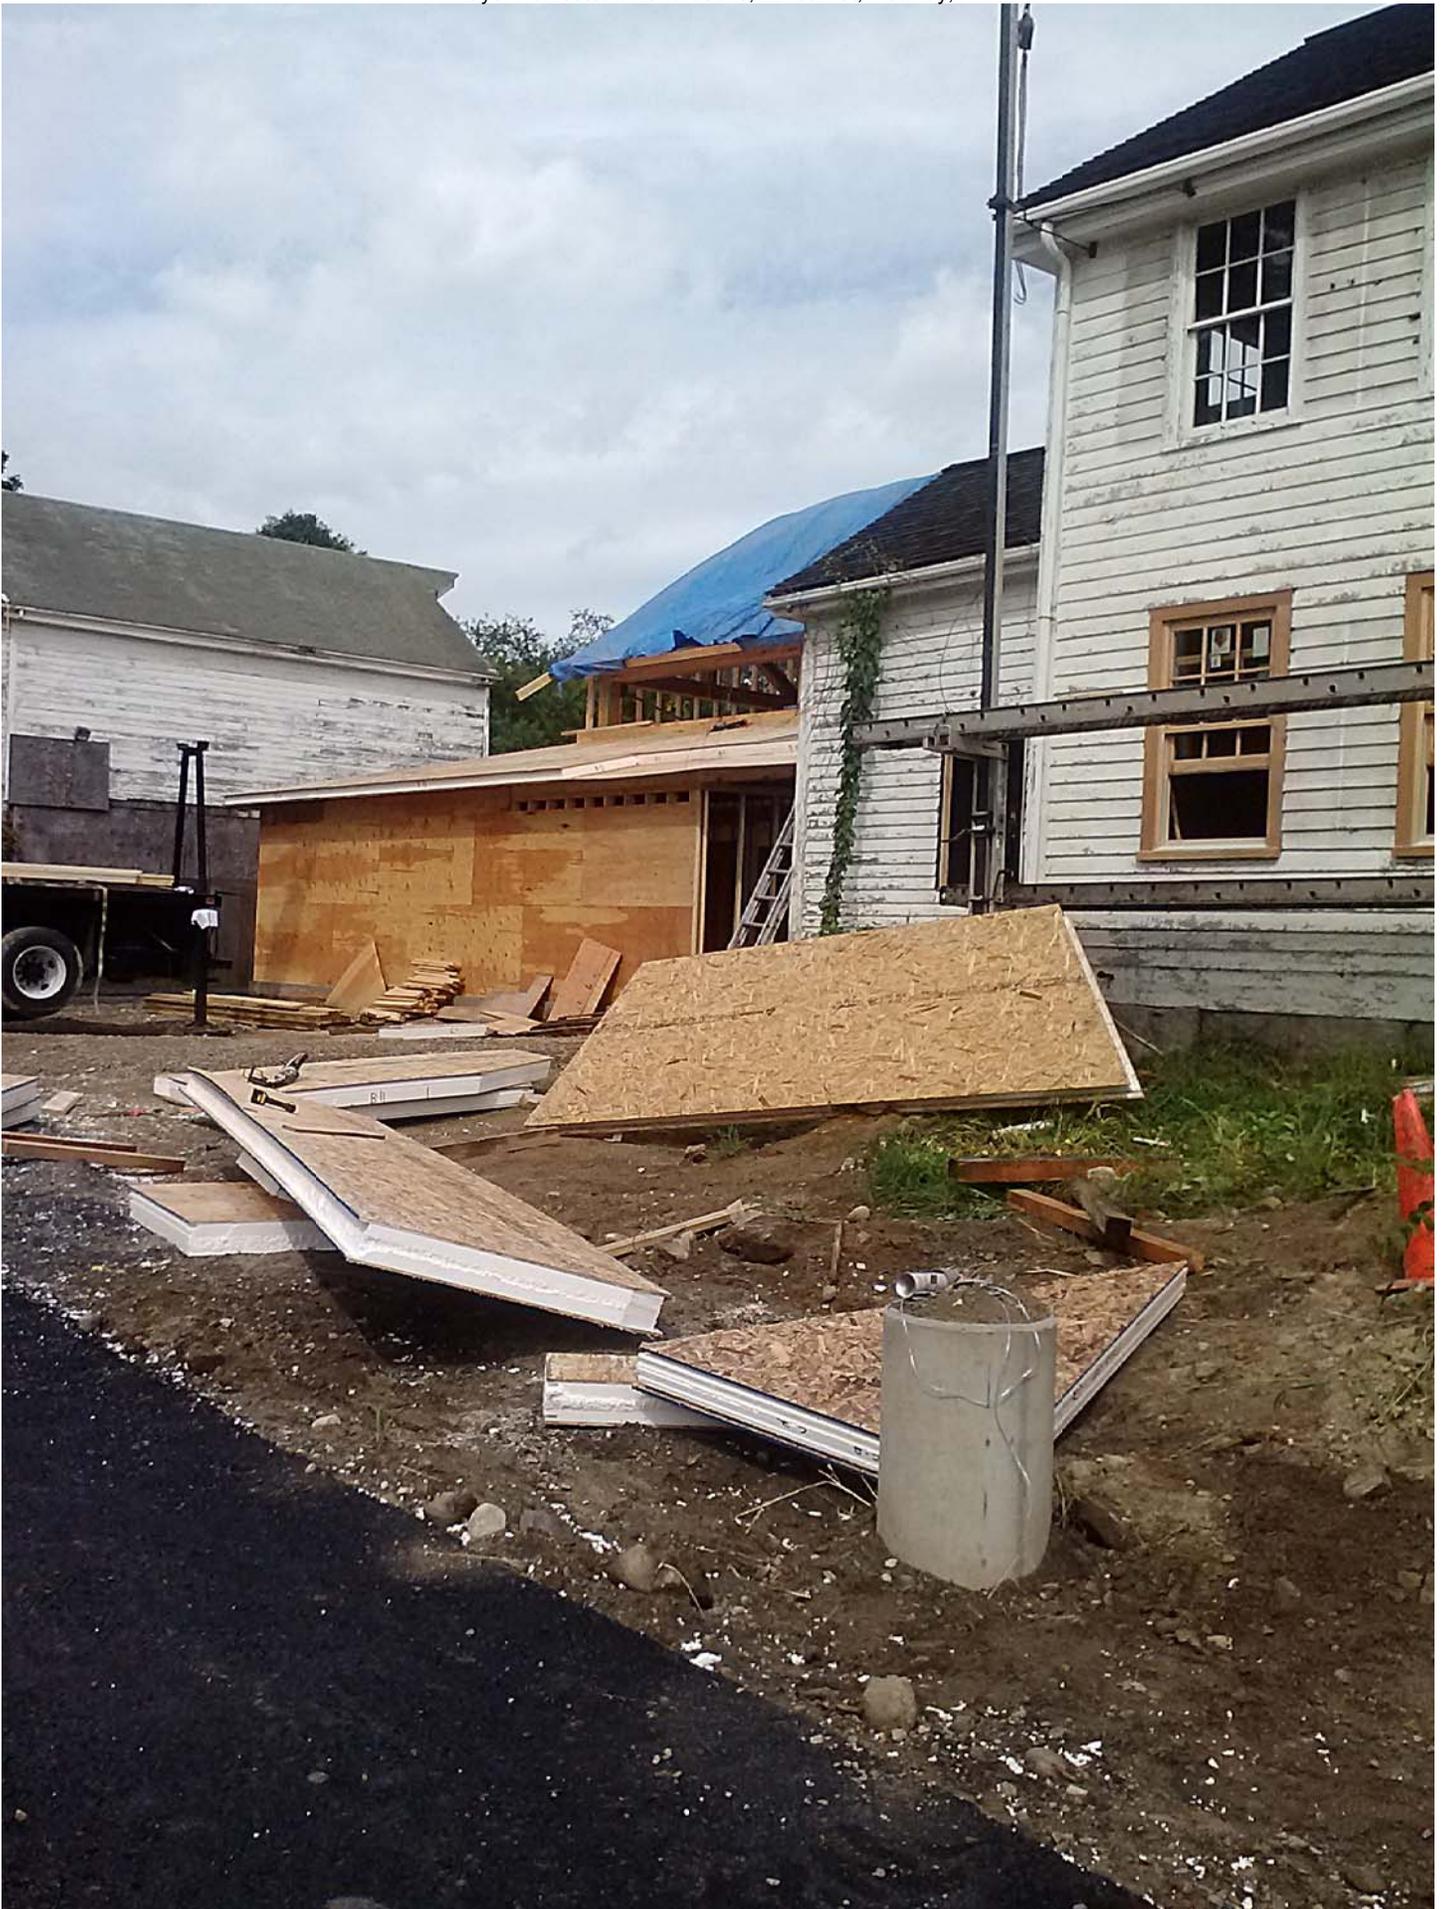
Lower SIPs installation in progress

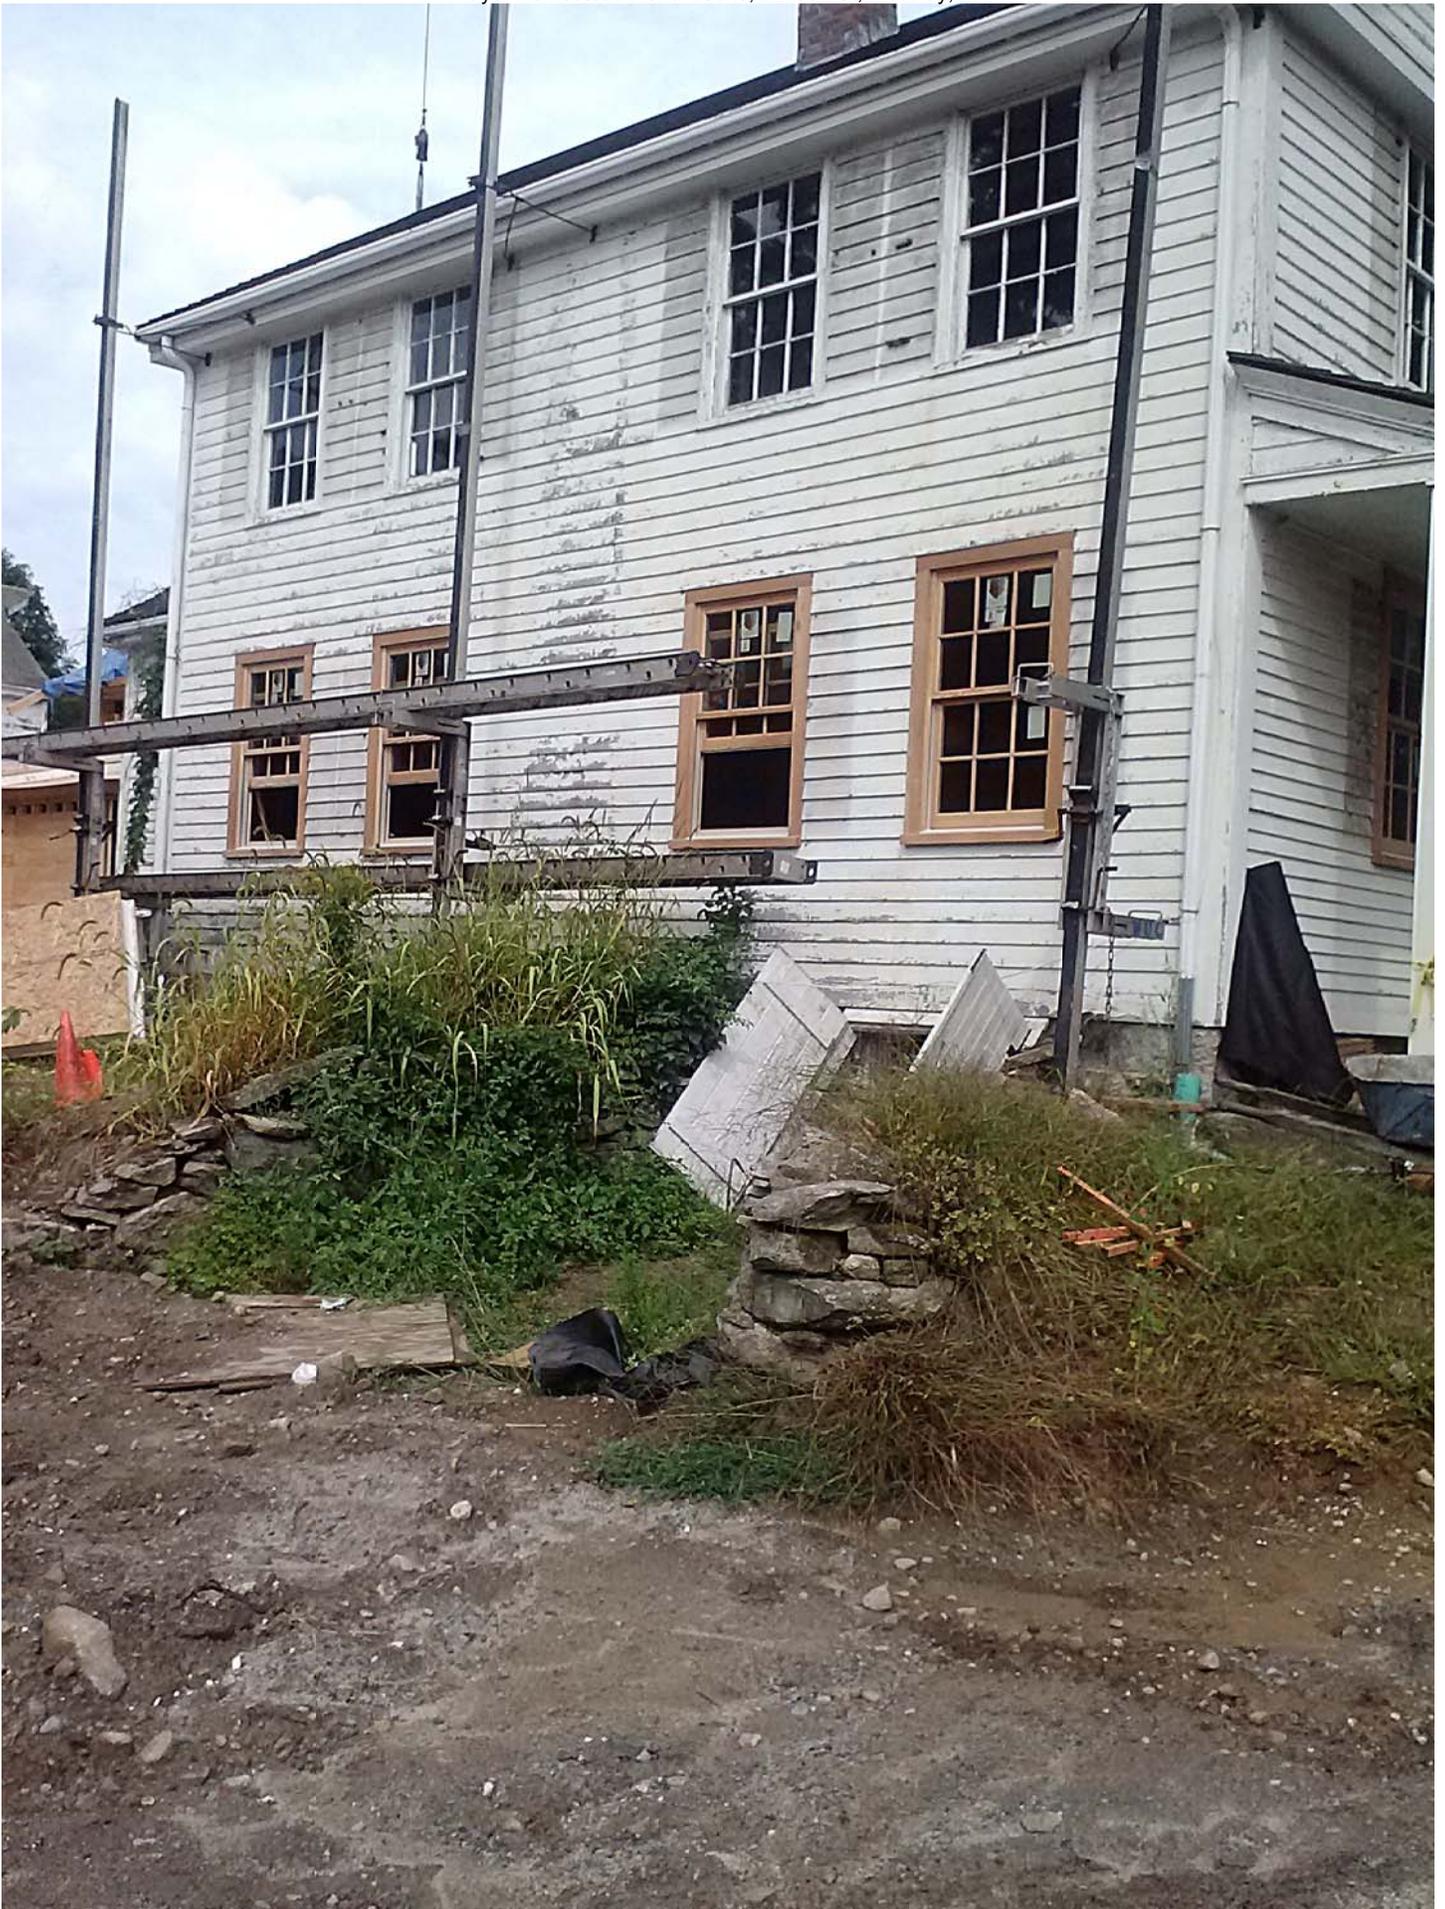
Wood windows installed at 1st fl

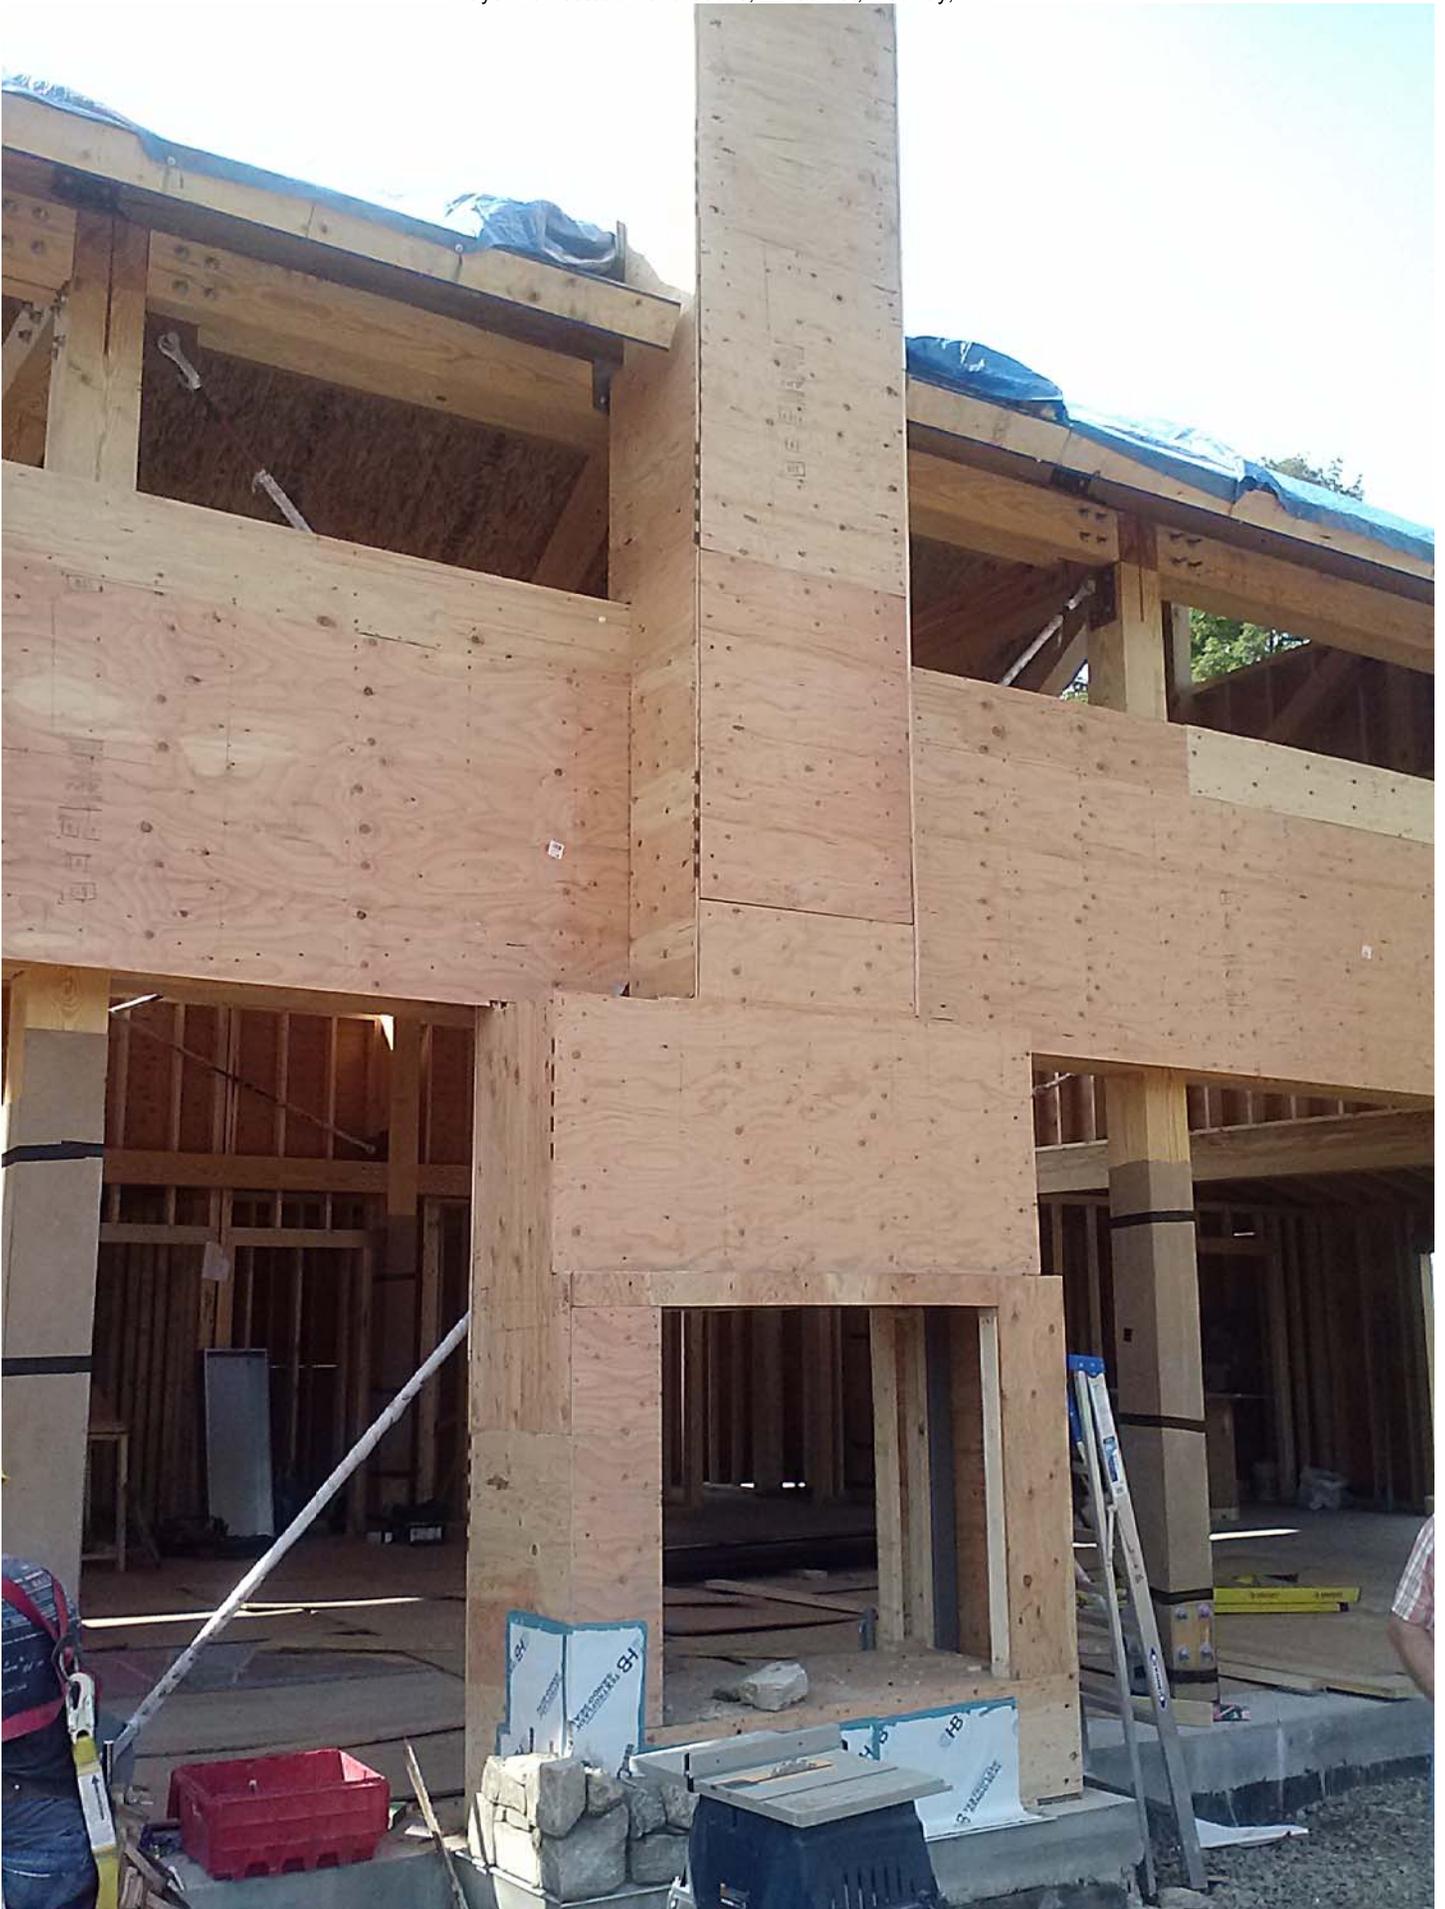
Exterior view of chimney

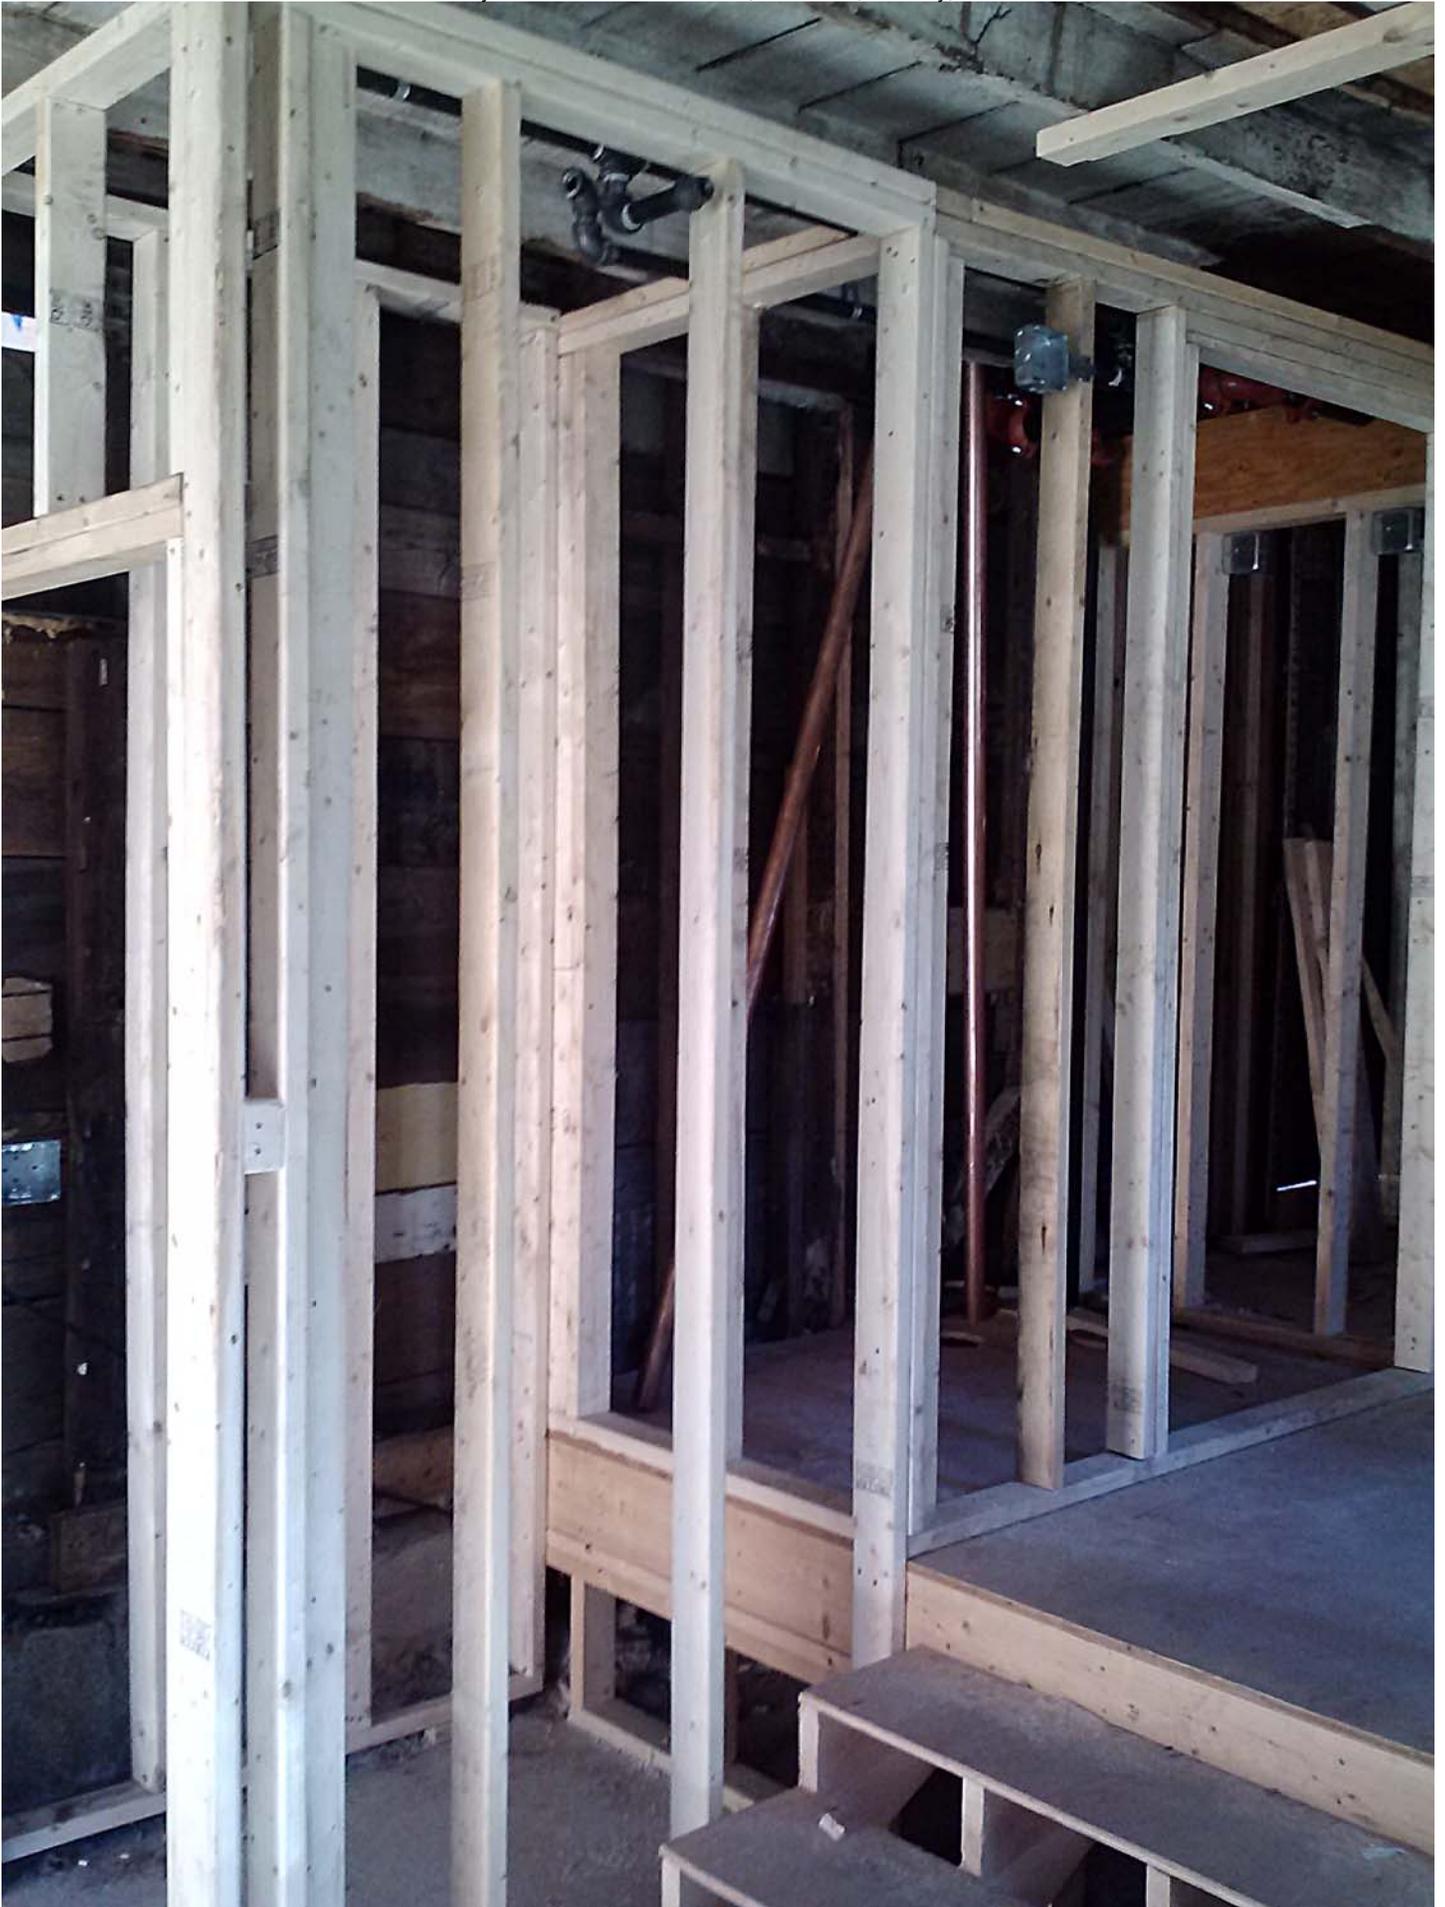
Framing lower landing closet

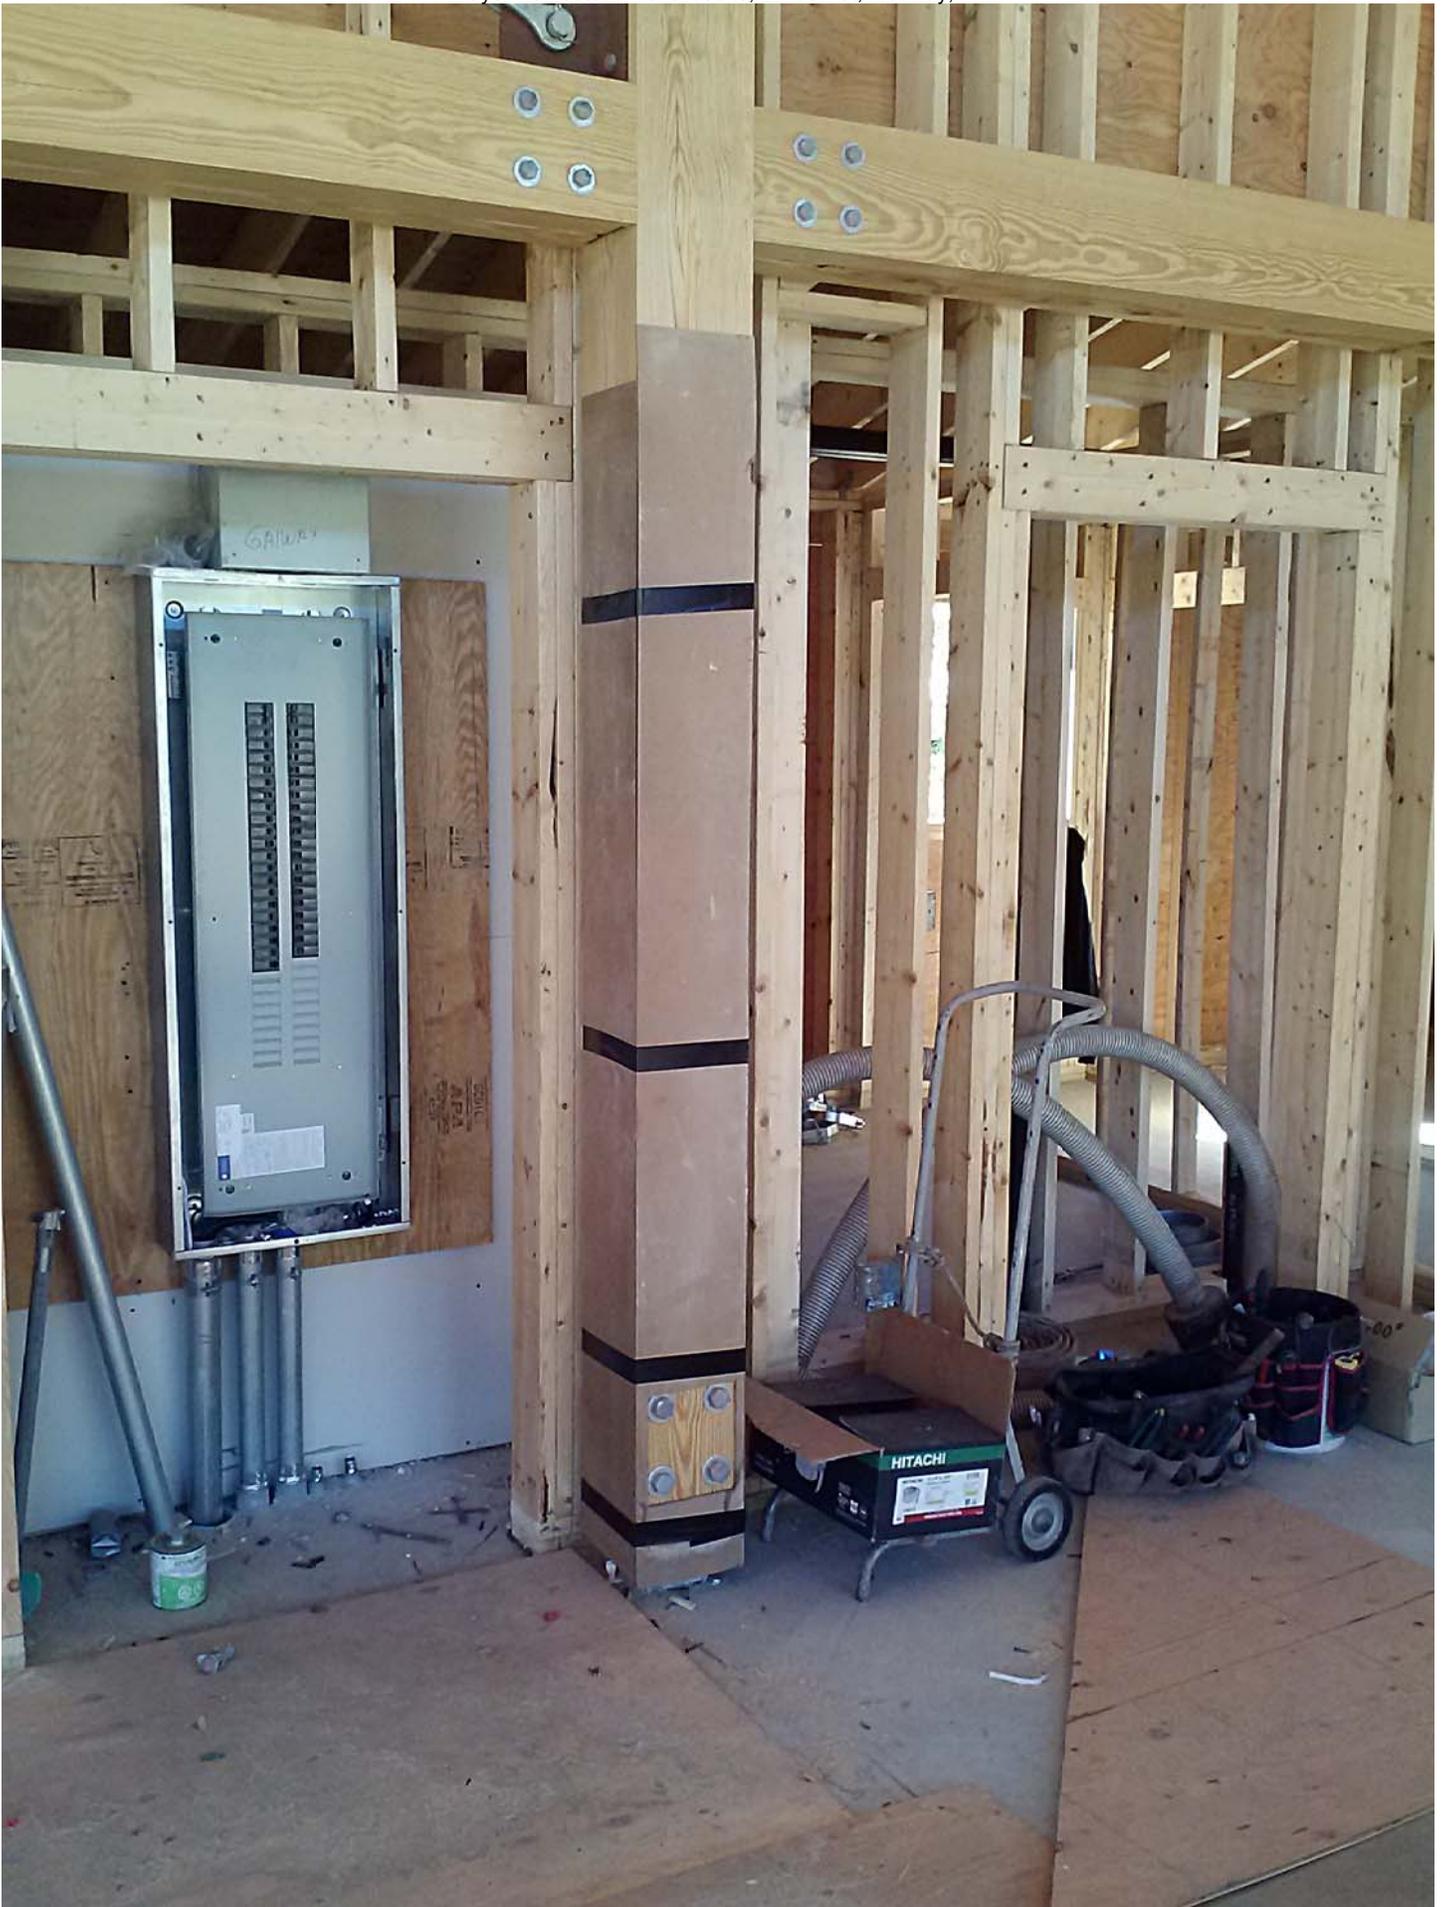
Addition - Electrical closet
