Charles River Amphitheatre Baseline Documentation Report

Prepared for: Town of Medway

Prepared by: Anne Capra, Conservation Works, LLC

Date of Report: May 5, 2018

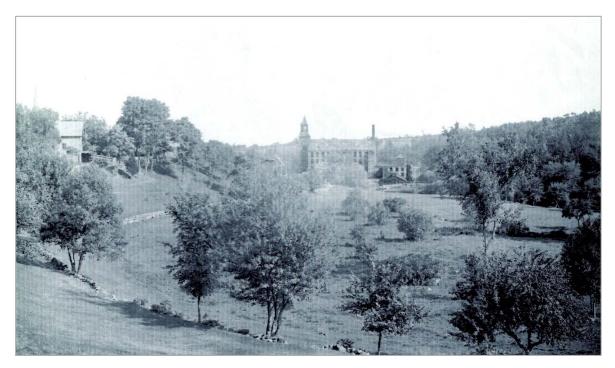
View to the east into Amphitheatre. Stone wall present forming arc of the Amphitheatre.

Sanford Mill in the distance, center of photo.

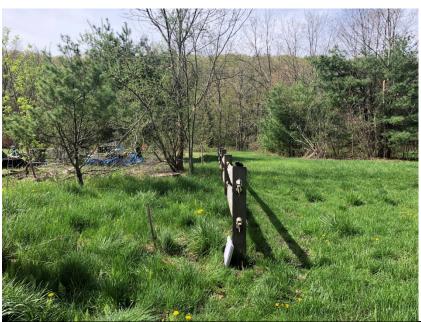
经外别 公司总统的第三			N*** # #
Photo	Cardinal	Wpt #	Location Description	Description of Photo Subject
#	Direction			
1	SW	1	Estimated east property line at driveway	Property on right of wood split rail fence; grass field with trees and shrubs; stake to
				left of fence

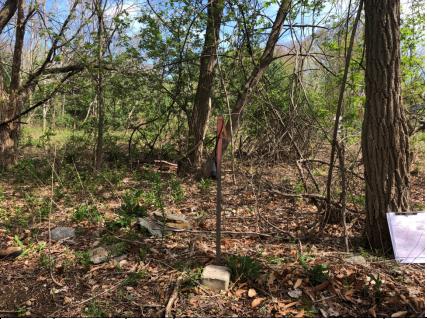
The state of the s	SECURIOR AND SECURIOR		
Photo	Cardinal	Wpt#	Location Description	Description of Photo Subject
#	Direction			
2	NE	2	Southeast corner at concrete bound	Property on left of bound; stake with
			with drill hole approx. 30' from	orange paint and tape; pile of stones;
			bank of Charles River	Oriental bittersweet vines, black locust

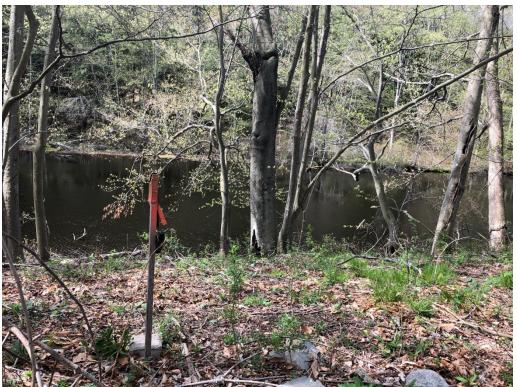
THE COLOR			
Photo	Cardinal	Wpt #	Location Description	Description of Photo Subject
#	Direction			
4	SW	2	Southeast corner at concrete bound	Property on right of bound; view to
			with drill hole approx. 30' from	Charles River and across into Franklin
			bank of Charles River

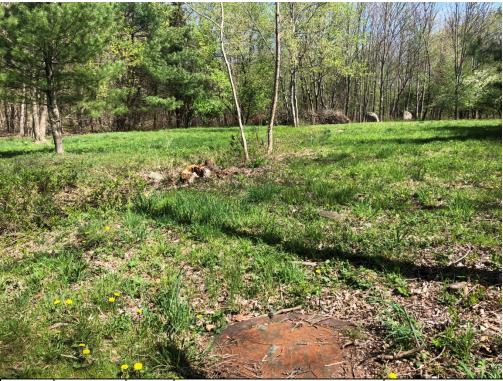
LA L	第 700号 200号 200号		STATE OF THE PARTY
Photo	Cardinal	Wpt#	Location Description	Description of Photo Subject
#	Direction			
5	N	3	Sewer manhole on property within	View into property of sewer manhole,
			sewer easement	open field, brush pile in distance at edge
				of field

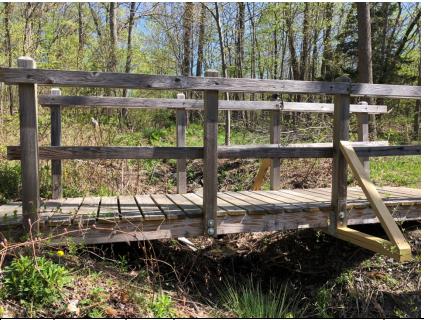
Photo	Cardinal	Wpt#	Location Description	Description of Photo Subject
#	Direction			
6	NE	4	Bridge over intermittent stream at	View into property of wooden bridge
			intersection with Charles River	15'x4' over intermittent stream

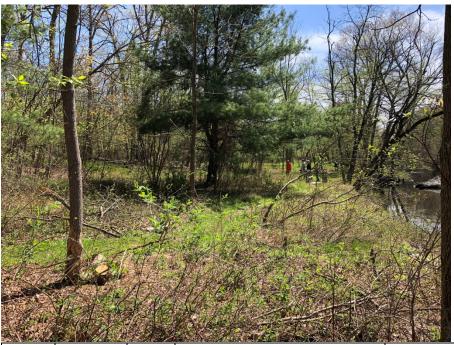
Photo	Cardinal Direction	Wpt#	Location Description	Description of Photo Subject
#	Direction			
8	E	5	Rebar pin at estimated southwest corner, wire fence on green metal posts	View into property along river bank; grassy trail follows property line turning northwest at corner

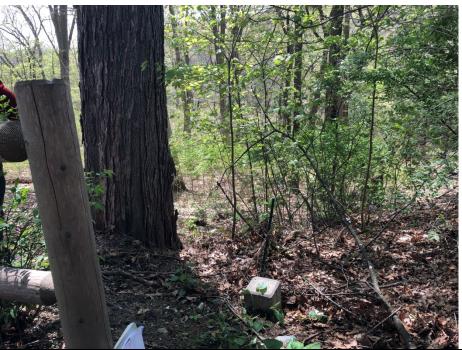
3 2			
Photo	Cardinal	Wpt#	Location Description	Description of Photo Subject
#	Direction			
9	S	6	Estimated northwest corner at	Property on left of concrete bound; rail
			concrete bound with drill hole	fence on abutter's property extends
				northeast; 26" DBH sugar maple

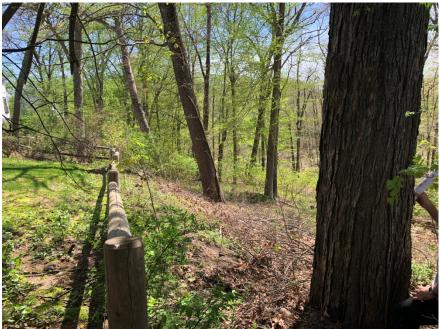
March 274	100		
Photo	Cardinal	Wpt #	Location Description	Description of Photo Subject
#	Direction			
10	E	6	Estimated northwest corner at	Property on left of wood rail fence;
			concrete bound with drill hole	barberry; 26" DBH sugar maple

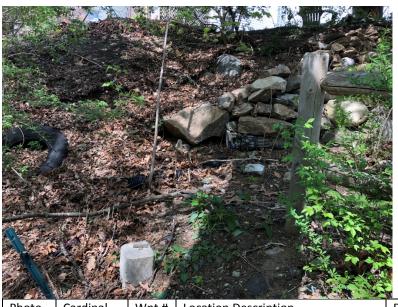
Photo	Cardinal	Wpt#	Location Description	Description of Photo Subject
#	Direction			
11	NW	6	Estimated northwest corner at concrete bound with drill hole	View out of property to stone retaining wall; concrete bound and wood rail fence; green metal post and wire fence; trash, old tire; black corrugated subdrain to retaining wall extending exposed

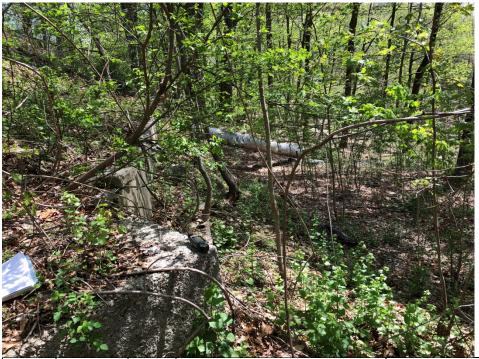
Photo	Cardinal	Wpt #	Location Description	Description of Photo Subject
#	Direction			
12	E	7	Approximate north property line at concrete retaining wall	Property on right of retaining wall; west end of concrete retaining wall; 24" CMP extending out of slope.

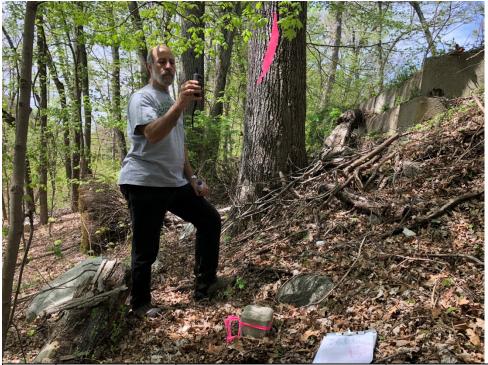
Photo	Cardinal	Wpt #	Location Description	Description of Photo Subject
#	Direction			
14	W	8	Concrete bound with drill hole on north property line	Property on left of concrete bound; Dave D'Amico taking GPS point; concrete retaining wall on right, top of slope

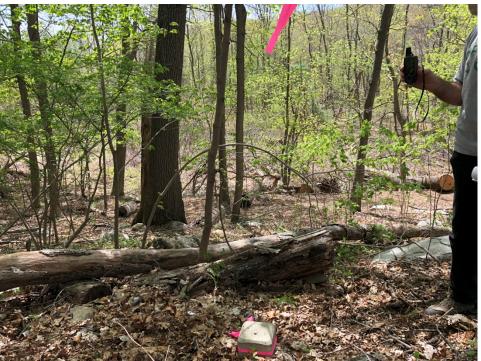
Photo	Cardinal	Wpt#	Location Description	Description of Photo Subject
#	Direction			
15	S	8	Concrete bound with drill hole on	View into property from concrete bound
			north property line	with drill hole; forested slope

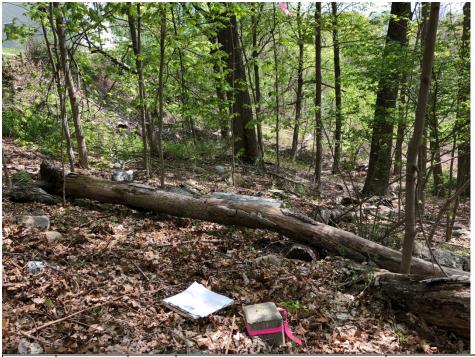
Photo	Cardinal	Wpt #	Location Description	Description of Photo Subject
#	Direction			
16	E	8	Concrete bound with drill hole on	Property on right of concrete bound;
			north property line	forested slope with large woody debris

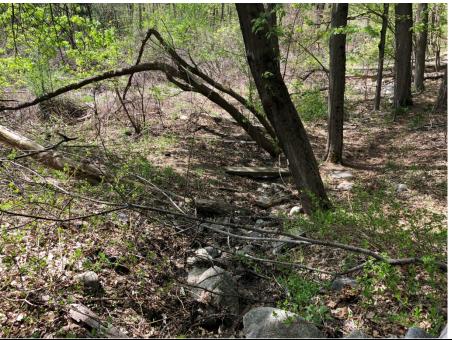
Several small wetlands were observed at the base of the slope along the northern boundary. Two stormwater outfall pipes were observed at waypoints 7 and 9 (photos 13, 18), with eroded channels down the slope at both locations.

The second secon		The second second		
Photo	Cardinal	Wpt #	Location Description	Description of Photo Subject
#	Direction			
19	S	9	Approximate north boundary line at	View into property of erosion channel
			erosion channel at outfall of 12"	down slope; trail at base f slope with
			HDPE	boards placed over channel

Consider hand-pulling garlic mustard throughout the forested portion of the	
site	
Stormwater Management	
Locate and map storm drains connected to outfall pipes along slope on north	2019
property boundary	
Evaluate erosion at storm drain outfalls and design and, engineer best	2019-2025
management practices to restore eroded areas, capture and treat runoff	
Incorporate any and all stormwater management efforts into the town's NPDES	2019+
Phase 2 program	
Ecological Management	
To maintain the meadow, continue to mow at least twice per year (mid-June	On-going
and after hard frost in Fall)	
Maintain woody debris along the banks of the Charles River as habitat	On-going
Nurture native woody saplings (maple, ash) to establish in areas cleared of	On-going
invasive species to encourage a multi-aged forest	
Consider planting native tree, shrub and herbaceous plants in areas cleared of	2019+
invasive species and not mowed (forest and forest edge)

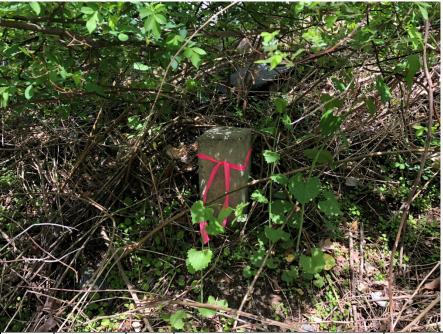
Photo	Cardinal	Wpt#	Location Description	Description of Photo Subject
#	Direction			
20	N	10	North property line at concrete	Concrete bound with drill hole under
			bound with drill hole near split rail	multiflora rose; garlic mustard
			fence on slope

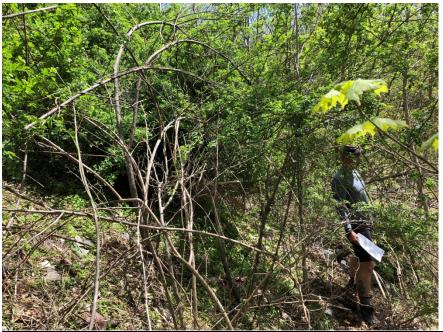
121		
Photo	Cardinal	Wpt #	Location Description	Description of Photo Subject
#	Direction			
21	E	10	North property line at concrete	Looking east along property line; thick
			bound with drill hole near split rail	multiflora rose on steep slope
			fence on slope

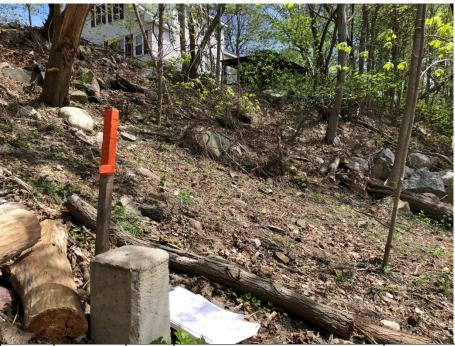
Photo	Cardinal	Wpt#	Location Description	Description of Photo Subject
#	Direction			
22	NE	11	North property line at concrete bound with drill hole and stake	Property on right of concrete bound and stake; open slope with large boulders and sapling trees

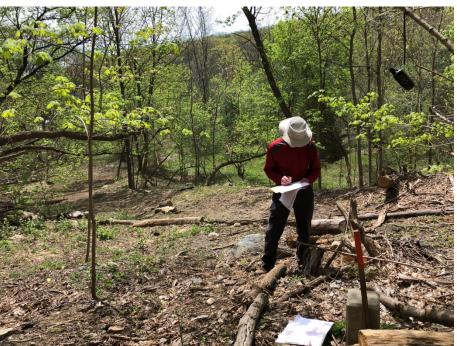
Photo #	Cardinal Direction	Wpt #	Location Description	Description of Photo Subject
23	SE	11	North property line at concrete bound with drill hole and stake	Property on left of concrete bound; open slope with young trees

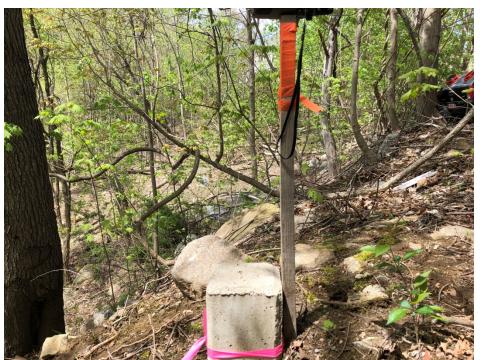
Photo	Cardinal	Wpt#	Location Description	Description of Photo Subject
#	Direction			
24	NW	12	North property line at concrete bound with drill hole and stake, at top of slope	Property on left of bound; steep slope with exposed boulders

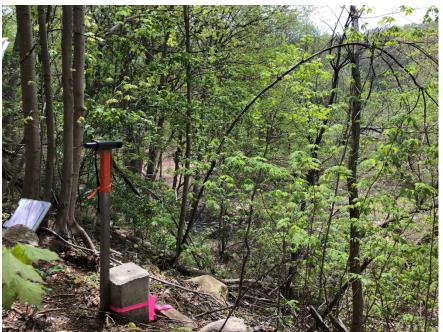
Į					
	Photo	Cardinal	Wpt #	Location Description	Description of Photo Subject
	#	Direction			
	25	SE	12	North property line at concrete	View into property along slope; concrete
				bound with drill hole and stake, at	bound with drill hole, stake
				top of slope

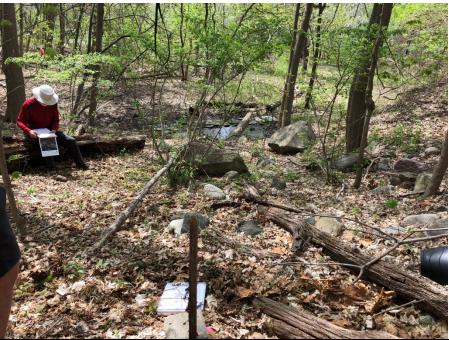
And the second		AND ASSESSED.		
Photo	Cardinal	Wpt#	Location Description	Description of Photo Subject
#	Direction			
27	SW	13	North property line at concrete	View into property from concrete bound;
			bound with drill hole	boulders, woody debris; trash; wetland
				at base of slope

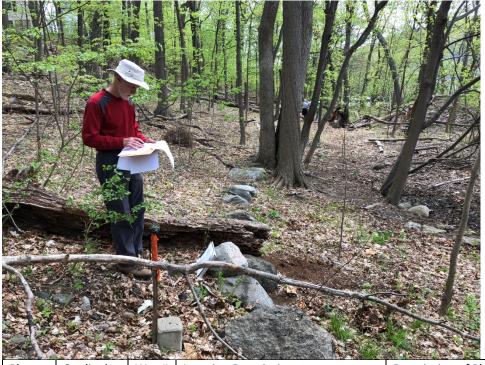
The state of the s	The second secon	A CONTRACTOR OF THE PARTY OF TH		
Photo	Cardinal	Wpt #	Location Description	Description of Photo Subject
#	Direction			
28	E	14	North property line at concrete	Property on right of bound; stone wall
			bound with drill hole	running east-west

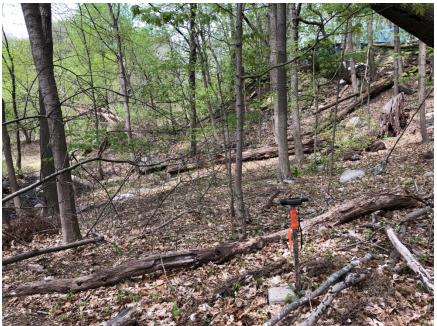
A STATE OF THE PARTY OF THE PAR	25. 图图的 图 图图图	100		
Photo	Cardinal	Wpt#	Location Description	Description of Photo Subject
#	Direction			
29	W	15	North property line at concrete	Property on left of bound; wetland at
			bound with drill hole and stake	bottom of slope

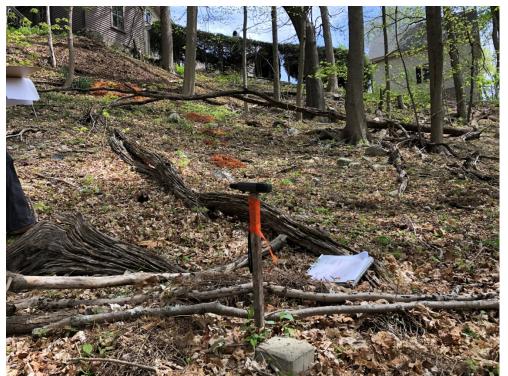
Photo	Cardinal	Wpt #	Location Description	Description of Photo Subject
#	Direction			
30	NE	15	North property line at concrete bound with drill hole and stake	Property on right of concrete bound; hedge row on abutter's property estimated boundary

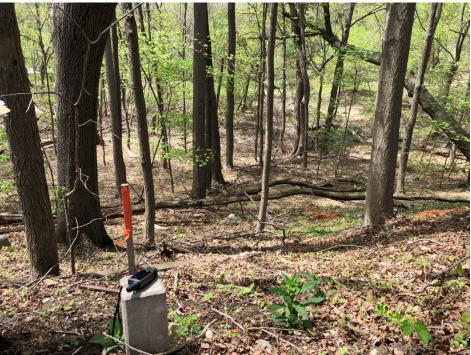
APT COME							
Photo	Cardinal	Wpt #	Location Description	Description of Photo Subject			
#	Direction						
31	SW	16	Northeast corner at concrete	View into property; forested slope			
			bound with drill hole and stake

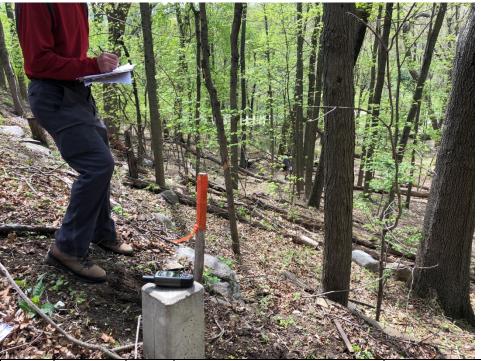
40 周发车记了				
Photo	Cardinal	Wpt#	Location Description	Description of Photo Subject
#	Direction			
32	SE	16	Northeast corner at concrete	Property on right of concrete bound;
			bound with drill hole and stake	view toward parking lot

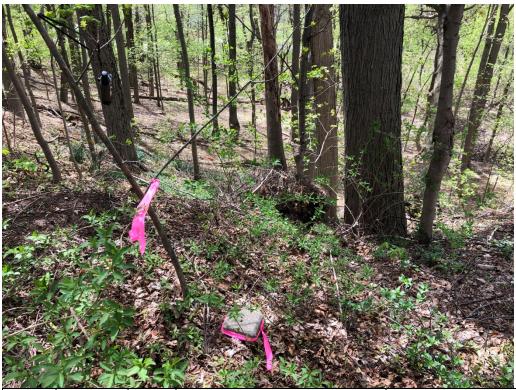
Photo	Cardinal	Wpt#	Location Description	Description of Photo Subject
#	Direction			
33	SW	17	Corner at concrete bound with drill,	View into property, down slope,
			between buildings	honeysuckle and barberry

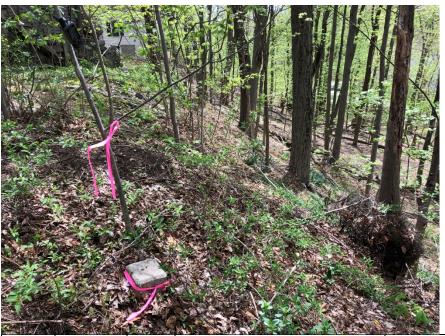
Photo	Cardinal	Wpt #	Location Description	Description of Photo Subject
#	Direction			
34	SE	17	Corner at concrete bound with drill,	Property on right of concrete bound,
			between buildings	down slope

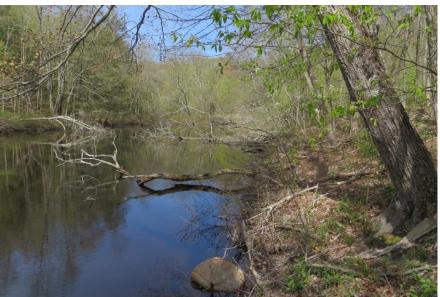
Photo	Cardinal	Wpt#	Location Description	Description of Photo Subject
#	Direction			
35	W	18	Near southeast corner	View from within property of north bank
				of Charles River

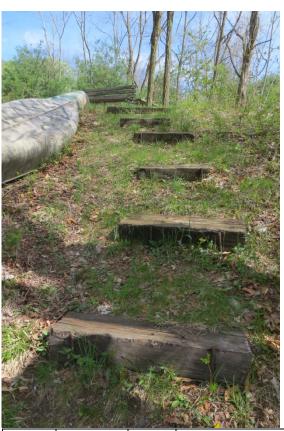
Photo	Cardinal	Wpt#	Location Description	Description of Photo Subject
#	Direction			
36	N	18	Near southeast corner	Steps down to Charles River; canoe
				stored on bank

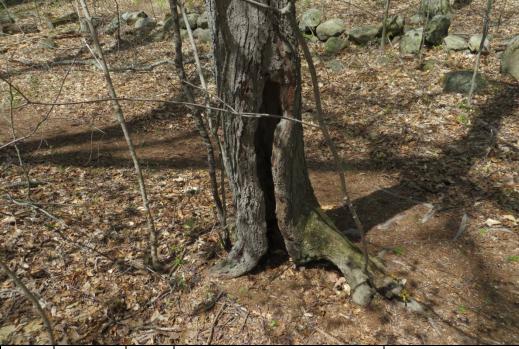
ALL DECEMBER OF THE PARTY OF TH		TA POYA		
Photo	Cardinal	Wpt#	Location Description	Description of Photo Subject
#	Direction			
39	N	19	Interior of property near west	Gypsy moth egg mass on beech tree
			property line

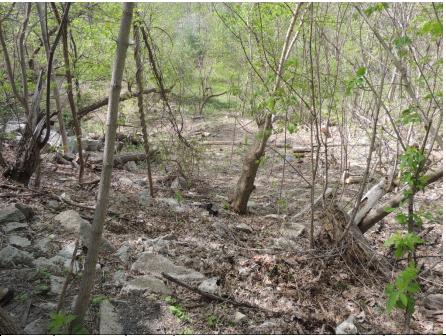
THE WAY TO SHARE THE			Colored Property Colored Color	
Photo	Cardinal	Wpt #	Location Description	Description of Photo Subject
#	Direction			
49	SE	27	Private driveway off Village Street	Private driveway crossing town-owned
				land (adjacent to Amphitheatre)

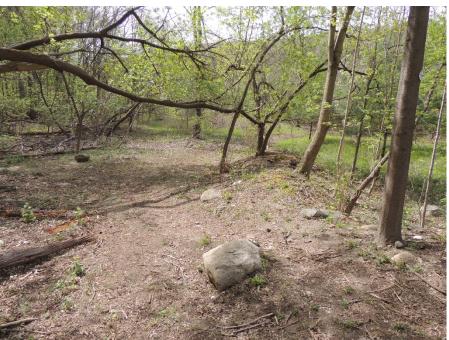
Photo #	Cardinal Direction	Wpt #	Location Description	Description of Photo Subject
50	SW	28	Edge of driveway	On town-owned property adjacent to Amphitheatre, looking down slope at exposed boulders
