**Medway Planning & Economic Development Board  
Meeting**

**Construction Reports**

## **CONSTRUCTION INSPECTION REPORT**

## Construction Observation Report

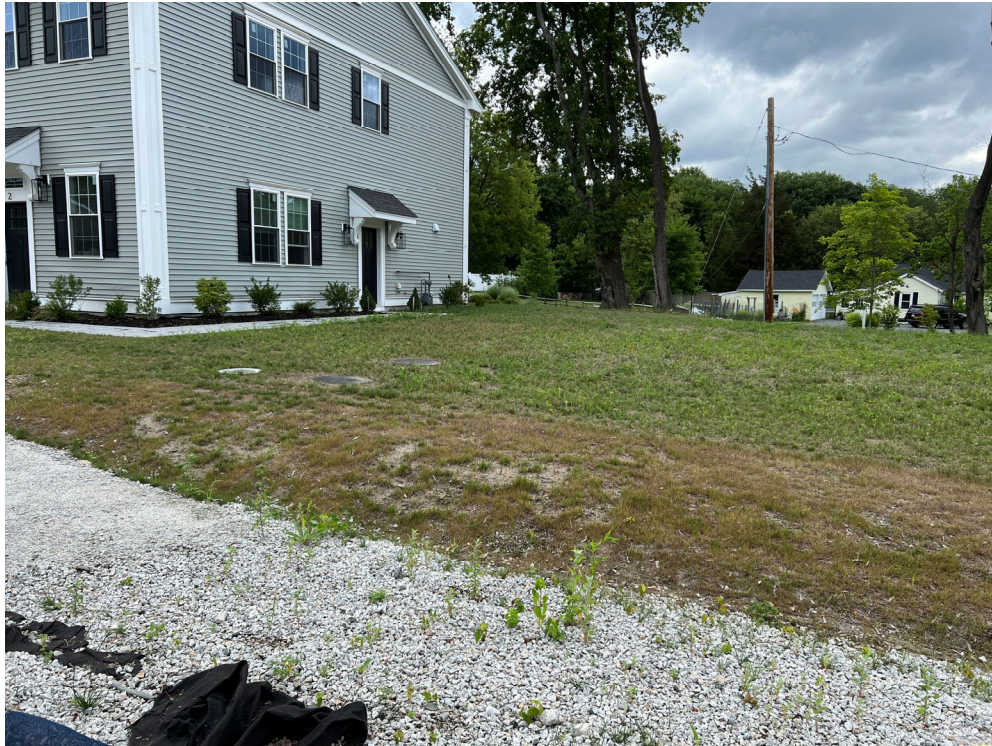
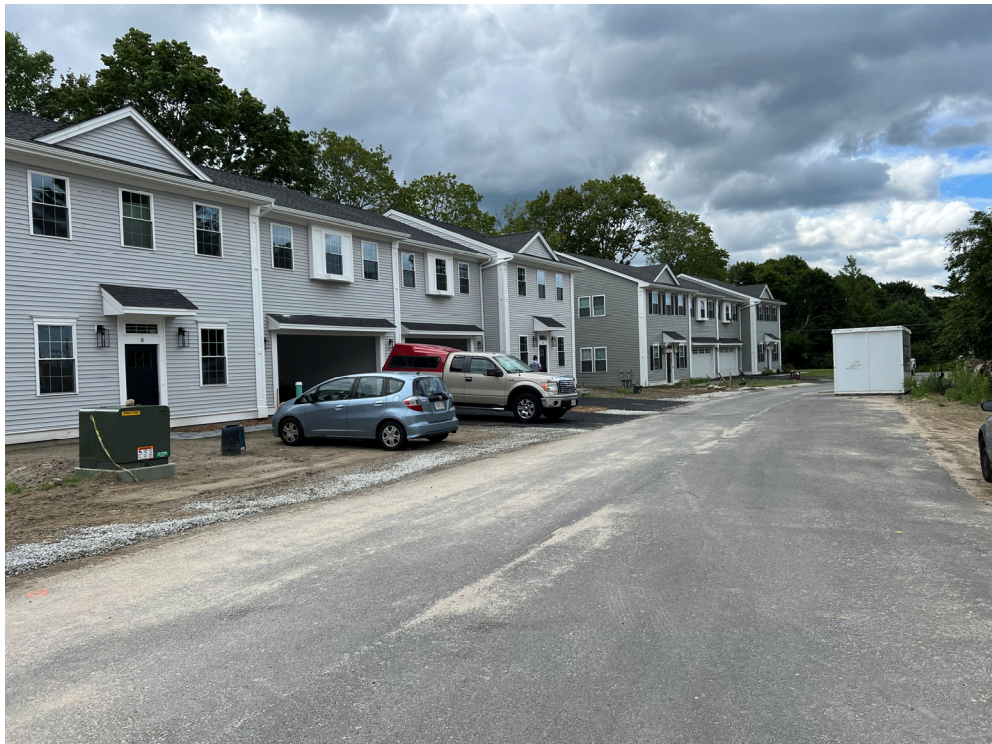
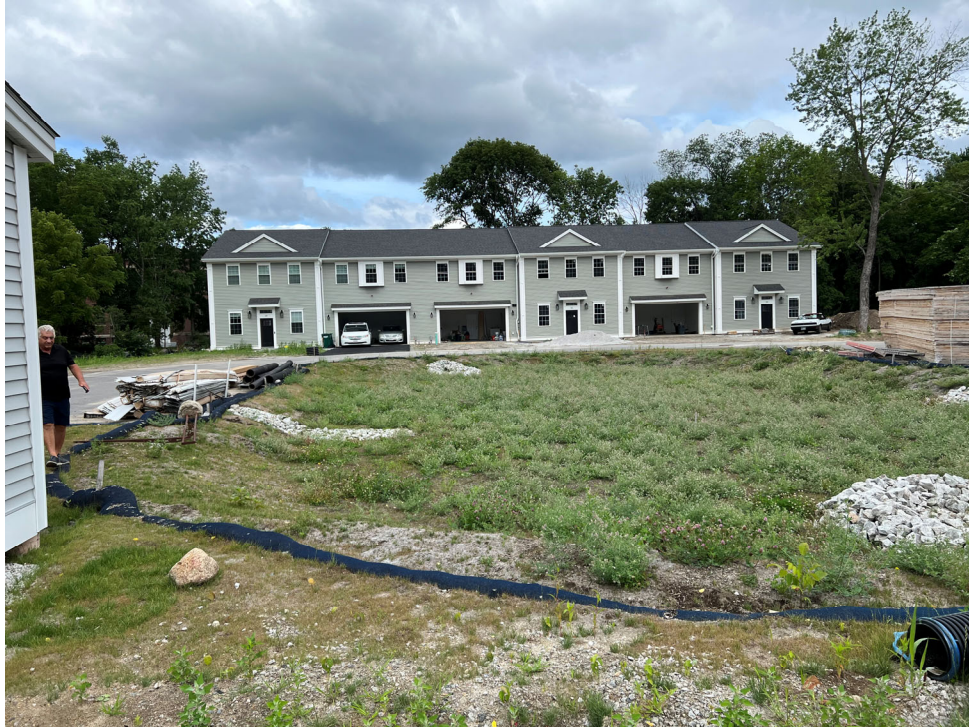
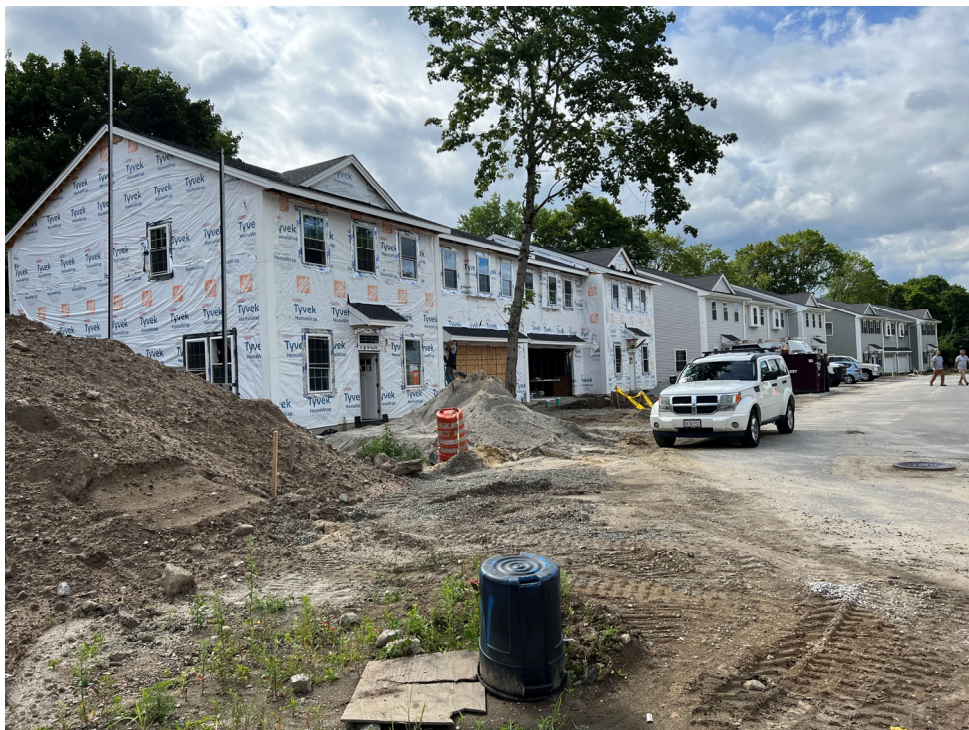
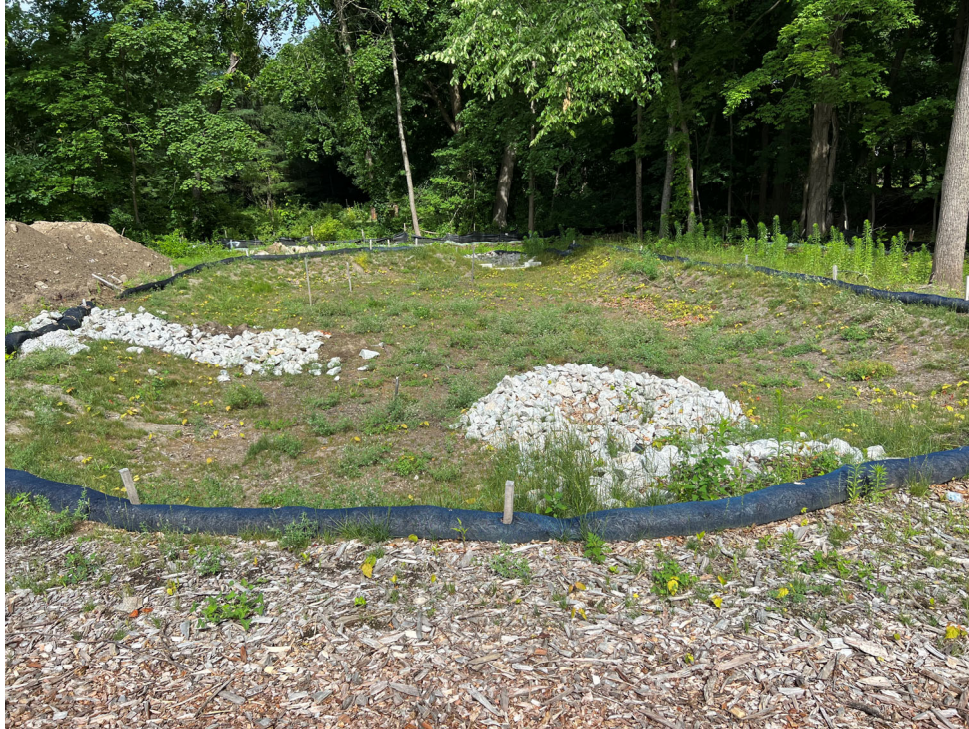
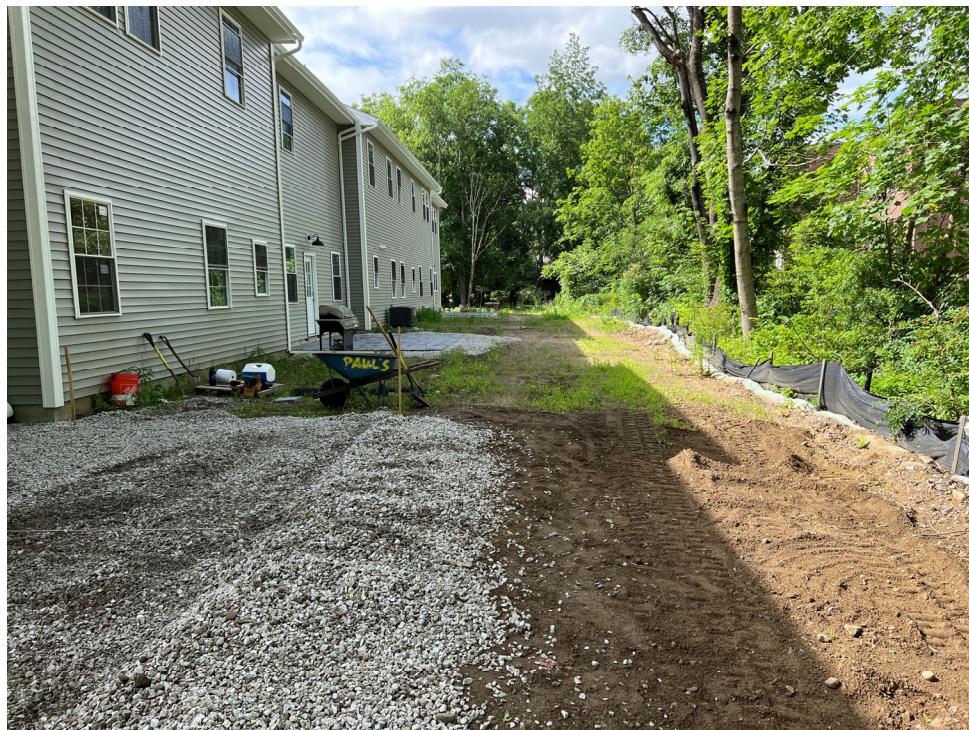
- Unit 2/4 is substantially complete and occupied.
- Unit 18 (old house) is substantially complete and occupied.
- Aside from garage doors, unit 6/8 is weather tight and interior construction continues.
- Aside from garage doors, unit 20/22/24 is weather tight and interior construction continues.
- Unit 10/12 is framed, roofed with doors and windows, and is awaiting siding installation.
- Unit 14/16 building foundations is partially excavated.
- The mail kiosk is substantially complete.

- Perimeter erosion controls were inspected and found to be in adequate condition.
- While the construction of the foundation for unit 14/16 has commenced, given the stage of construction, we do not believe that temporary sediment basins are needed. Many areas of the site are stabilized with impervious surfaces and vegetation. The remaining disturbed areas are small and decentralized. Perimeter erosion controls should be adequate for the small remaining areas.

1. None.
