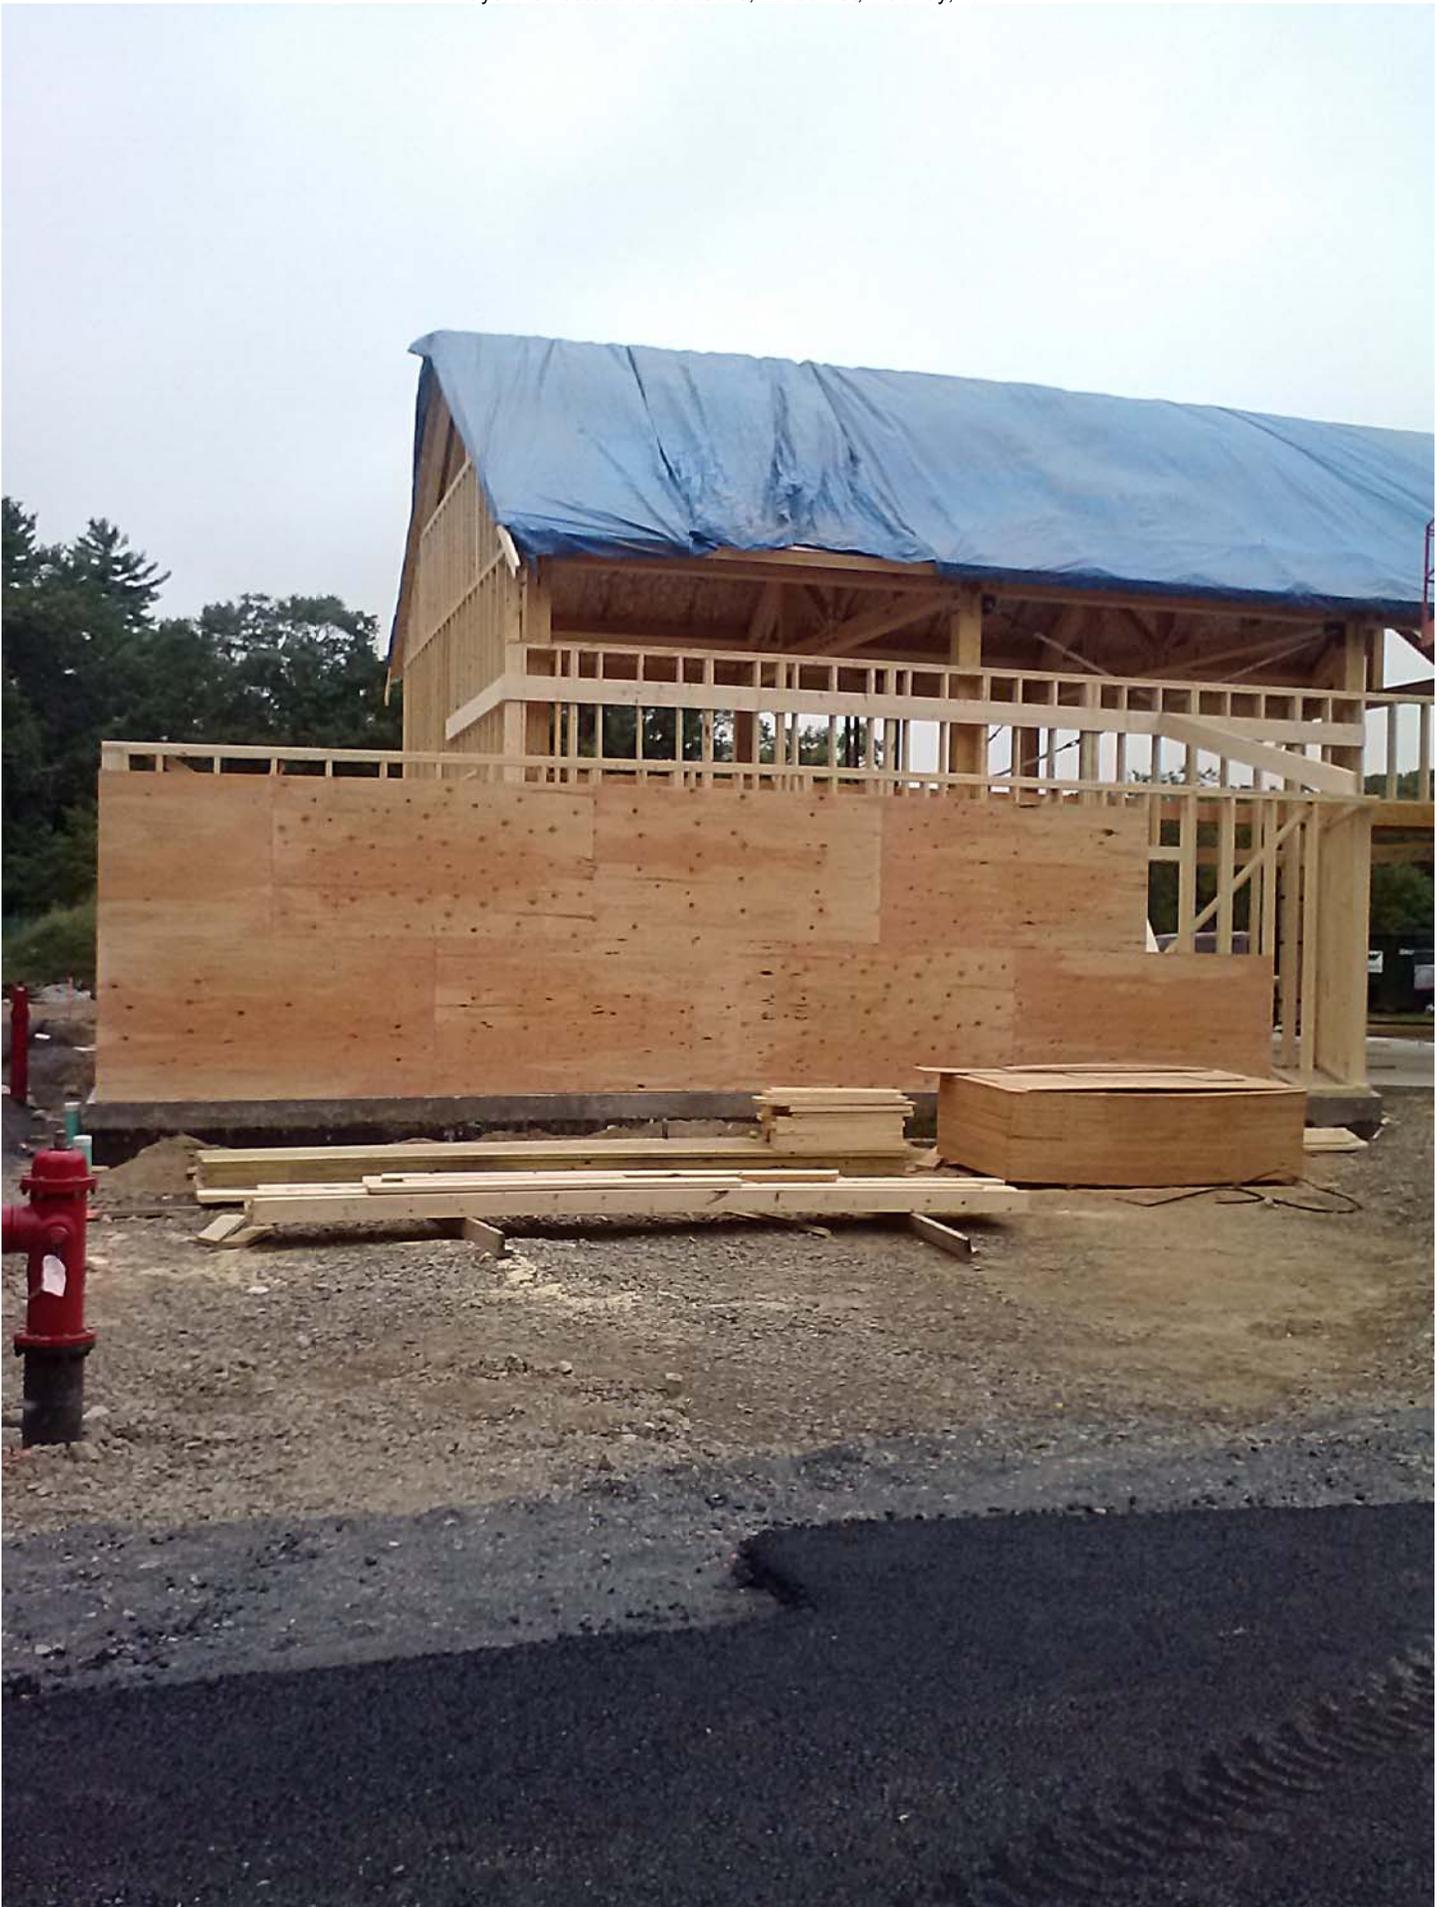
Addition framing in progress from exterior

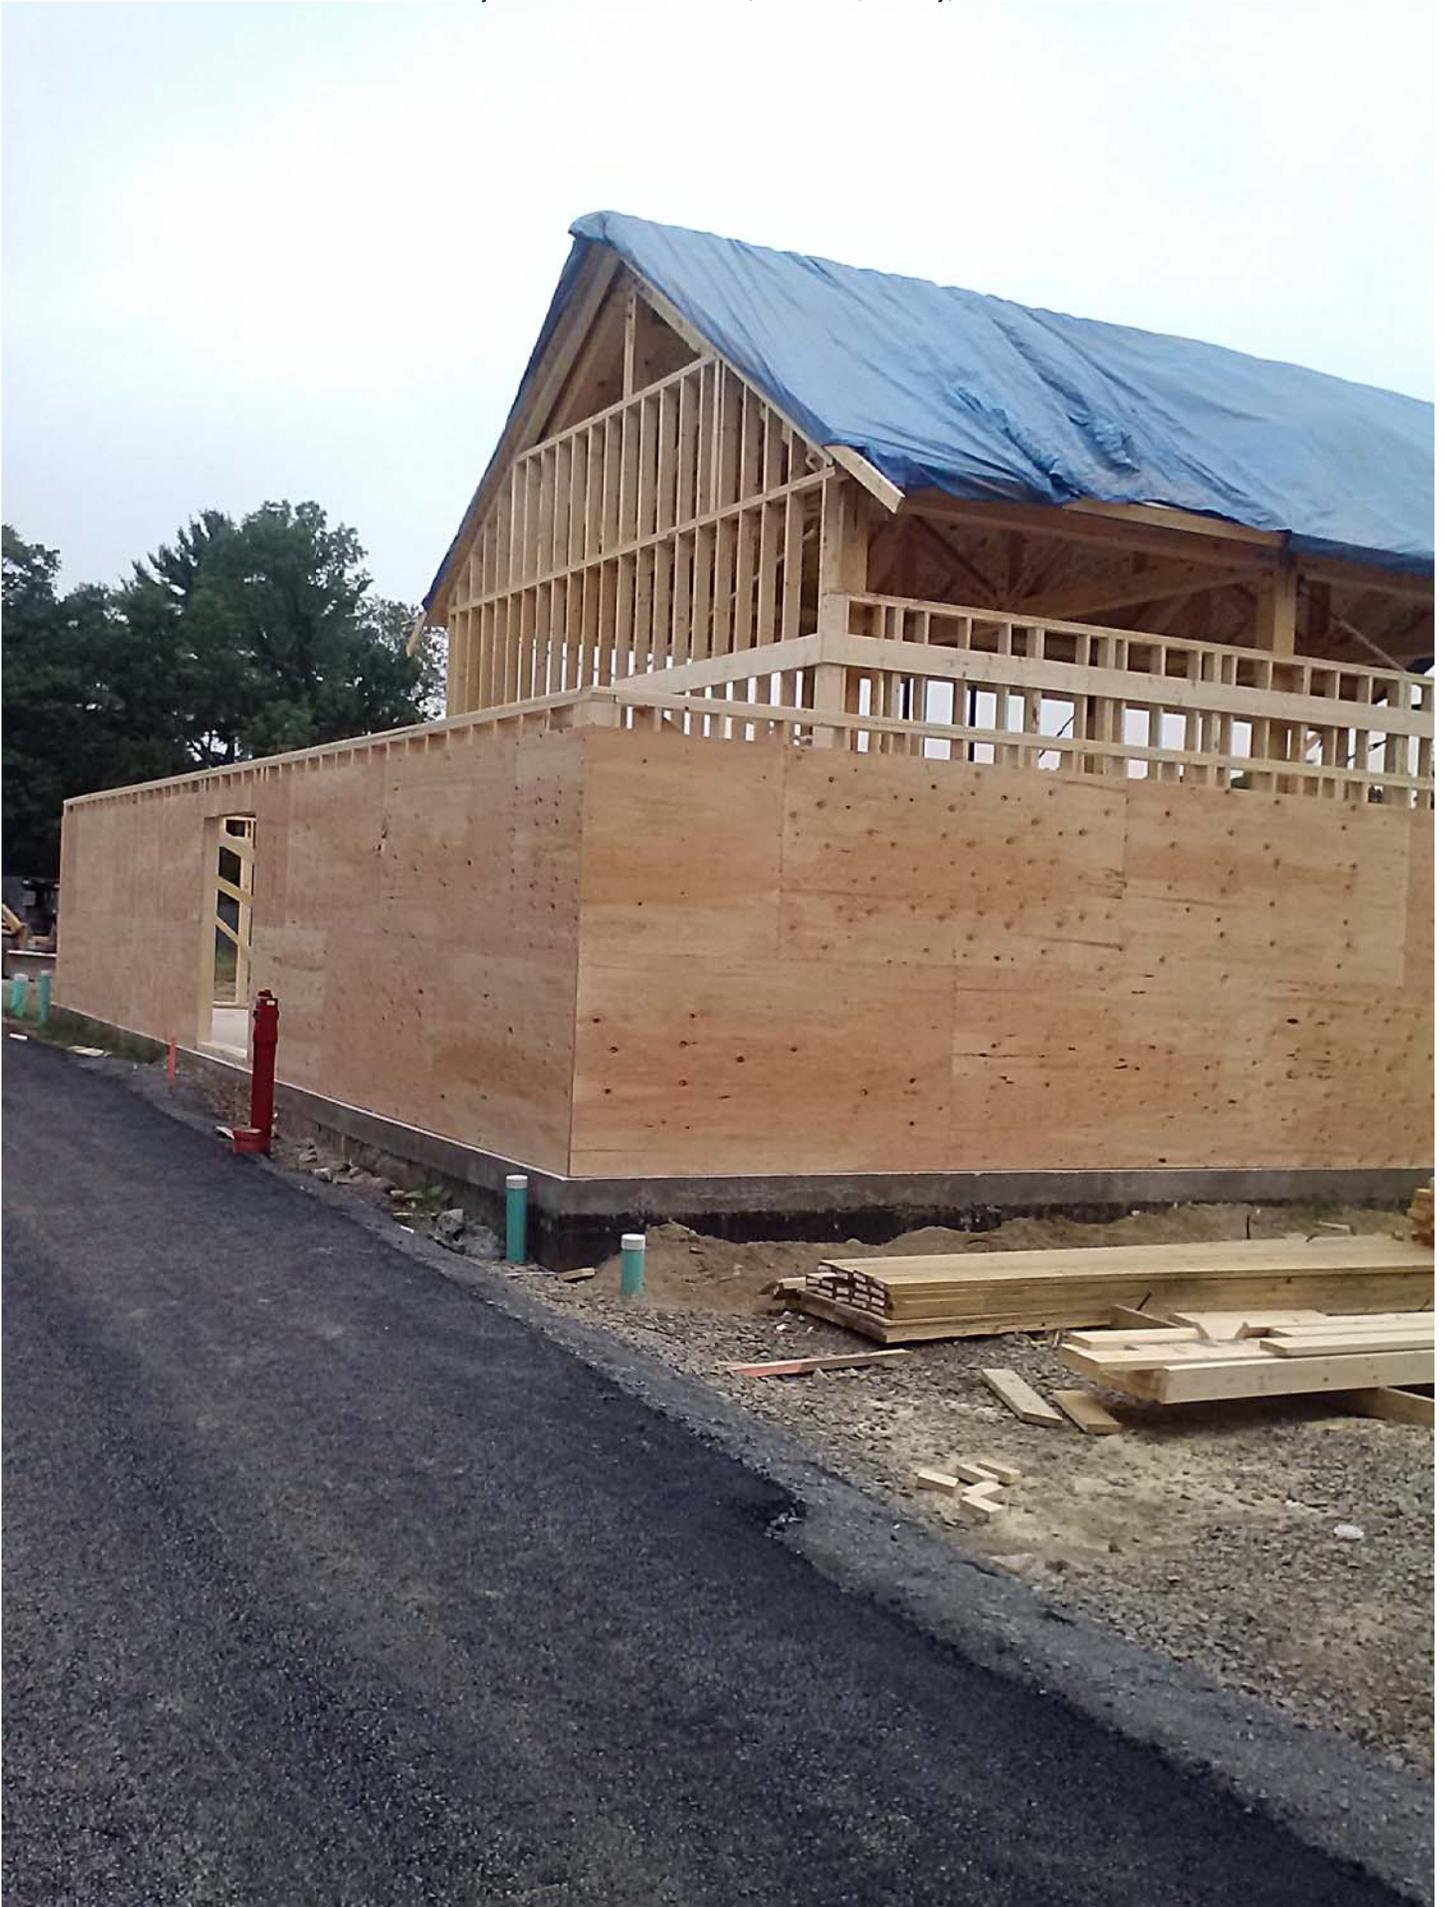
Addition framing in progress from ext.

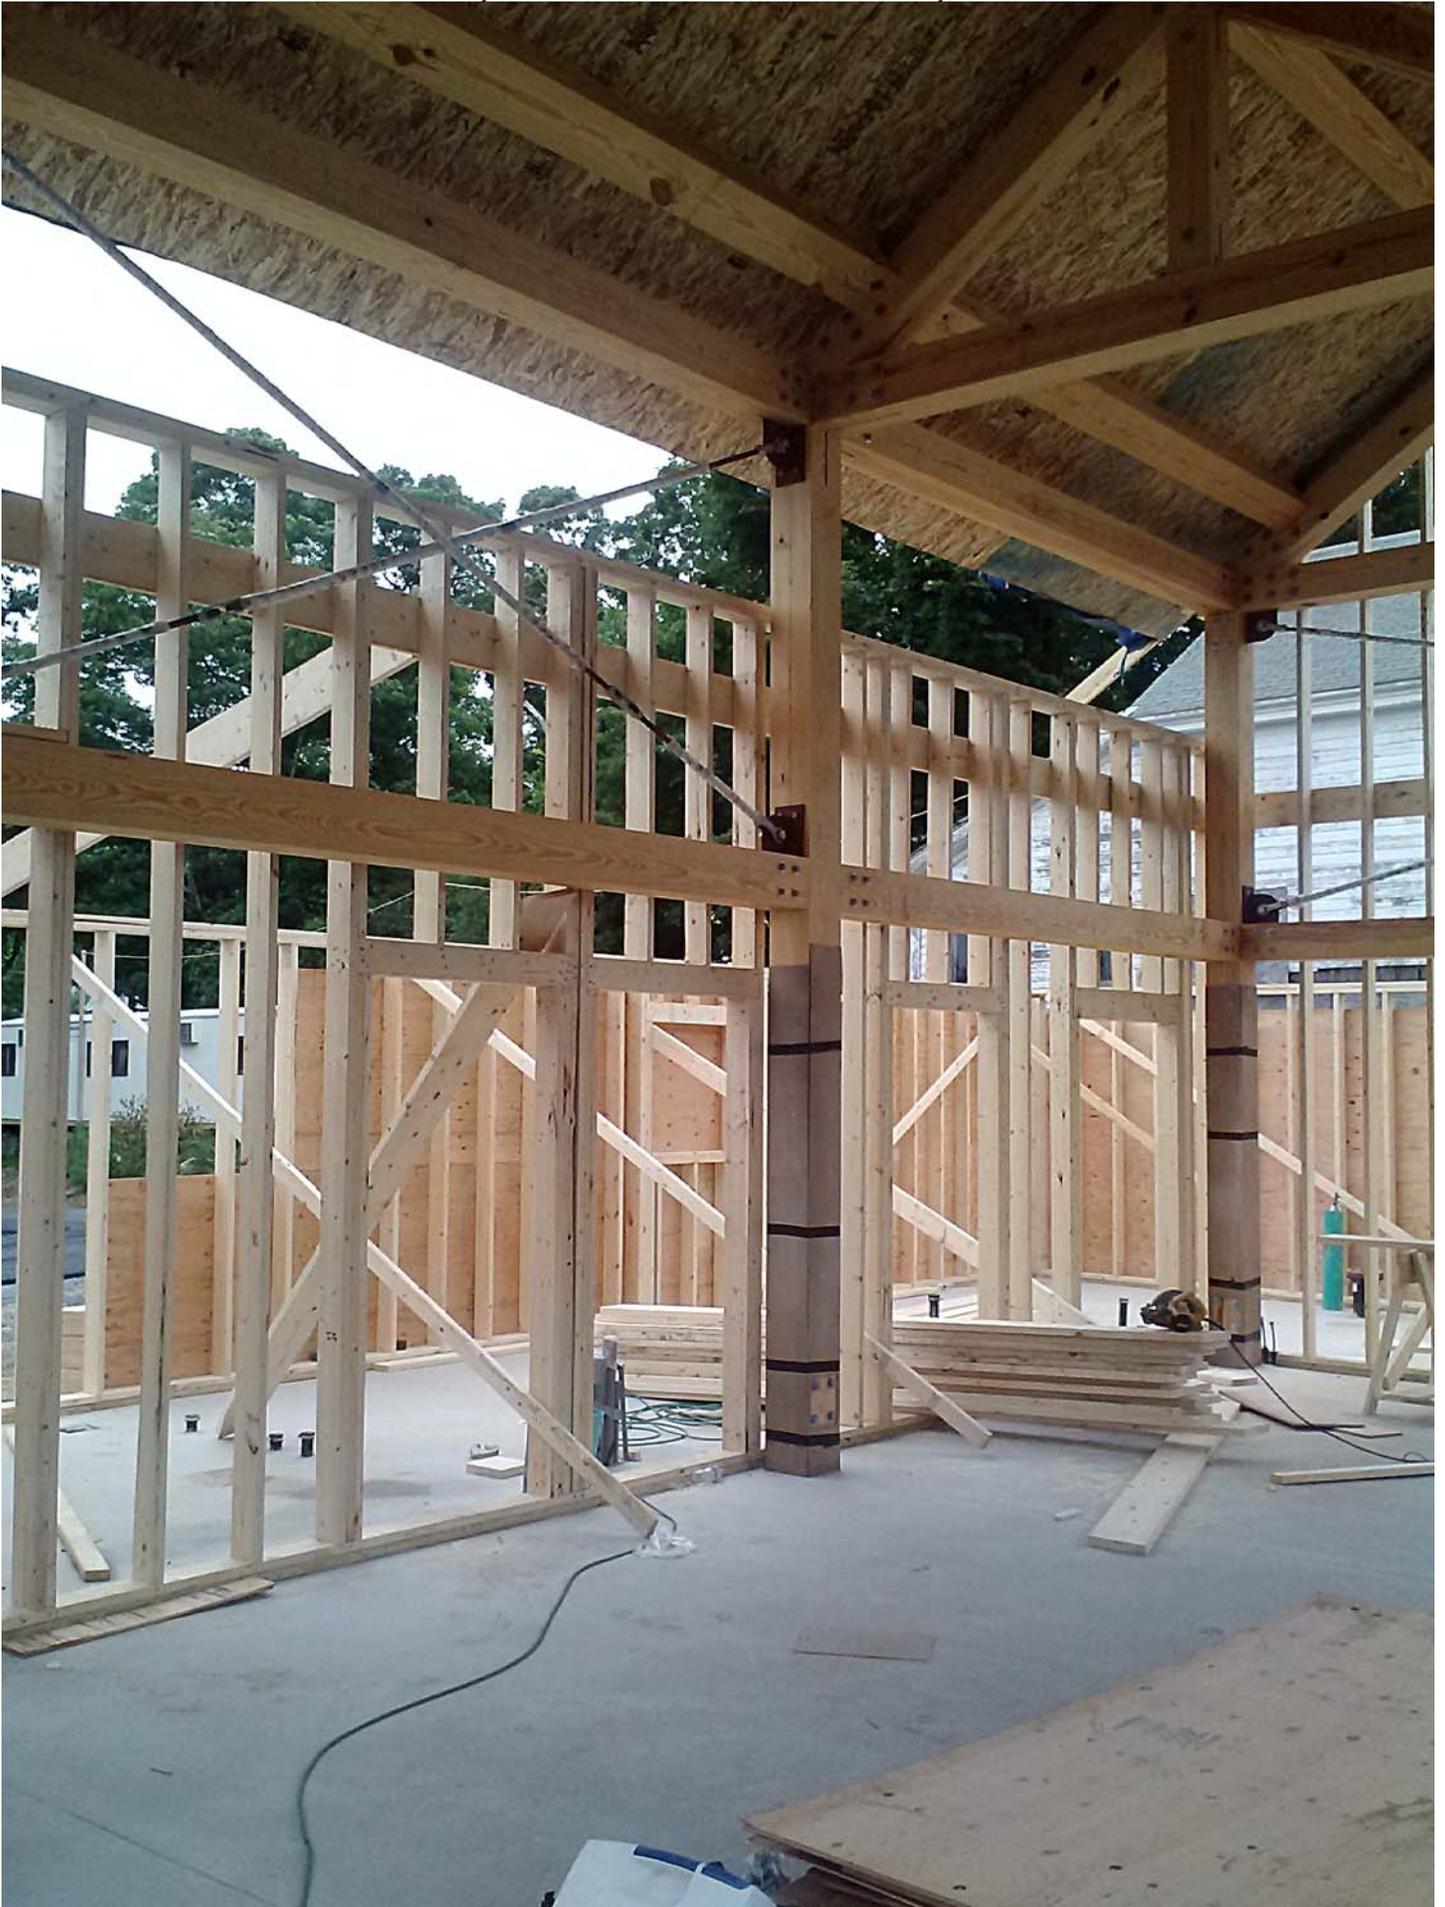
Addition framing in progress

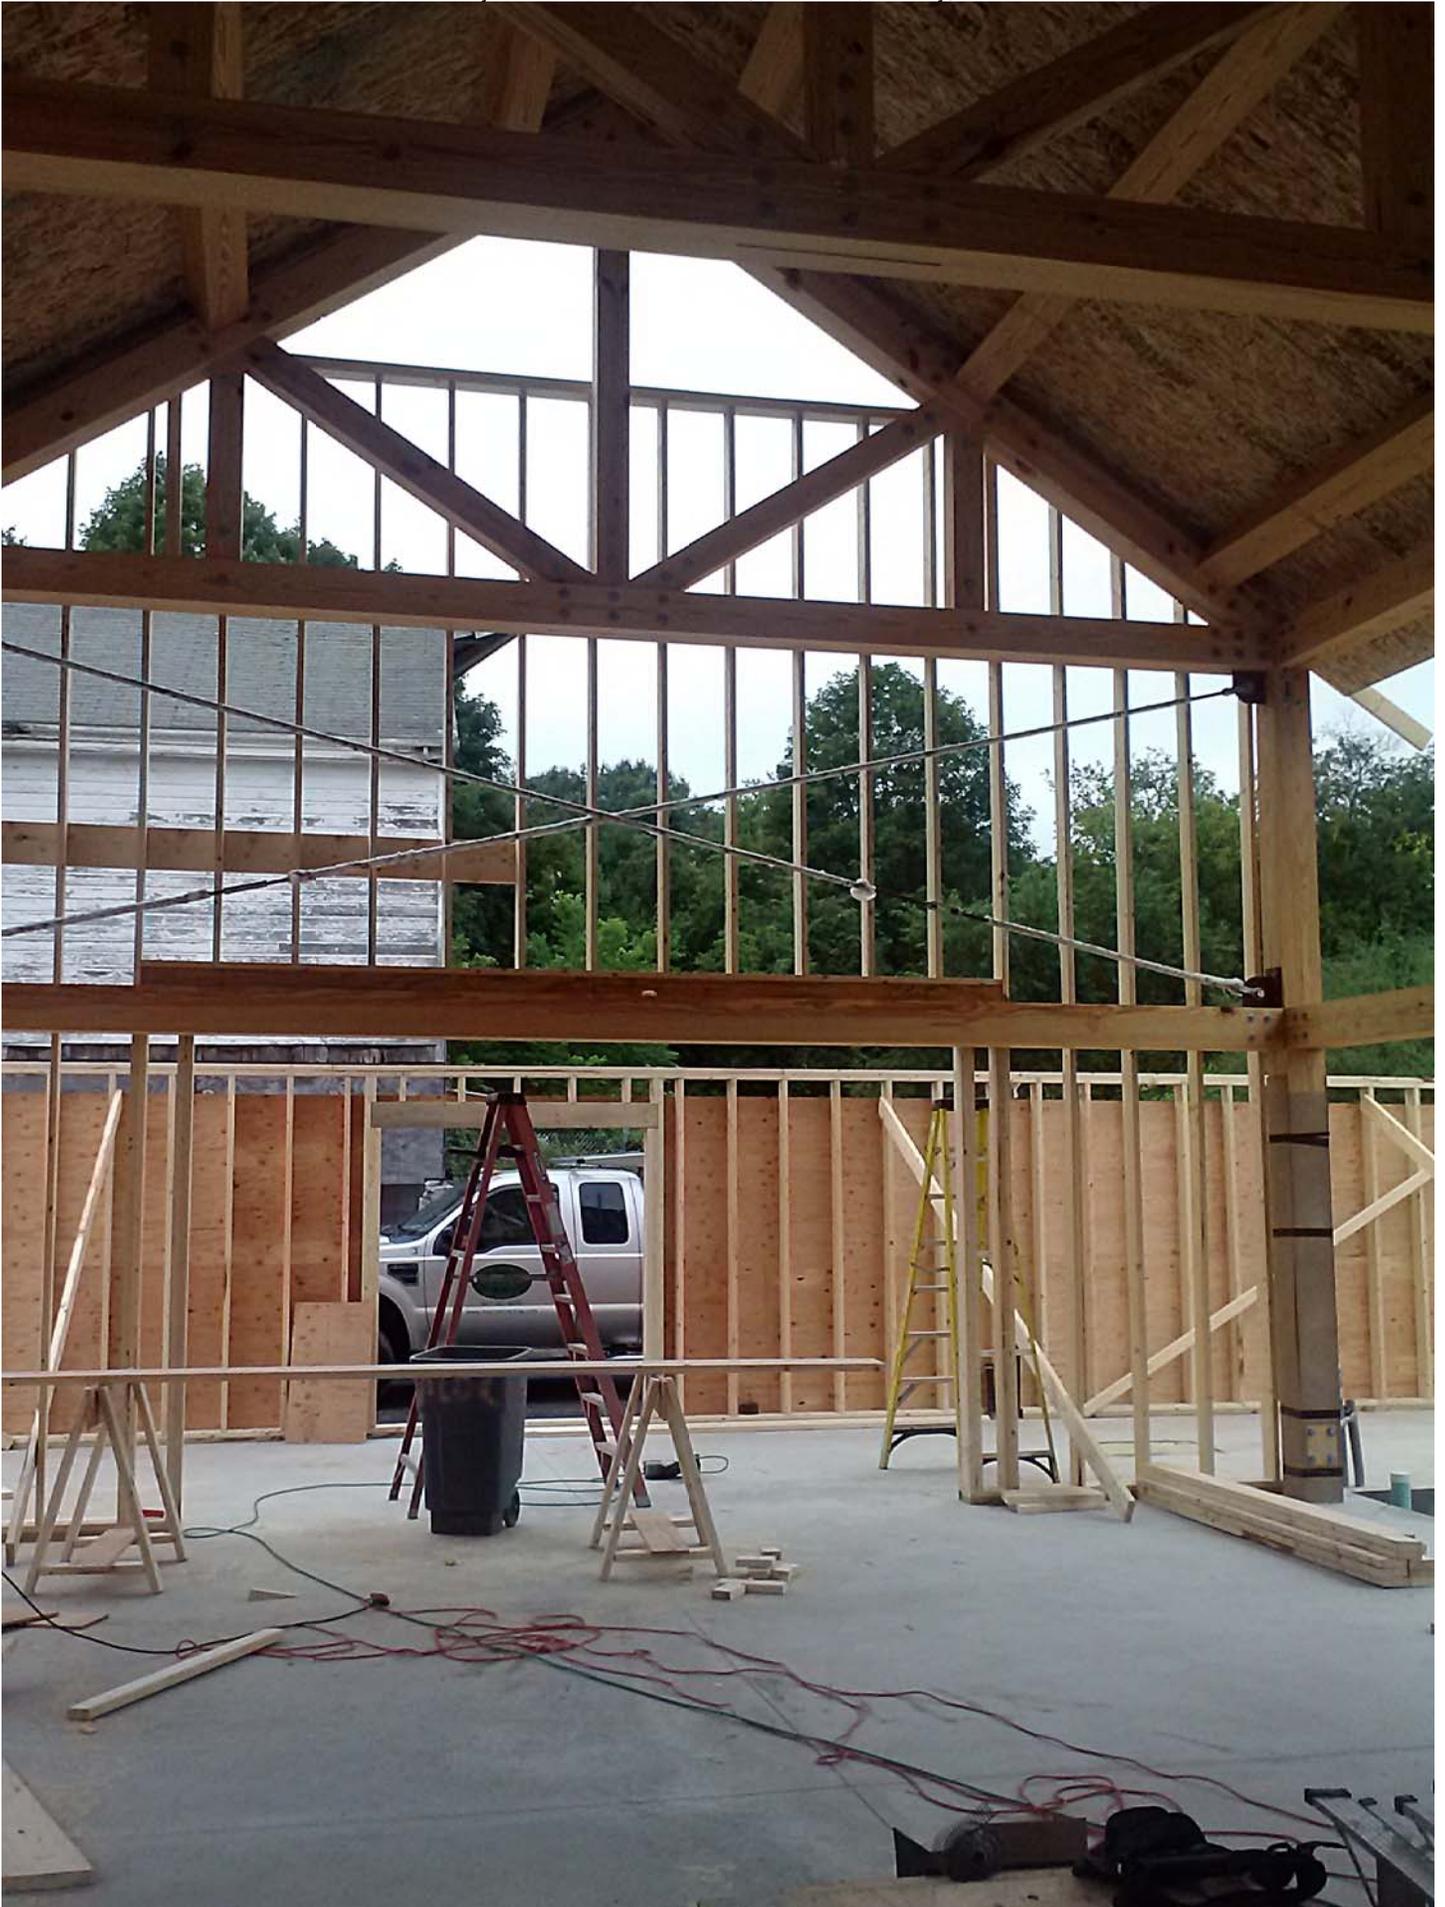
Addition framing in progress

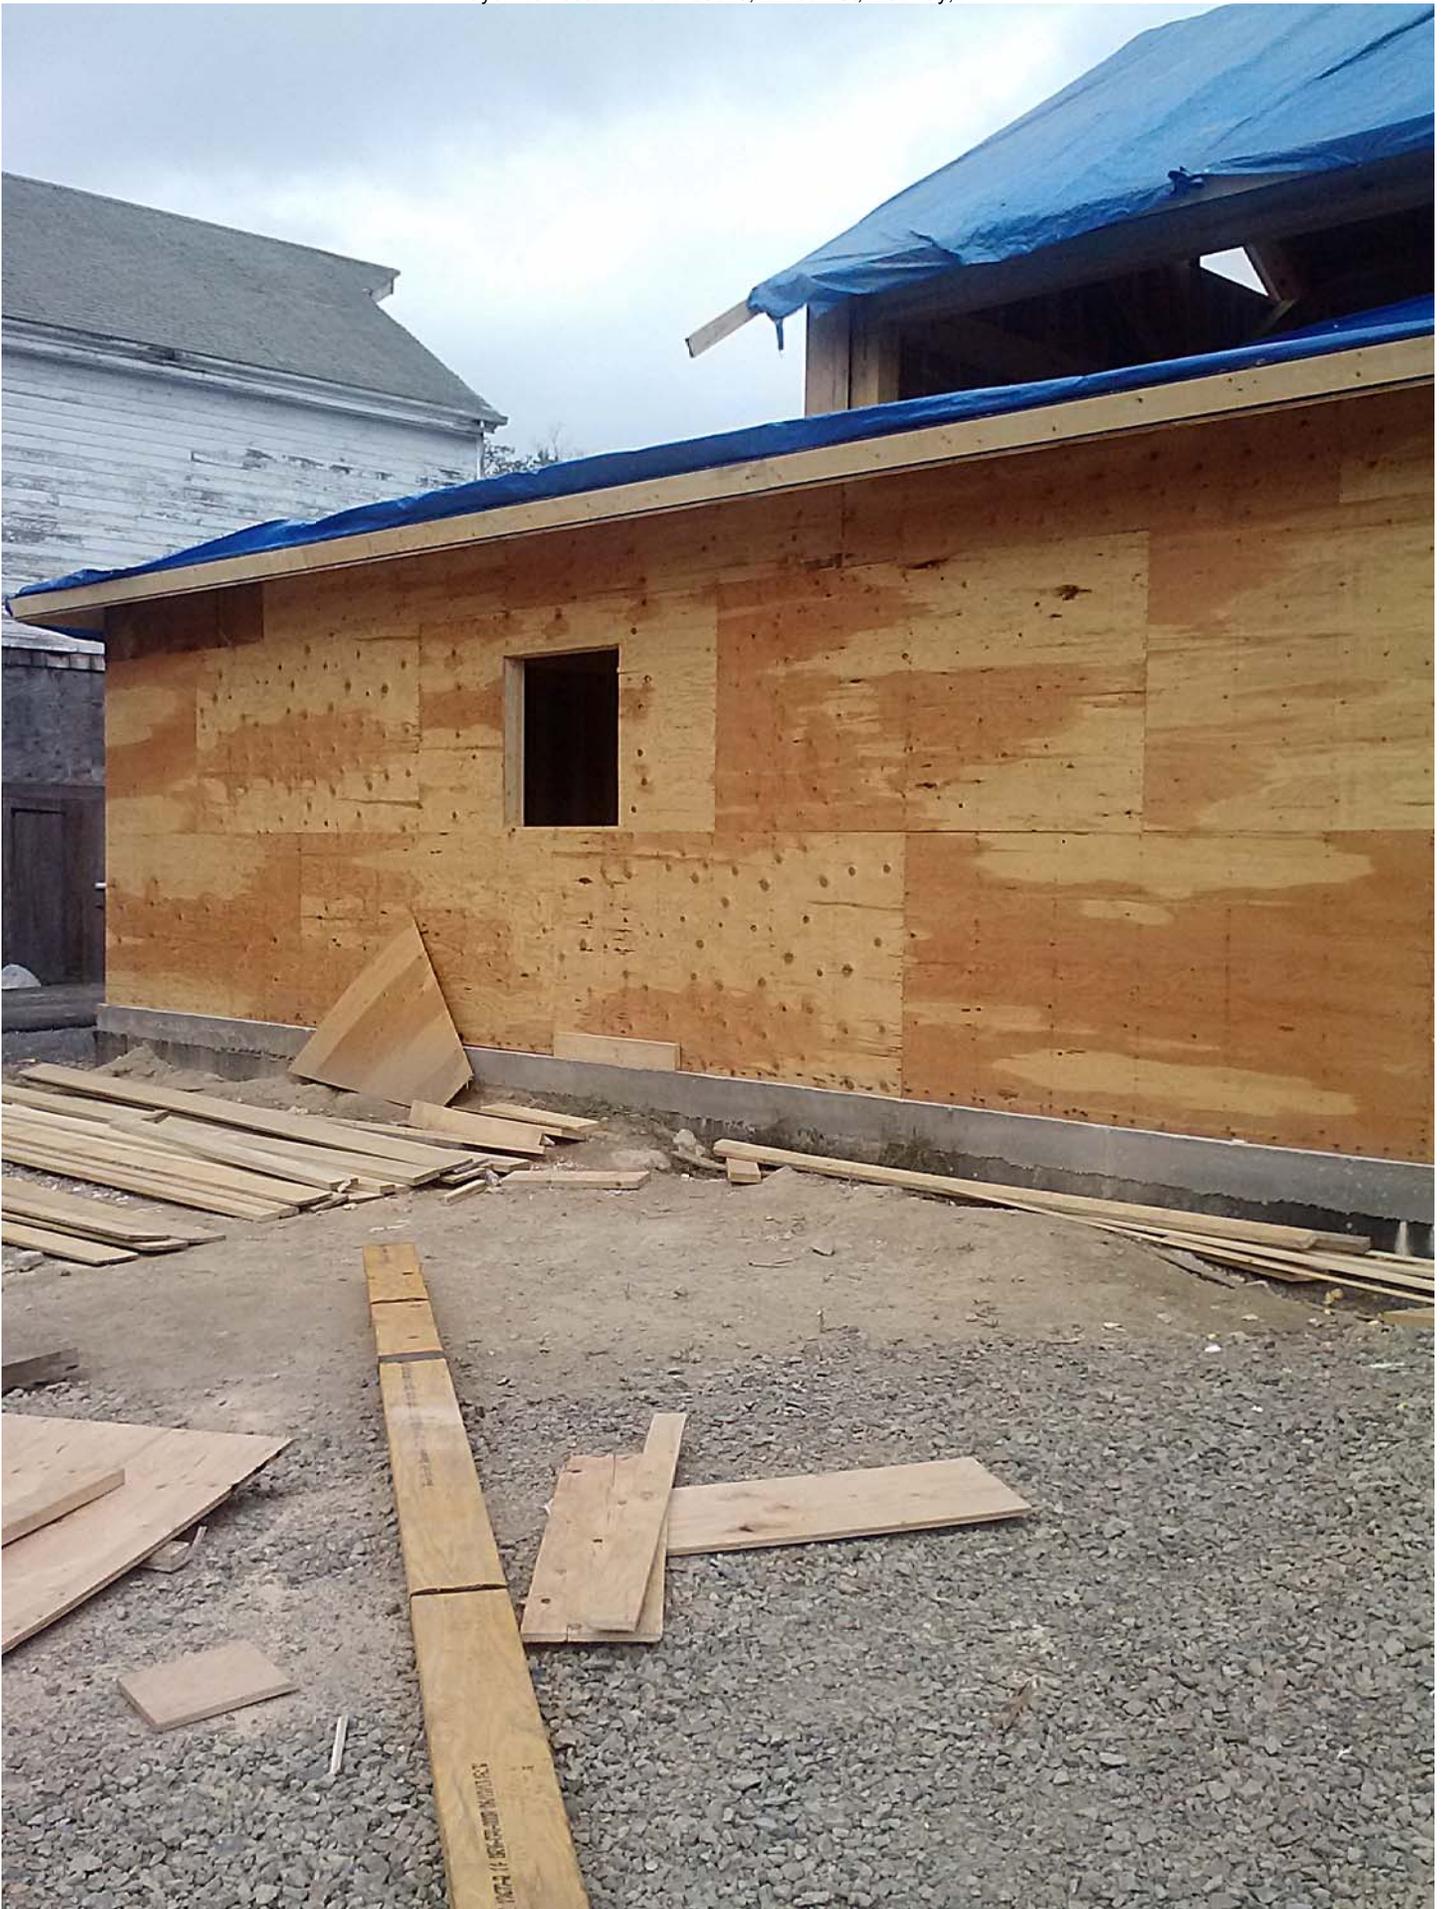
Addition from exterior

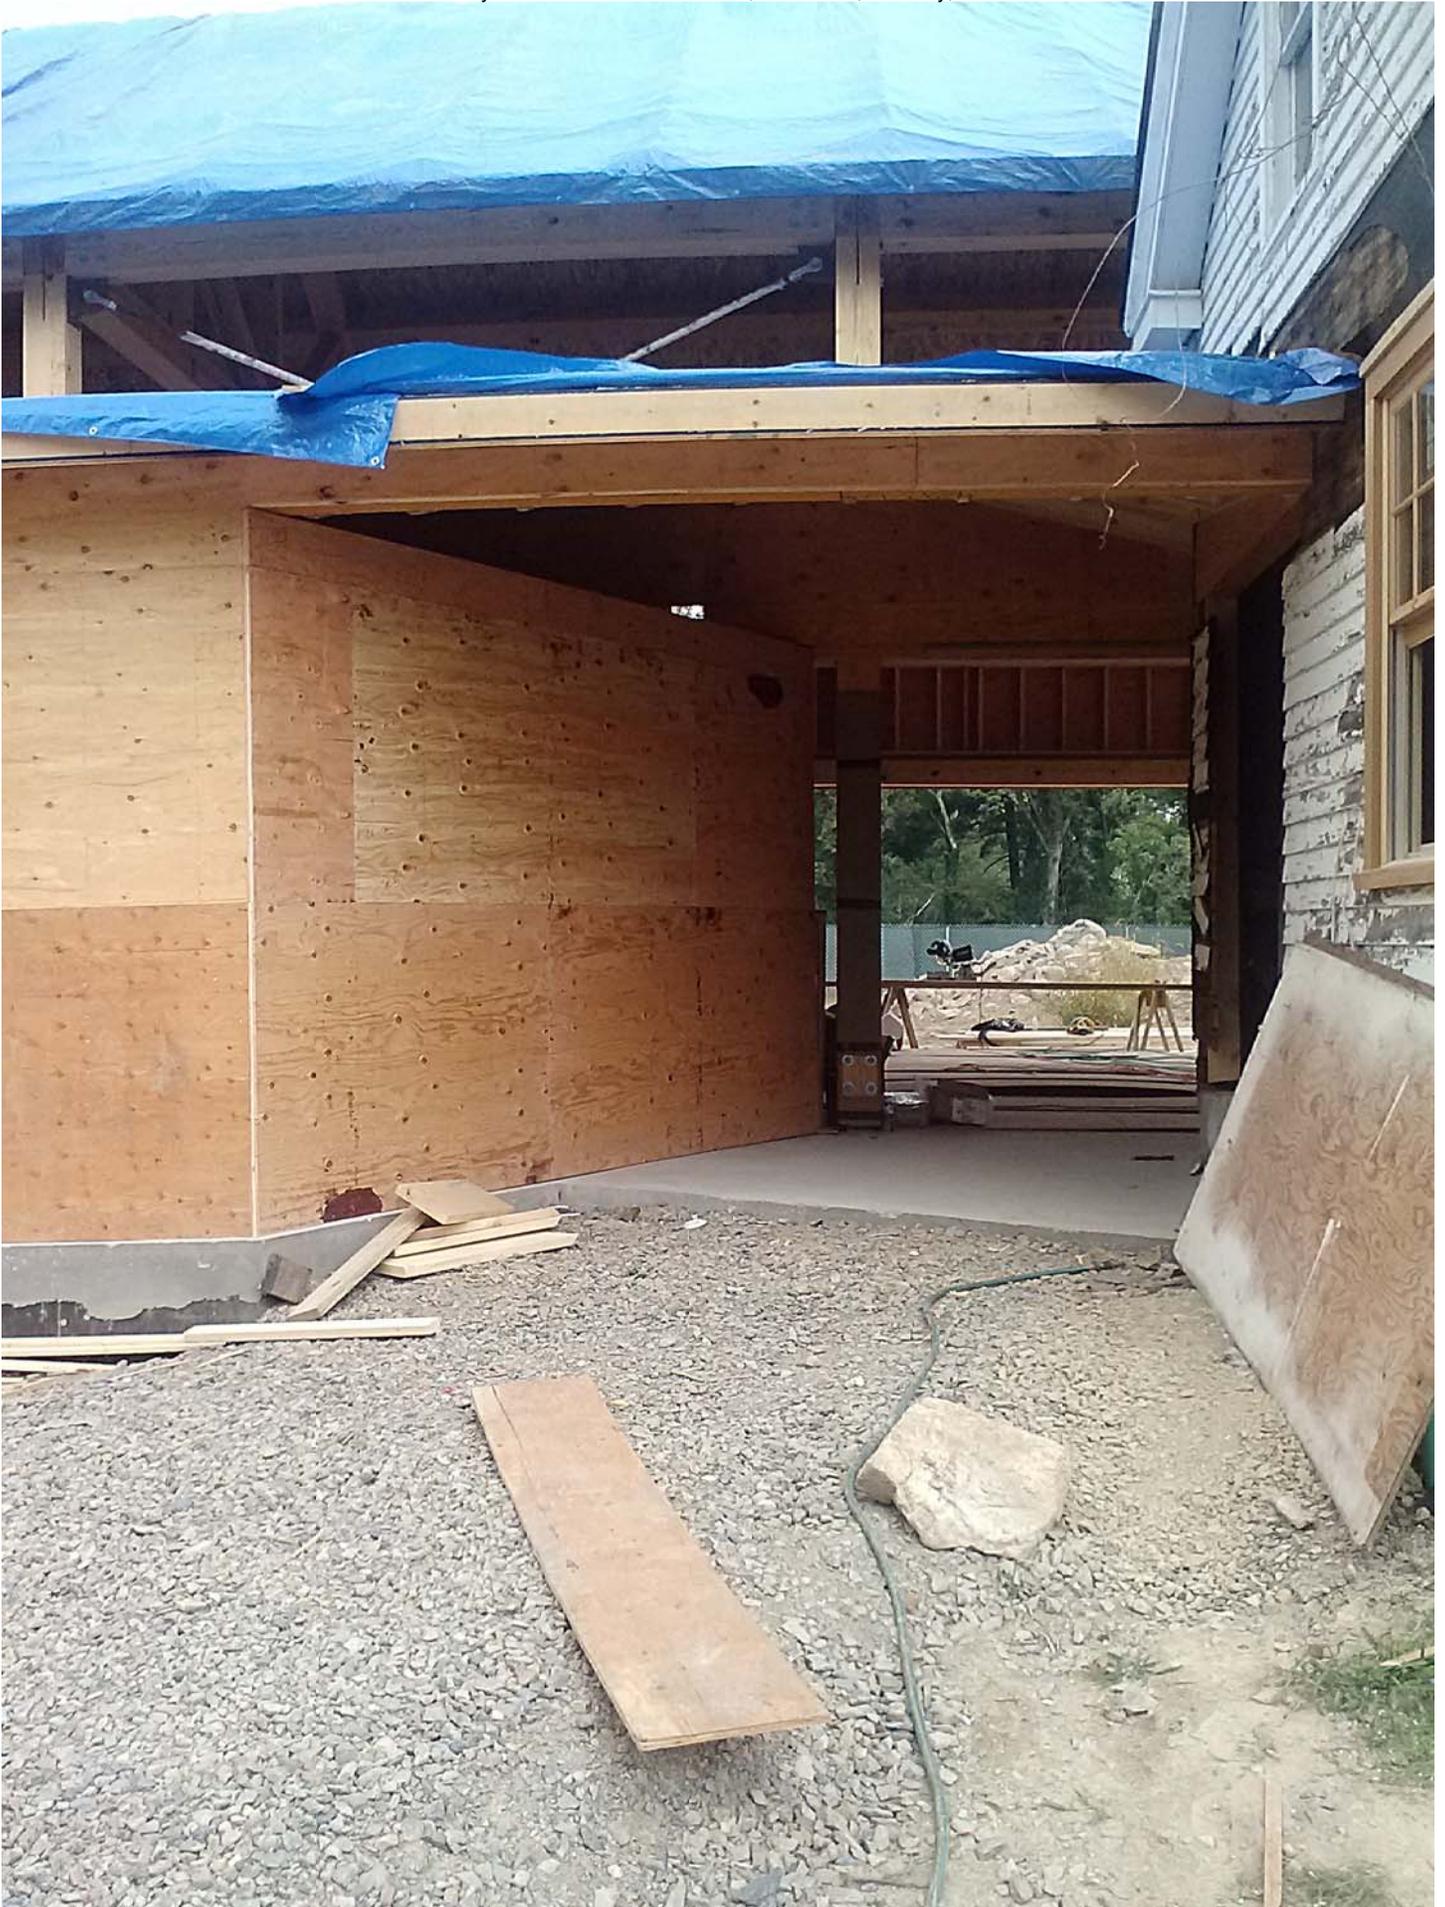
Lobby between existing and addition

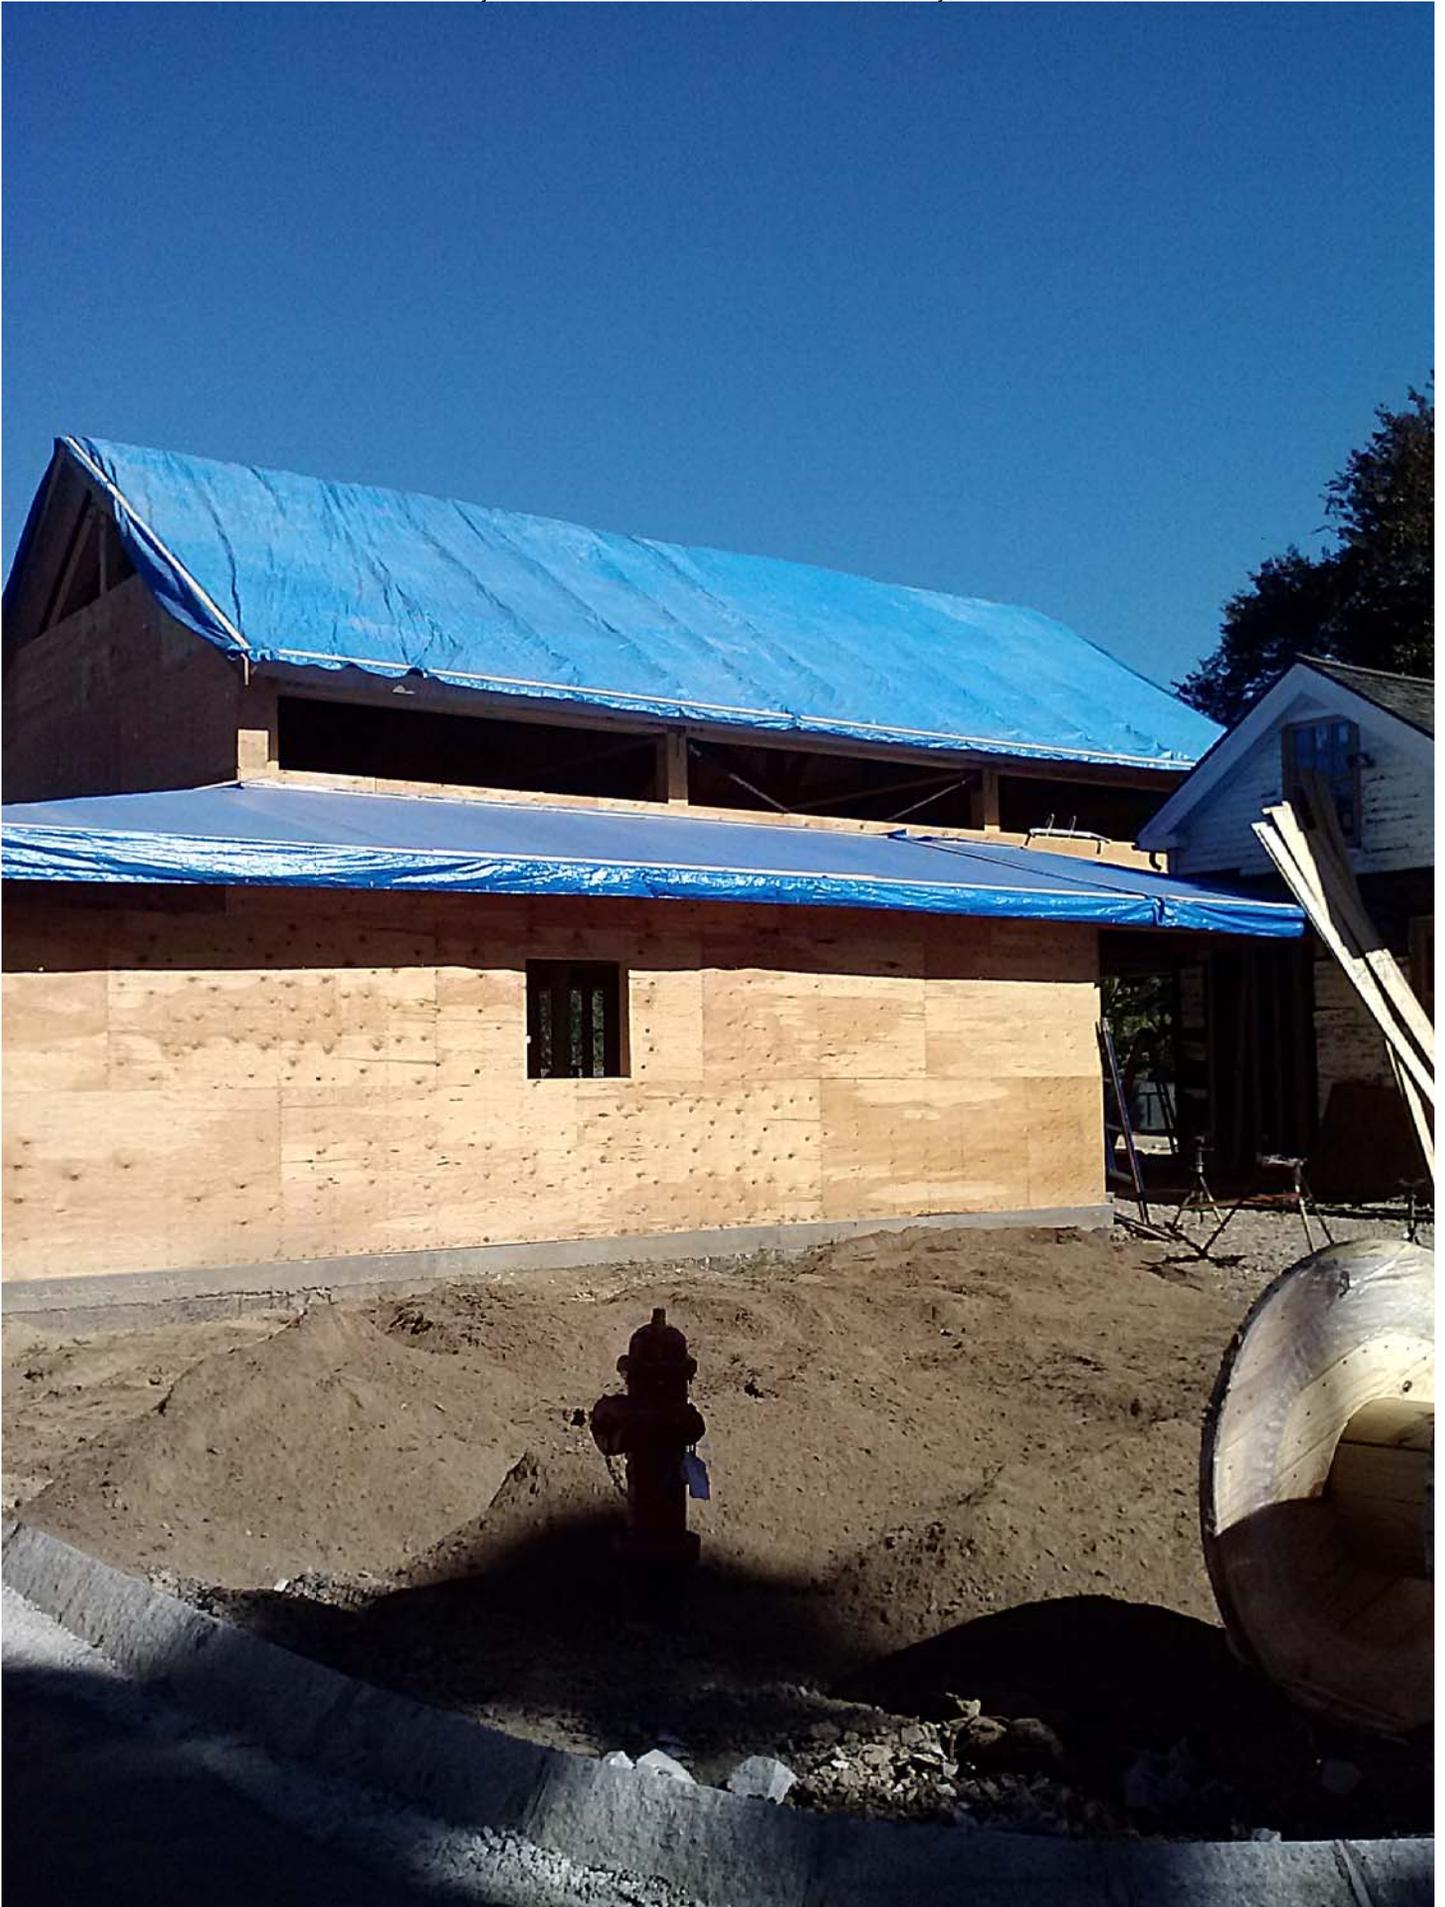
Addition view from driveway

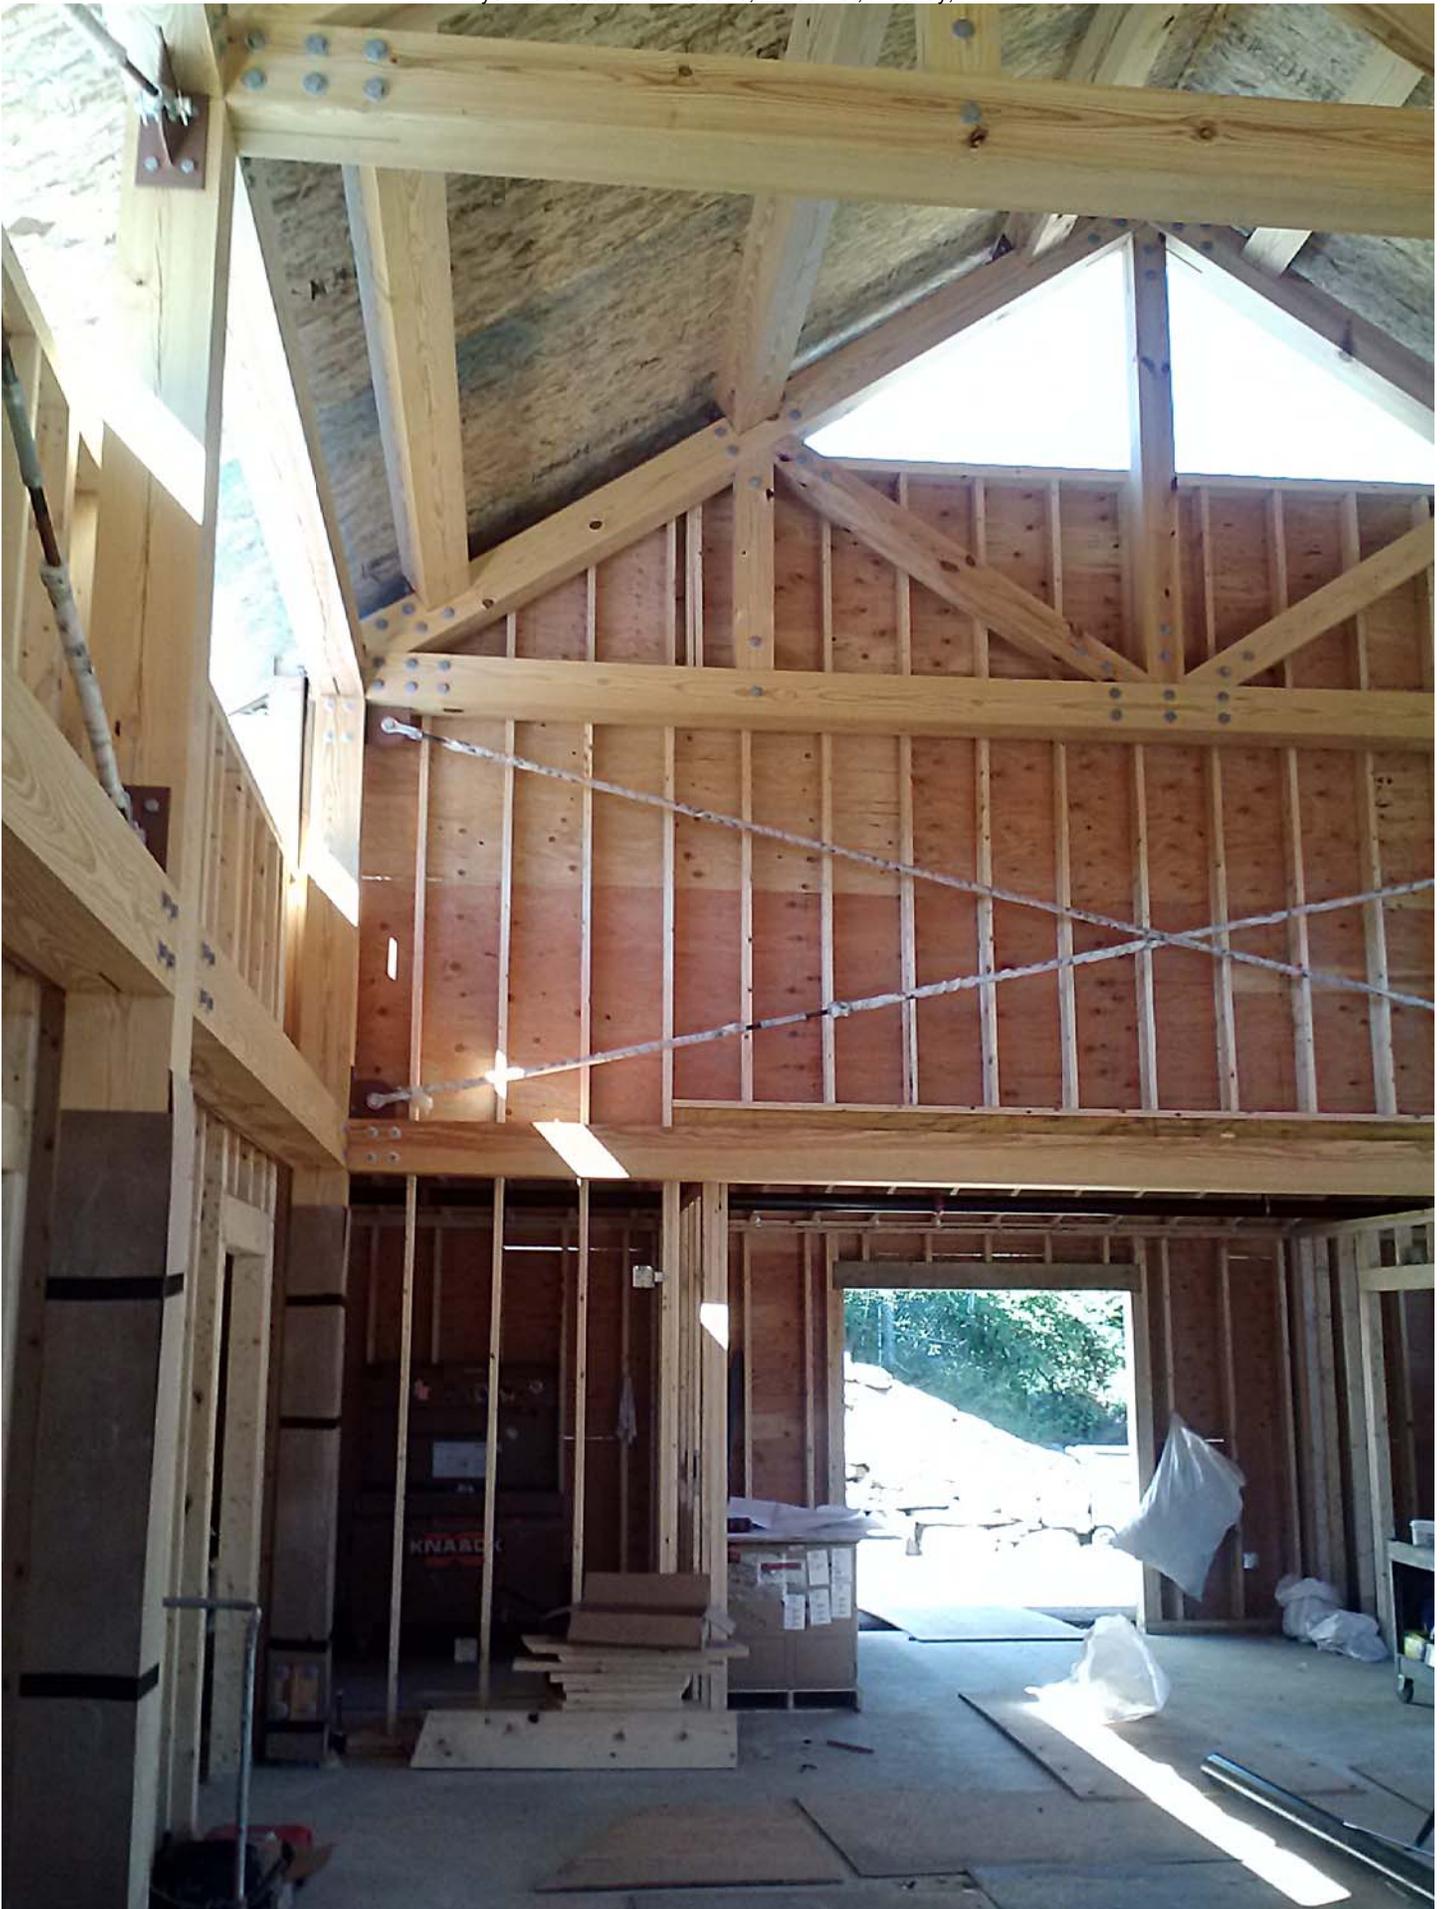
Addition
